Otway Water

- One Giant Environmental Footprint.

Boundary Creek

October 2008

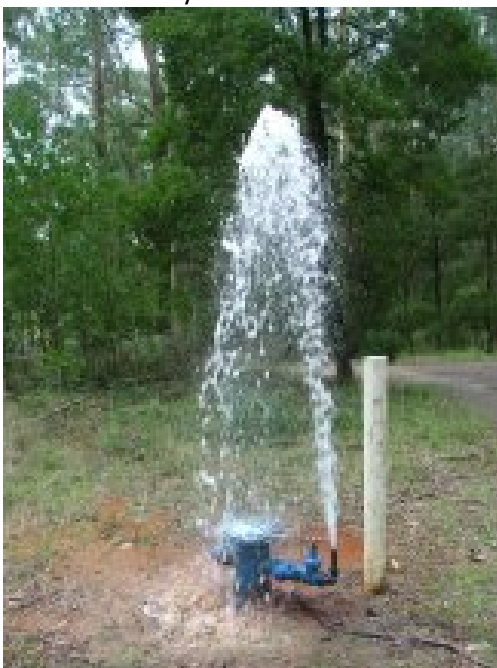
This is Bore 82840 along Wire Lane, Muroon. The corrosive effect of the groundwater is obvious.

In 2004 this bore was no longer considered artesian as indicated in the groundwater extraction Licence Number 893889 (see page 9). Under normal conditions this bore would be

regarded as artesian. Stop the groundwater extraction and this bore would replenish and water would freely flow from it.

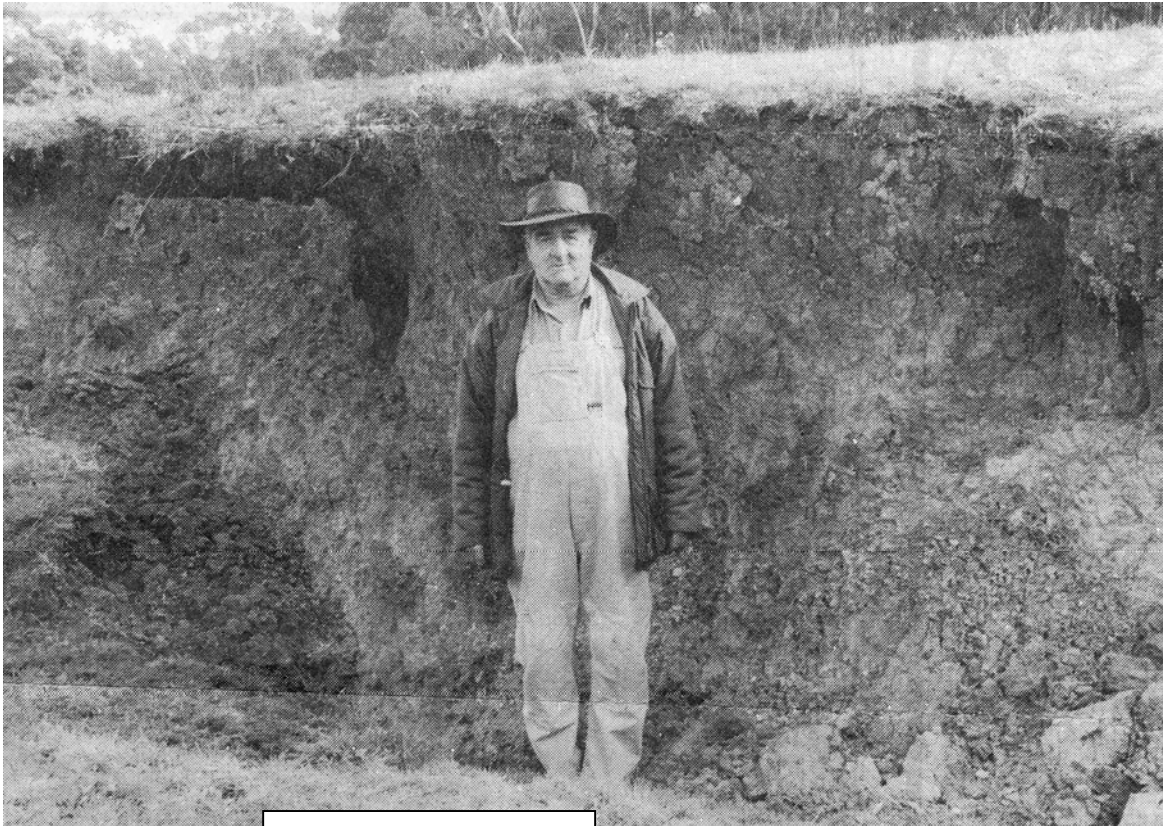
These two black and white photographs were taken in September 1990. The Barry property is in the headwater area of Boundary and Ten Mile Creeks at Barongarook. No conclusive reason for this subsidence was reached but the report in the Colac Herald makes interesting reading.

Mr Barry standing in the depression where the earth has fallen away.

He said the only way to repair the damage was to bulldoze it and resow.

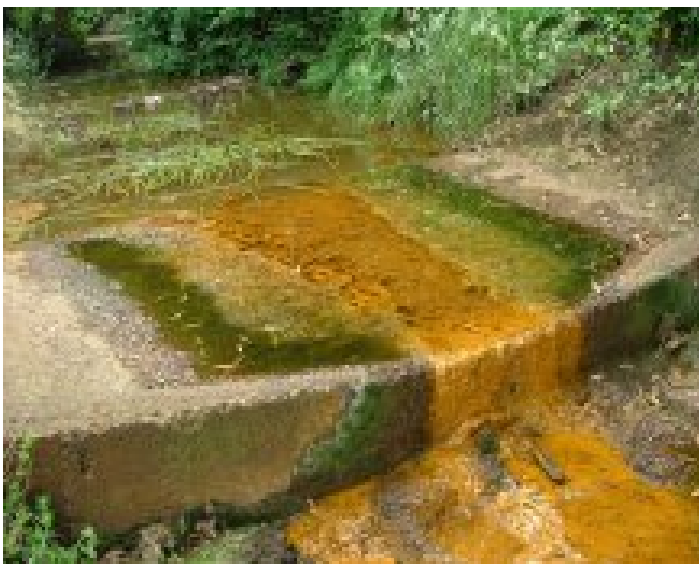
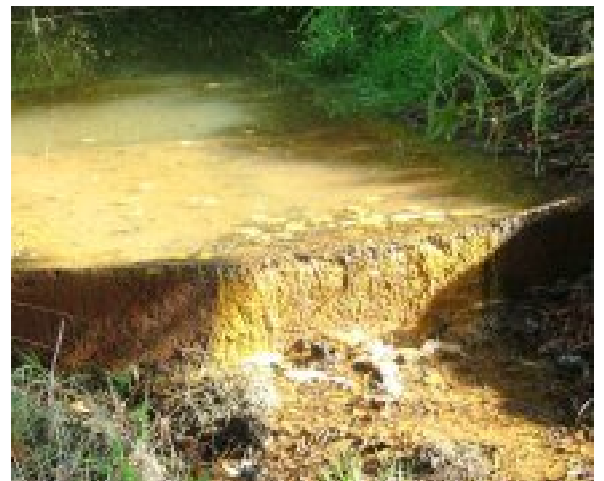
The oxidising acid sulfate soils can cause rust coloured stains and slimes as an orange-red iron oxide scum. This scum can smother stream beds destroying aquatic habitat.

These are photographs of Boundary Creek just after the first rains following a long dry period. This creek used to flow at an average flow of 3.2 ML/day before groundwater extraction took place.

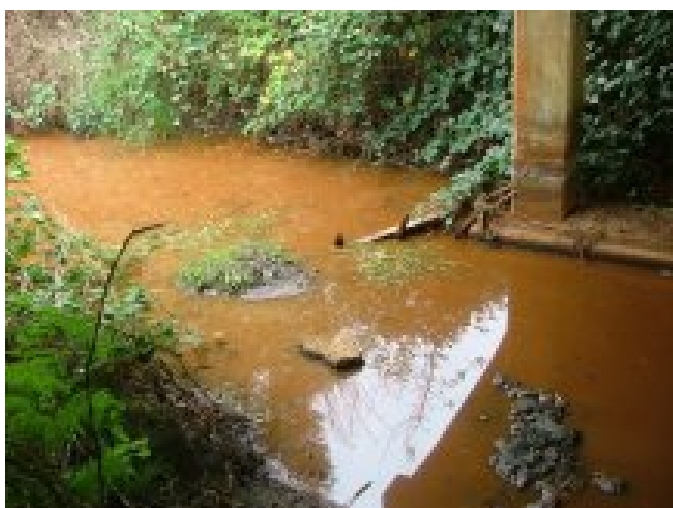
This site is at the stream flow gauging station site code number 233228 on the Colac to Forrest Road, Yeodene.

The water in this photograph turned a red rusty colour once the flow over the weir at the Forest Road bridge ceased.

There would appear to be evidence of concrete corrosion on the bridge pylons.

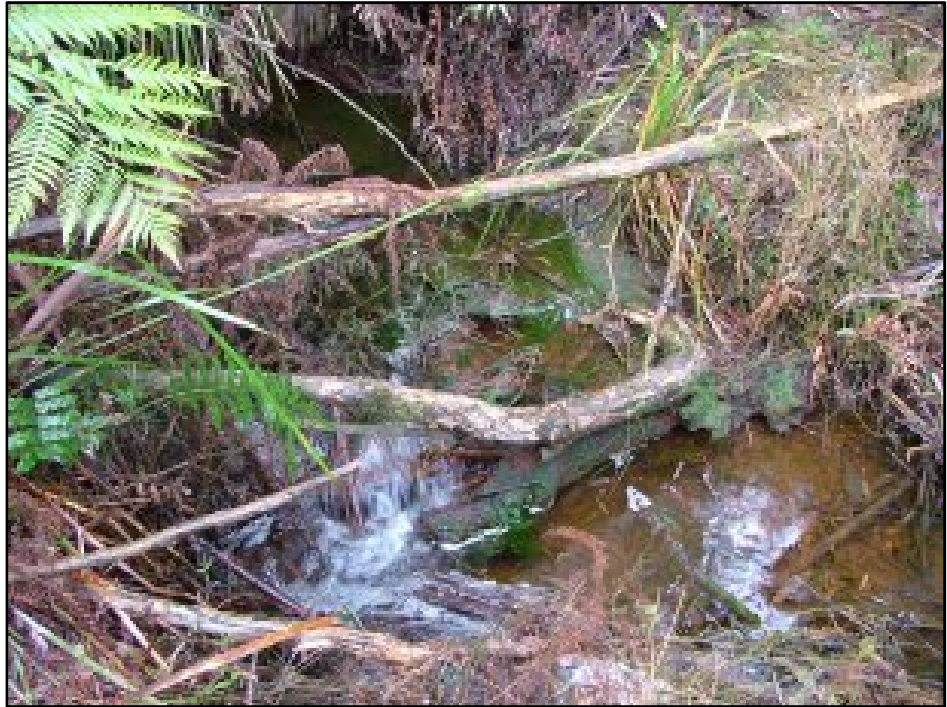
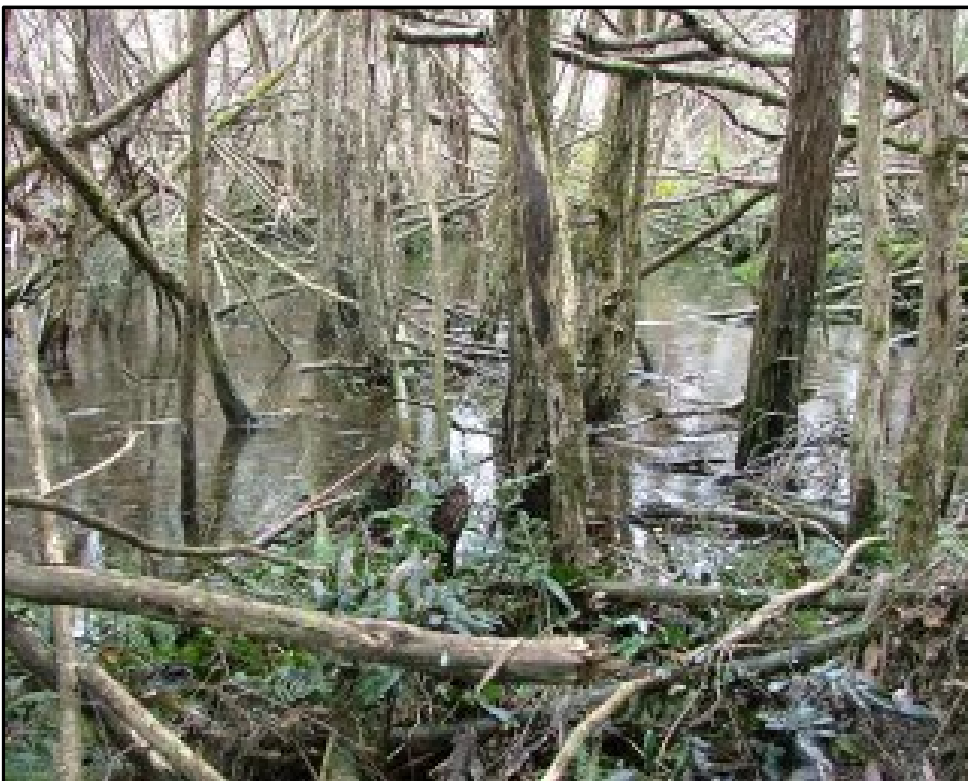
Soil from a dry area in the peat 20 metres from this picture was tested using a simple pH soil test. At 45 mm the peat was dry. At one metre it was moist and between 1.2 metres and 2.2 metres it was wet. These samples tested between 4 and 5 pH.

The pH in this backwater was 2.3 and the EC was 650. At first glance this area appeared to be relatively healthy. However, there was much fallen vegetation and signs of stress - as evident in this photograph.

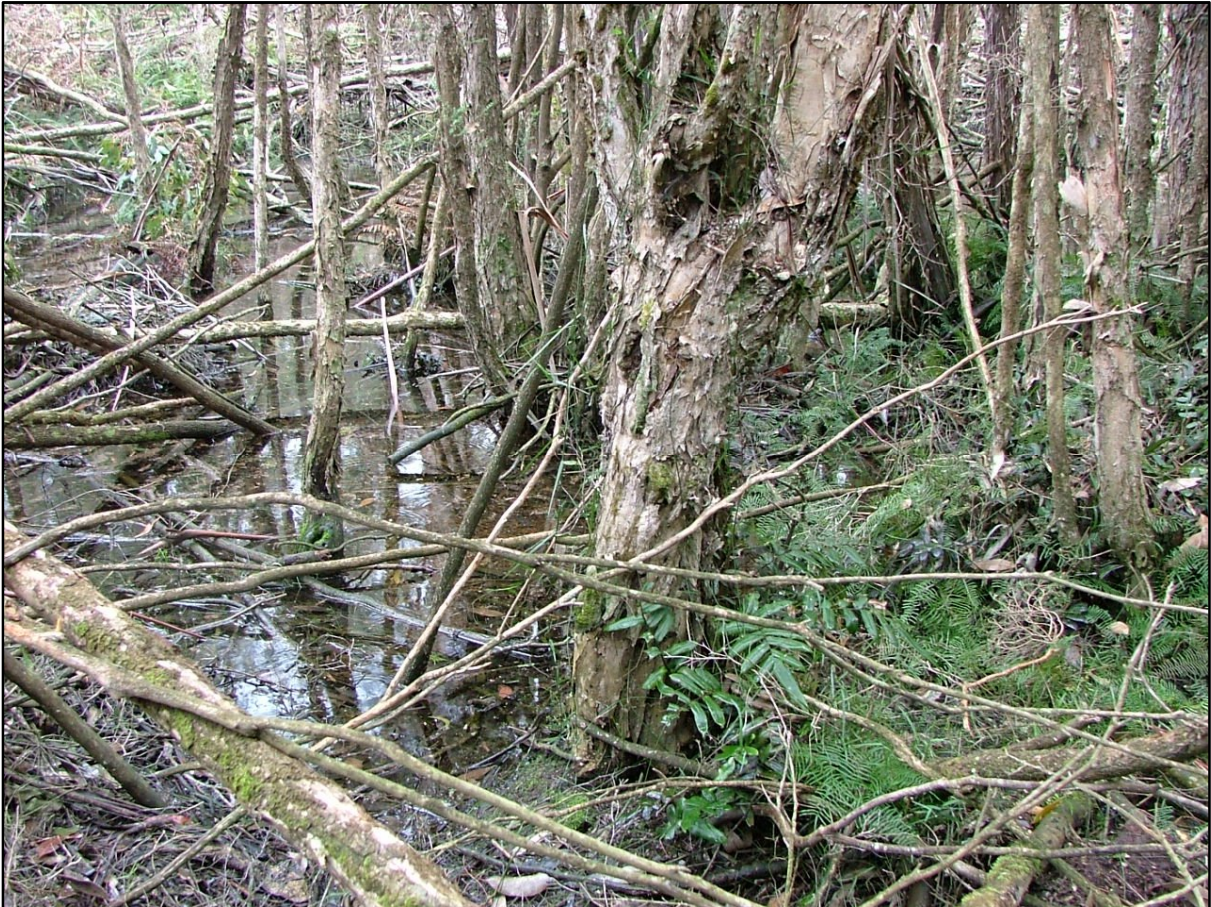
This photograph is looking down over Site two.

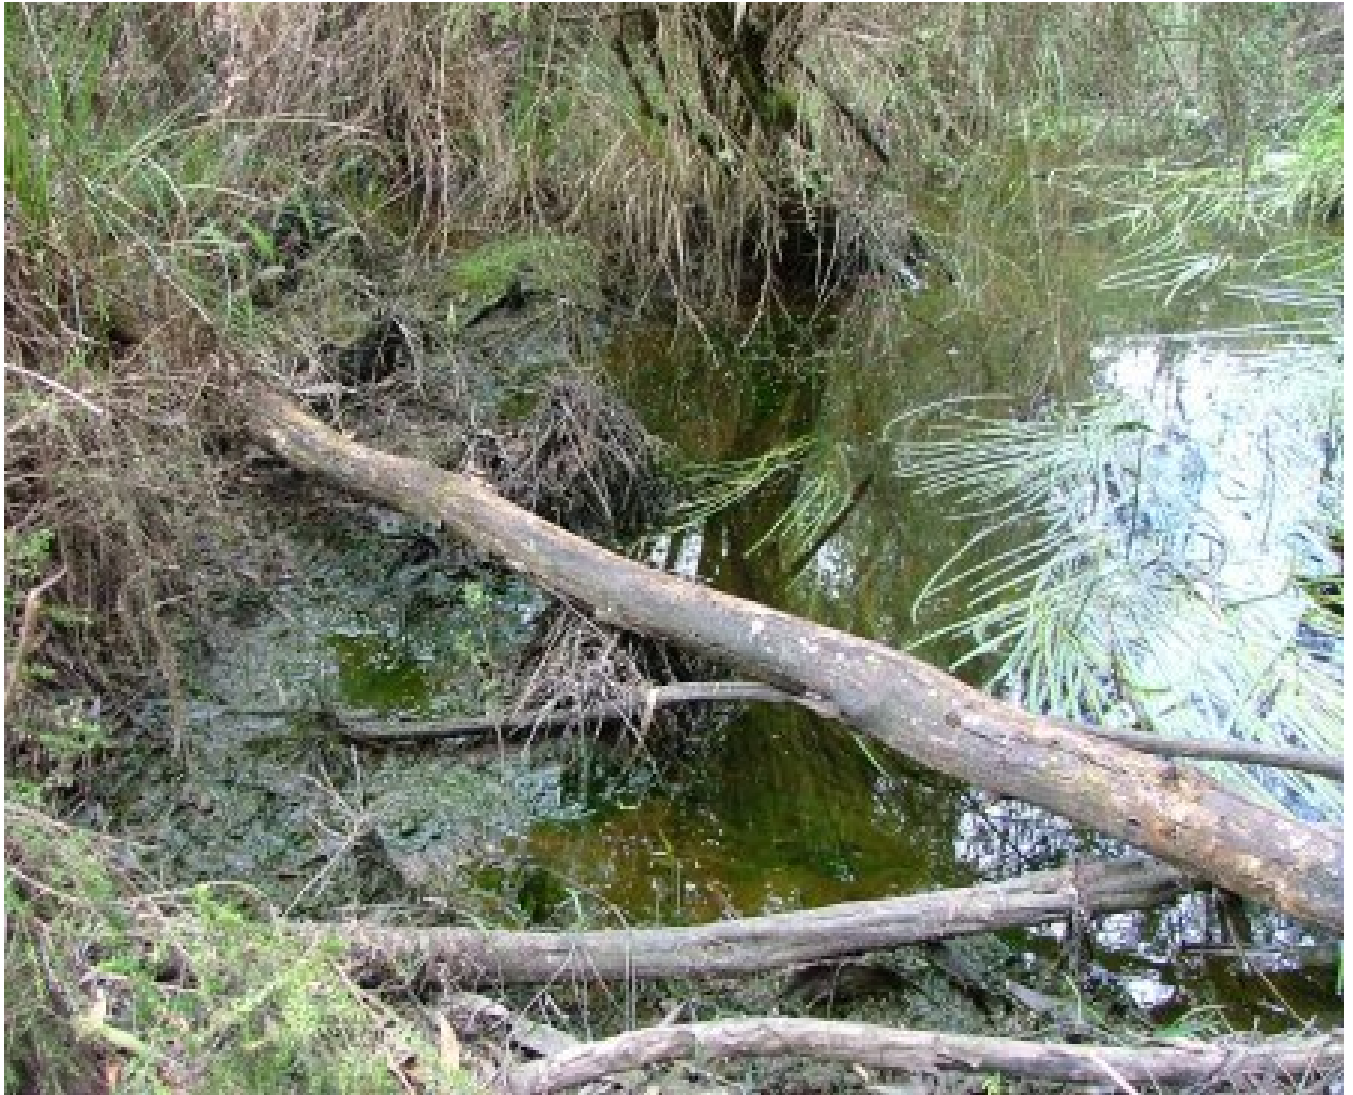
Boundary Creek was running at a pH of 4.1 and an EC of 420 at the site in this photograph. Along this section of the creek first appearances gave the impression that it is a healthy stream. On closer inspection the algae blooms don't appear to be kept under control from algae grazing life forms.

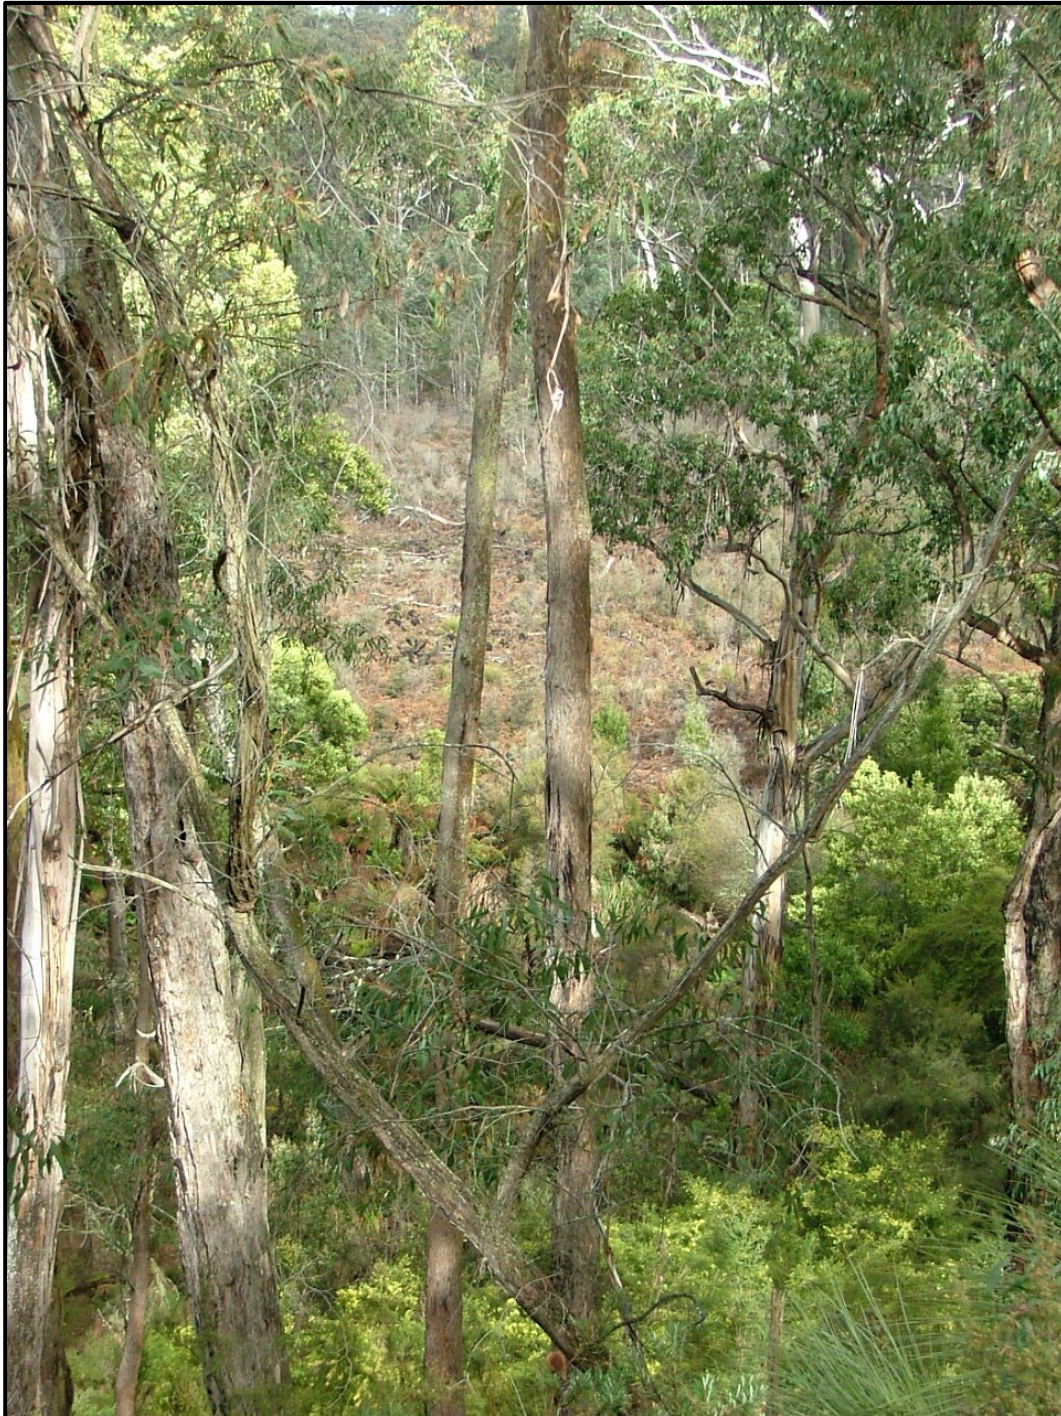
In the middle of this picture the dead and dying wetlands are quite evident. This area should be as rich and vibrant looking as the rest of the vegetation skirting this wetlands area.

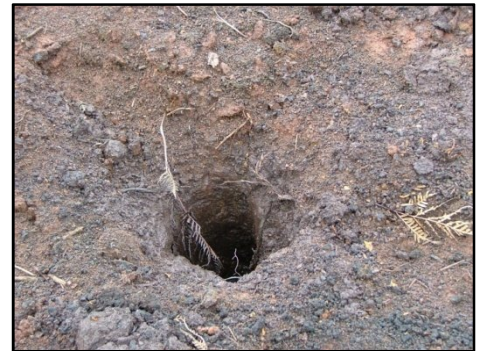
moisture was located at 75 cm and left for 45 minutes before the water sample was extracted from the hole. The sample tested was 2.5 pH (15 Sep. 2008).

This site within 50 metres of the creek shows absolutely no sign of animal life in the soil. Logs and peat alike can be turned over and searched minutely and no animal life form can be found. The surface peat is dry, bracken fern struggles to survive and to find any fungi is a most difficult task.

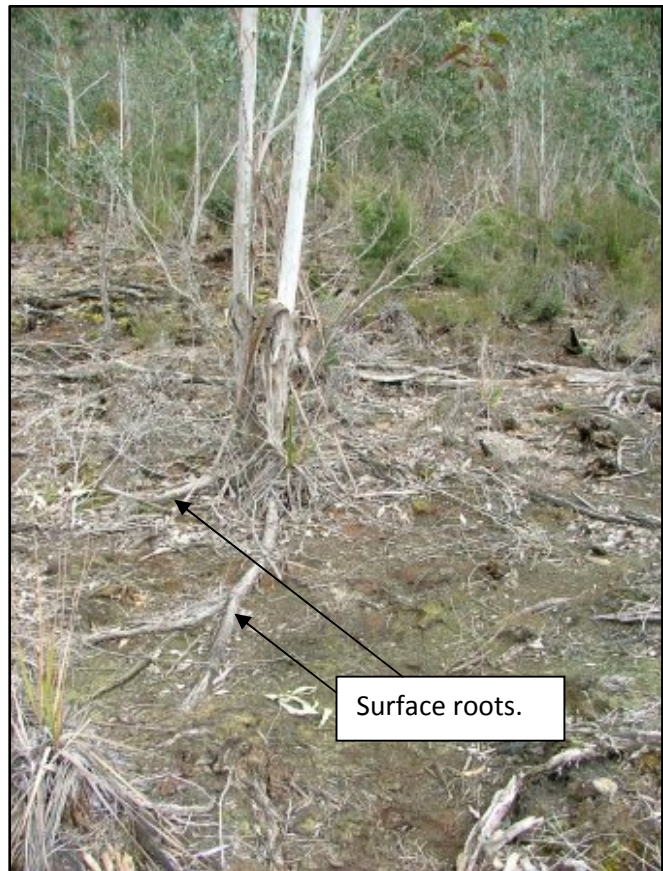
There are areas of the peat displaying hydrophobic reaction to water. This means that the peat and water repel one other. This is quite unusual considering this whole area was water logged pre groundwater pumping. The soil being hydrophobic also creates a problem for any seed germination.

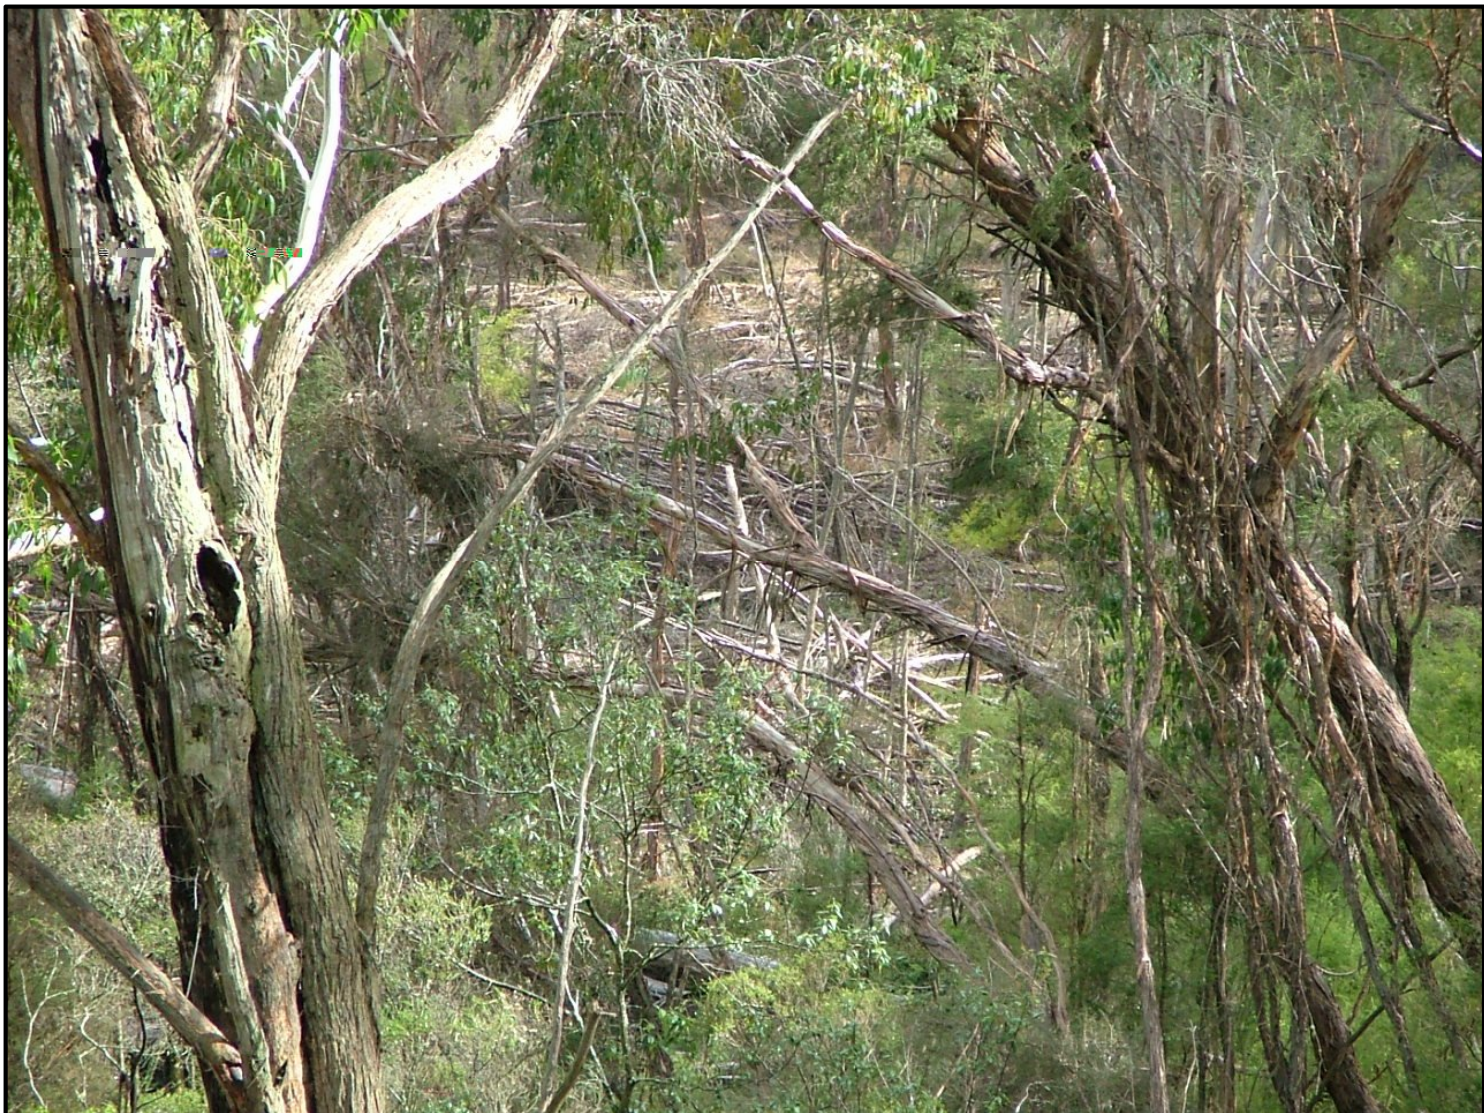
Site Six

A hole was hand dug through the dry peat until moisture was located at 50 cm and left for several minutes. By this stage the water had risen to the 30 cm mark in the hole. A sample was taken for testing. It tested out at 2.6 pH (15 September 2008).

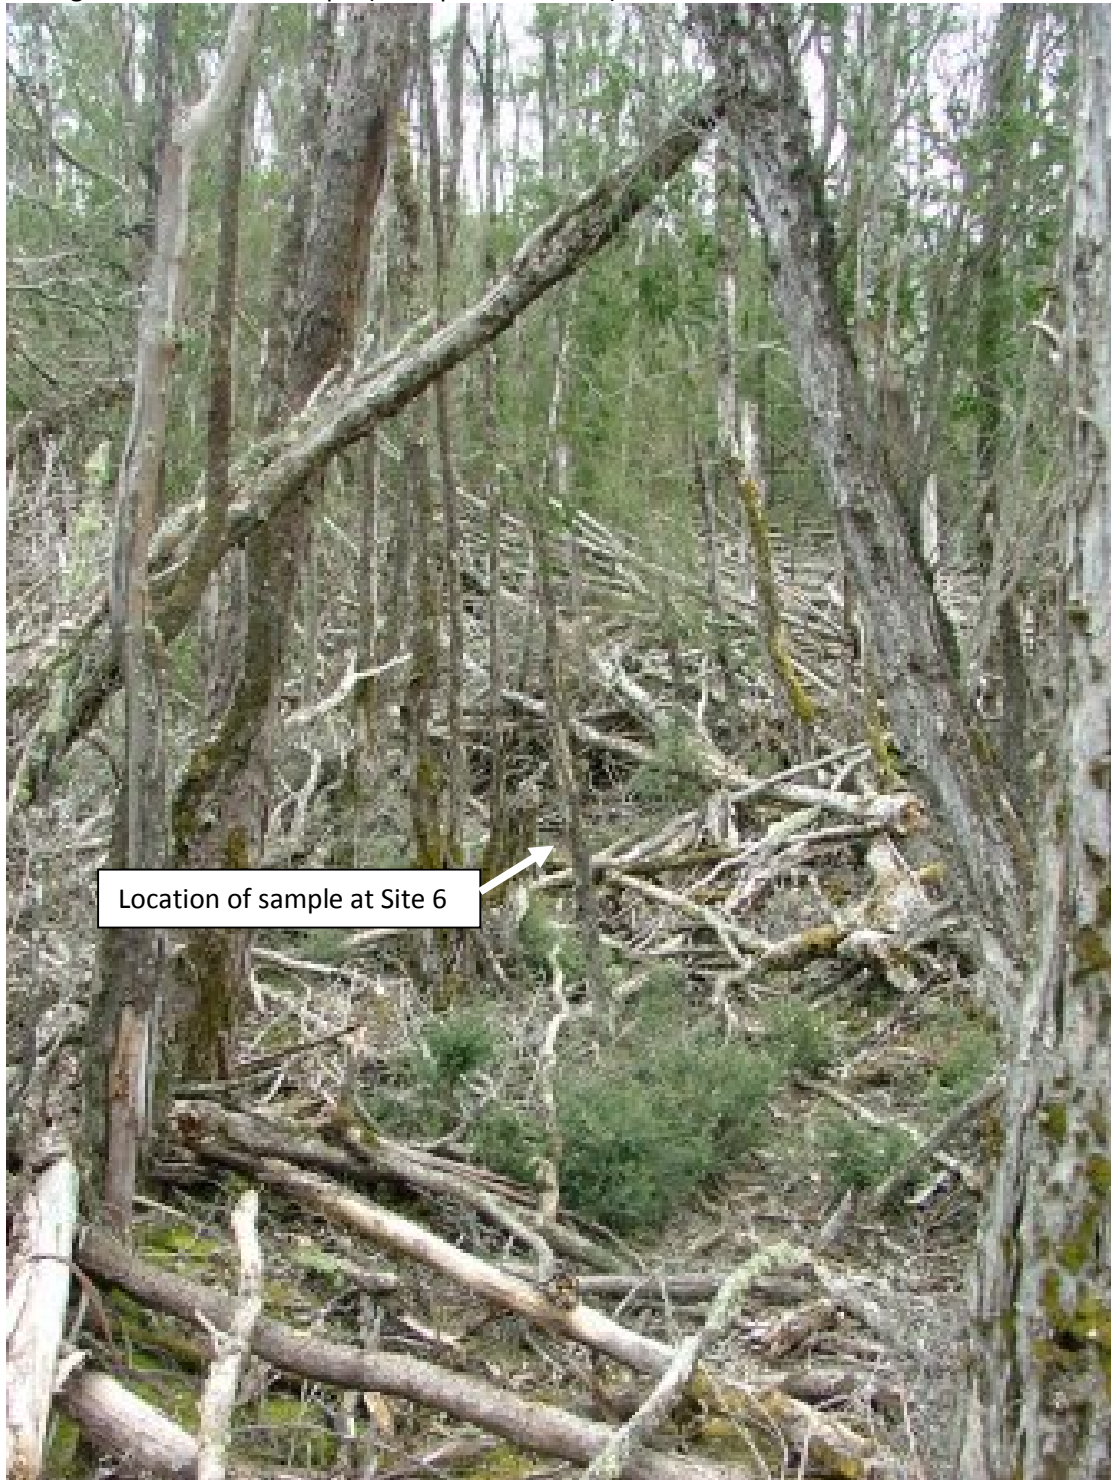
This site is downstream of the “moonscape” 1996 fire area (Sites 4, 5) and has no evidence of any fire. Much of the dead vegetation is still standing whereas the rest has fallen in the direction of the prevailing winds. This area could have been scorched by the peat fires and consequently died but it could also have died as a result of the acid in the soil slowly leaching downstream killing the vegetation as it spreads into the root zone.

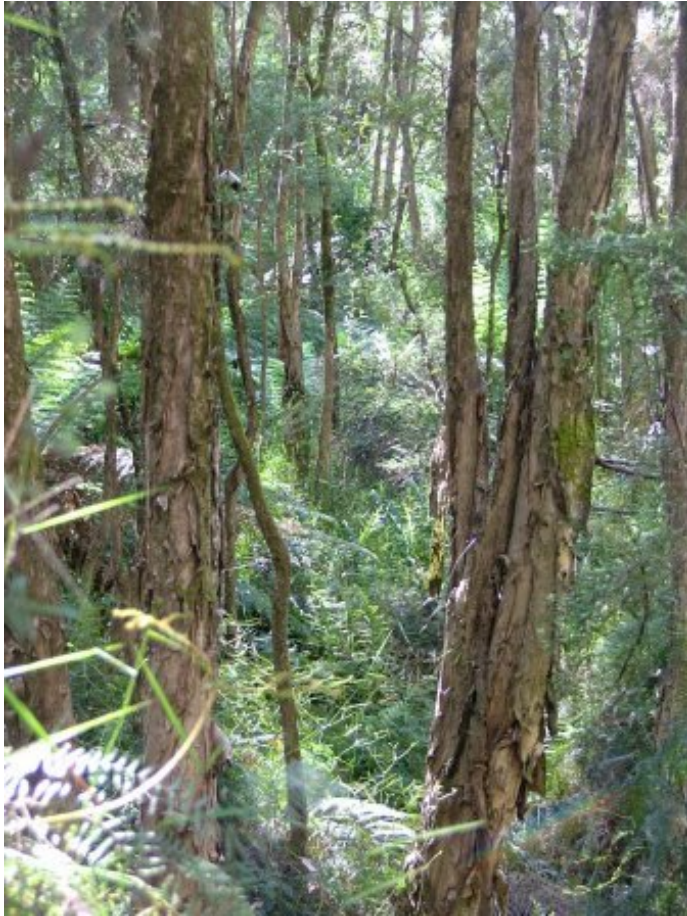
Ten Mile Creek wetlands, saturated, vibrant and healthy.

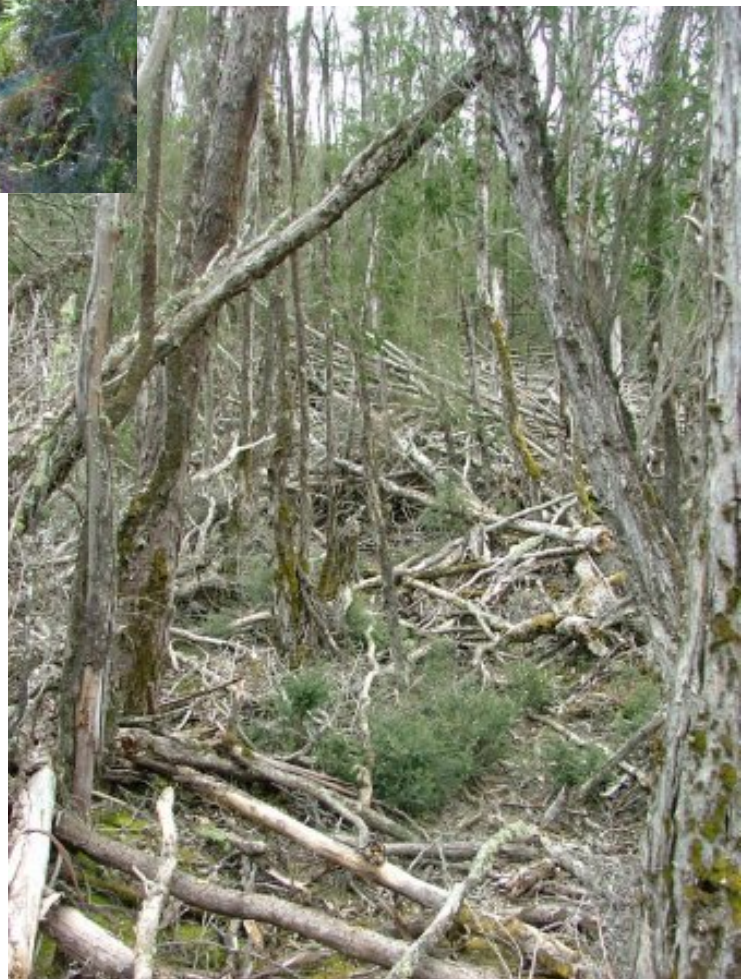
Boundary Creek wetlands under considerable stress.
