**APPENDIX**  
to  
**Save the Barwon River**  
**LAWROC**  
&  
**Otway Water**

# Appendix.

# Appendix One EPA Report Number 8100017391, Inspection report No. 80011868.

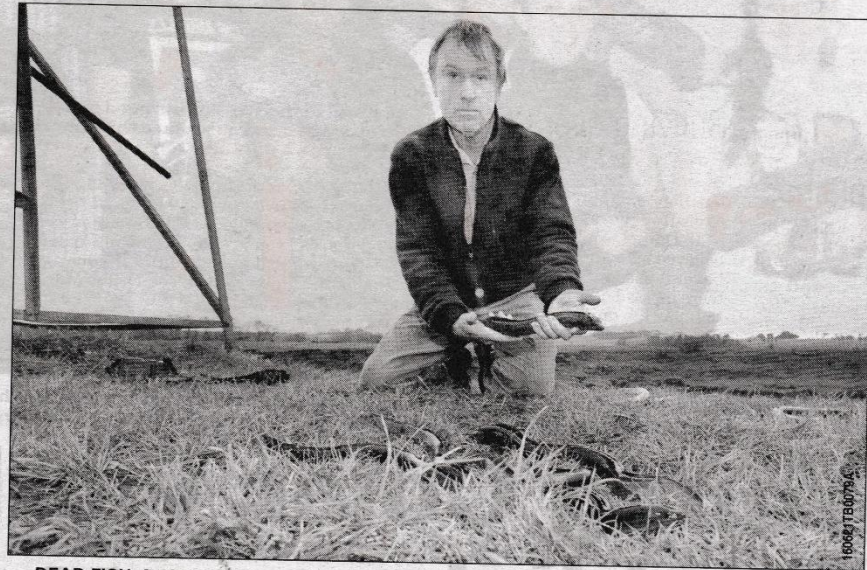
**DEAD FISH:** Andrew McLennan inspects the Barwon River where acidic water has killed fish.

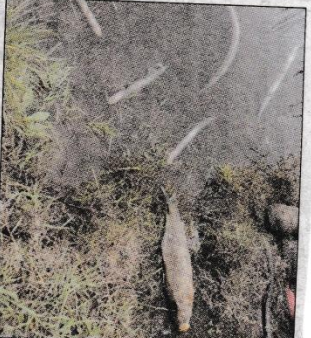
**DANGER ZONE: Acid leaching from acid sulphate soils has killed fish in Boundary Creek and the Barwon River.**

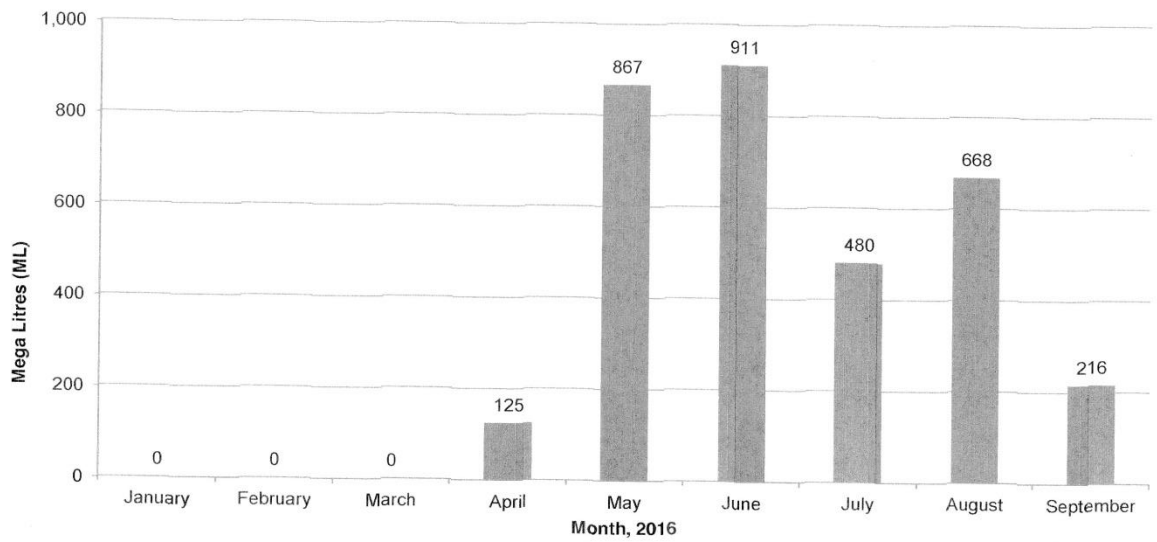
### ML extracted for 2016

**Total = 3,267 ML**
