**"Preliminary Upland Inland
Freshwater ASS Assessment of
Wetland Habitats Around Wannan
Water South Off-take Number 2
Pumping Station."**

**LAWROC (Land And Water Resources Otway Catchments)
as
OTWAY-WATER Book 37**

**Land And Water Resources Otway Catchments, Landcare Group.
(LAWROC)**

Introduction

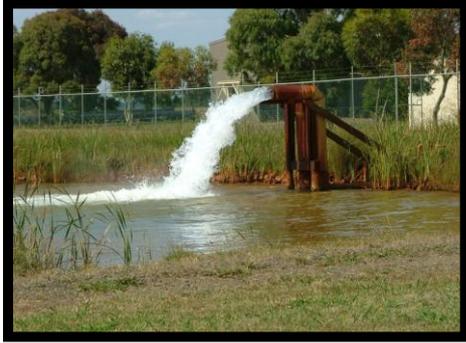
Groundwater extraction.

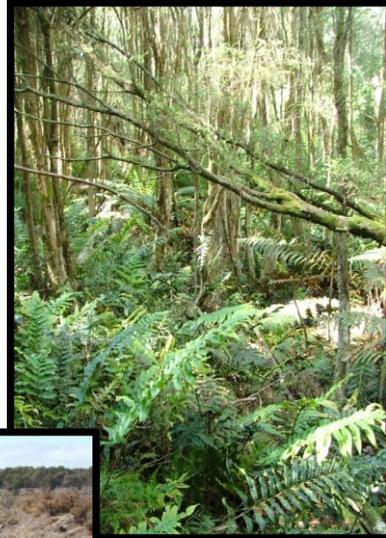
Barwon River at Conns Lane, dry for months on end.

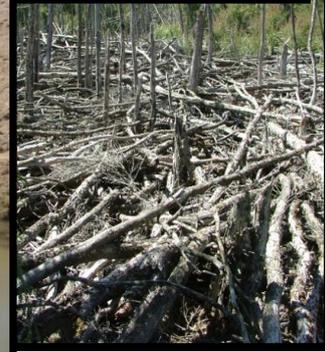
Acid and Aluminium creep.

Site of 1997 fire. Photo taken in 2009.

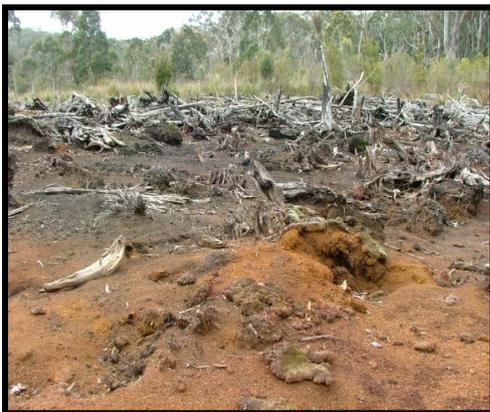
Another site with treated pine post eaten off at ground level . It would appear that inland ASS such as the Big Swamp over in the Barwon River Catchment, is one of the first to be discovered in Victoria and is the highest upland freshwater site found in Australia and coincidentally one of the worst.

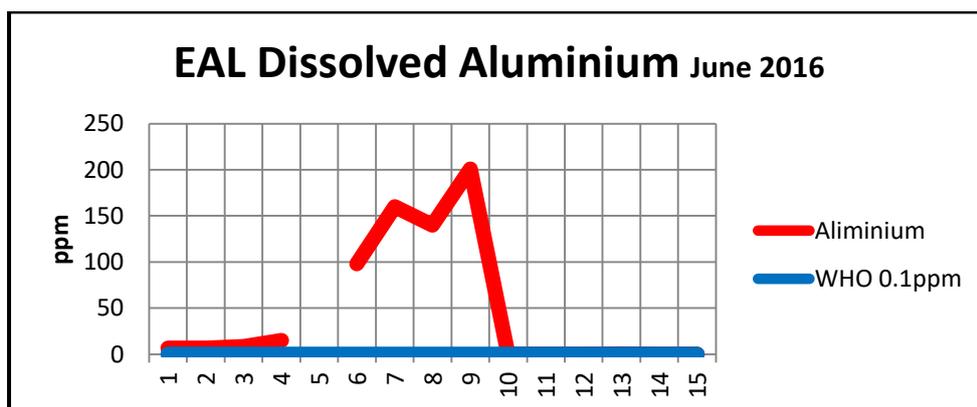
Below are some of the analysis results of water taken during the 2016 thirty kilometre *fish kill* down the Barwon River. The contamination at Sites 6, 7, 8 & 9 along the Barwon River originated from the Big Swamp's Actual Acid Sulfate Soil.

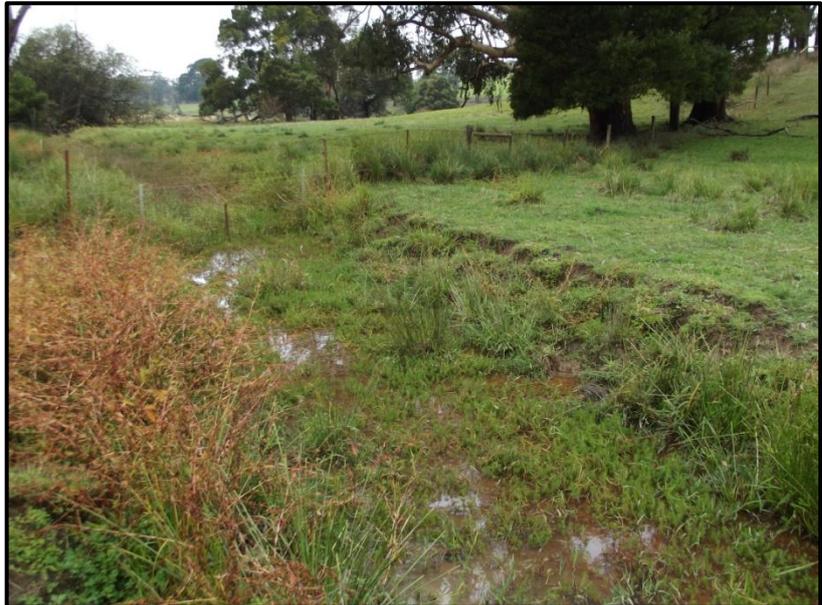
SITE 1.

East side of the Gellibrand River in a drainage line (man made). The non flowing water level in the drain was approximately 500 mm below the pasture surface. The soil sample was taken 300 mm below the drain profile.

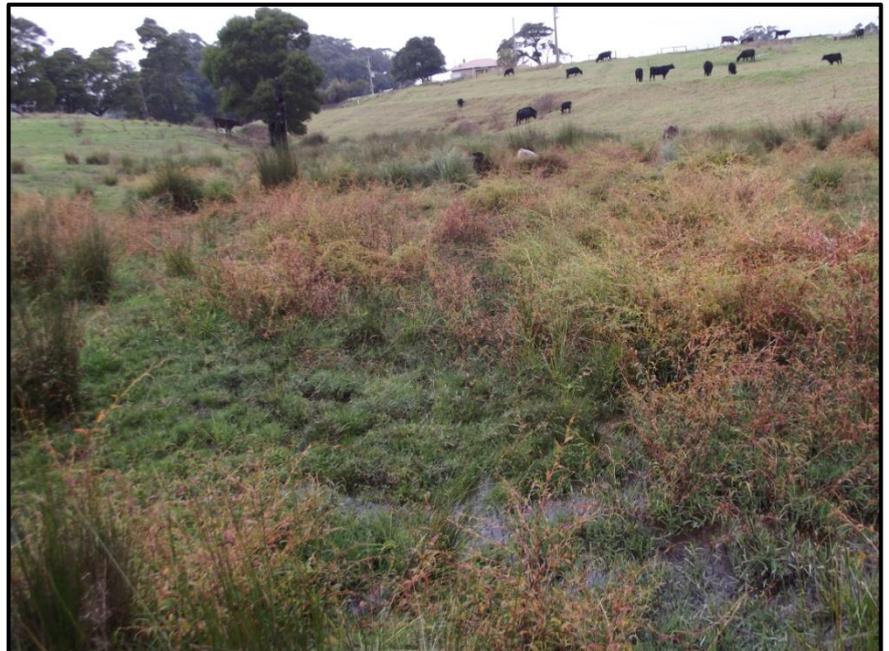
SITE 2.

This site was in a swamp situated in surrounding pasture. Cattle had access to the swamp. This was also on the east side of the Gellibrand River. There was running water. The sample was taken 300mm down the profile.

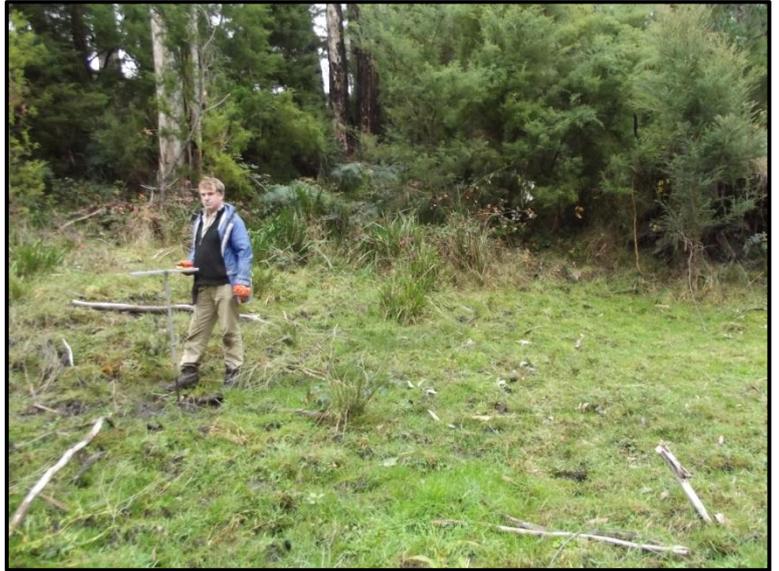
SITE 3.

This site is 50 metres from the west bank of the Gellibrand River in a slip area. It is located below the power lines running up to the No. 2 pumping station. Sample taken at 300 mm depth.

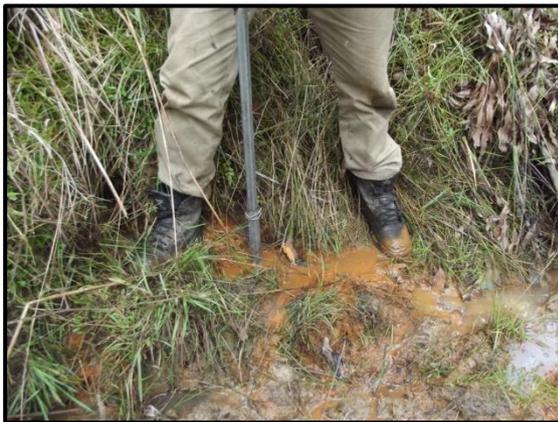
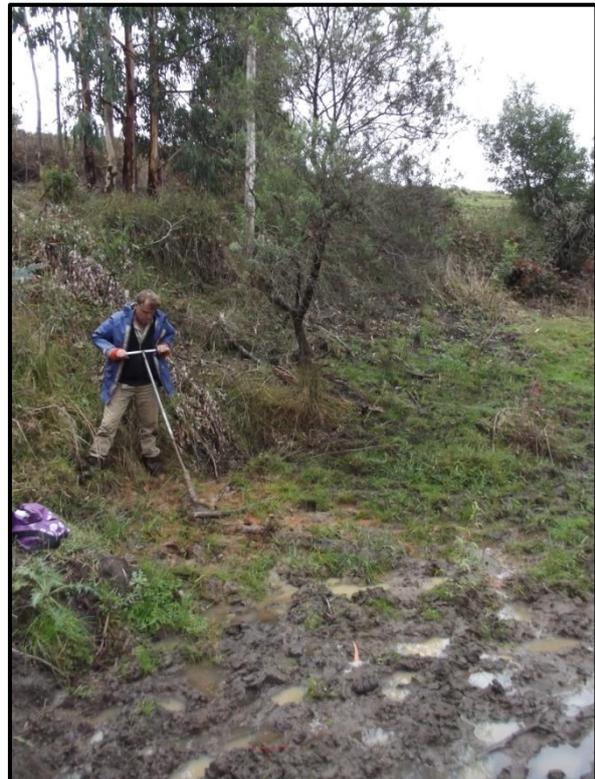
SITE 4.

This site is within metres of Site 3 and had iron floc visible with a trickle of running water. Sample taken at 300 mm.

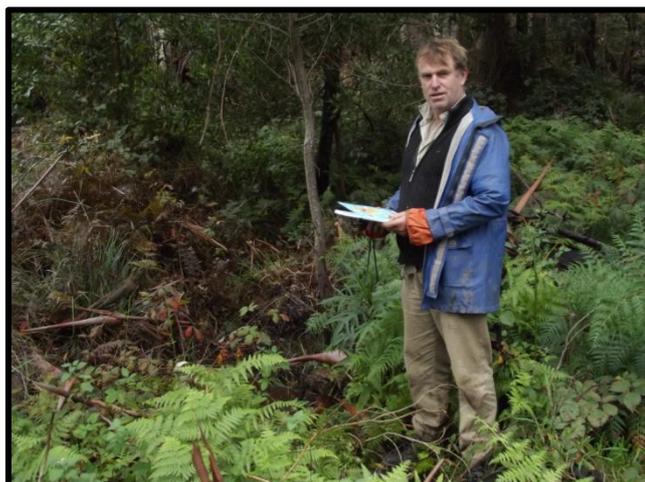
SITE 5.

This site is also on the west side of the Gellibrand River at a creek with substantial flow of running water. Lots of organic matter present with vegetation in a very water logged area.

Sample 5 is 10.5 times over this 0.03% limit. Sample 6 is 6.4 times greater and sample 10 is 2.1 time over the Victorian Action Criteria limit. These cursory figures indicate a very real area of concern.

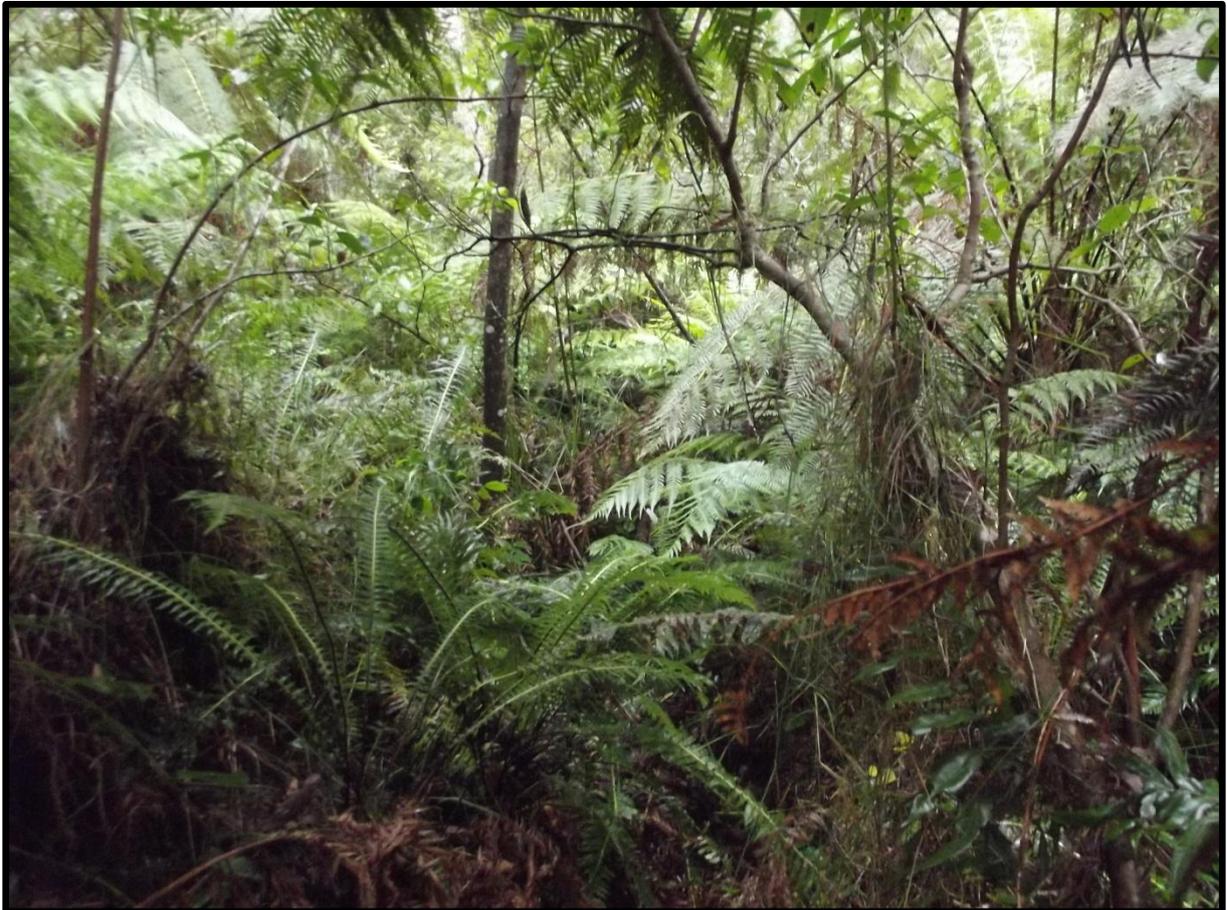
SITE 6.

Site 6 is on the same stream as Site 5 by approximately 100 metres upstream in a heavily fern and tree covered gully.

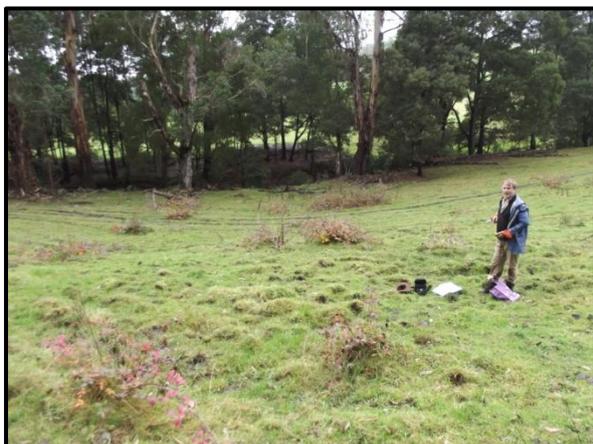
SITE 7.

This site is a soak in pasture and appeared to have been previously “scalded” from acid. West side of the Gellibrand River approximately 80 metres away.

Looking down to the river.

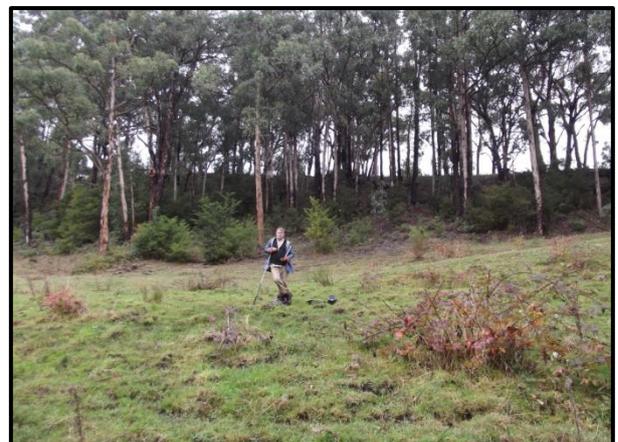
Looking up from the river.

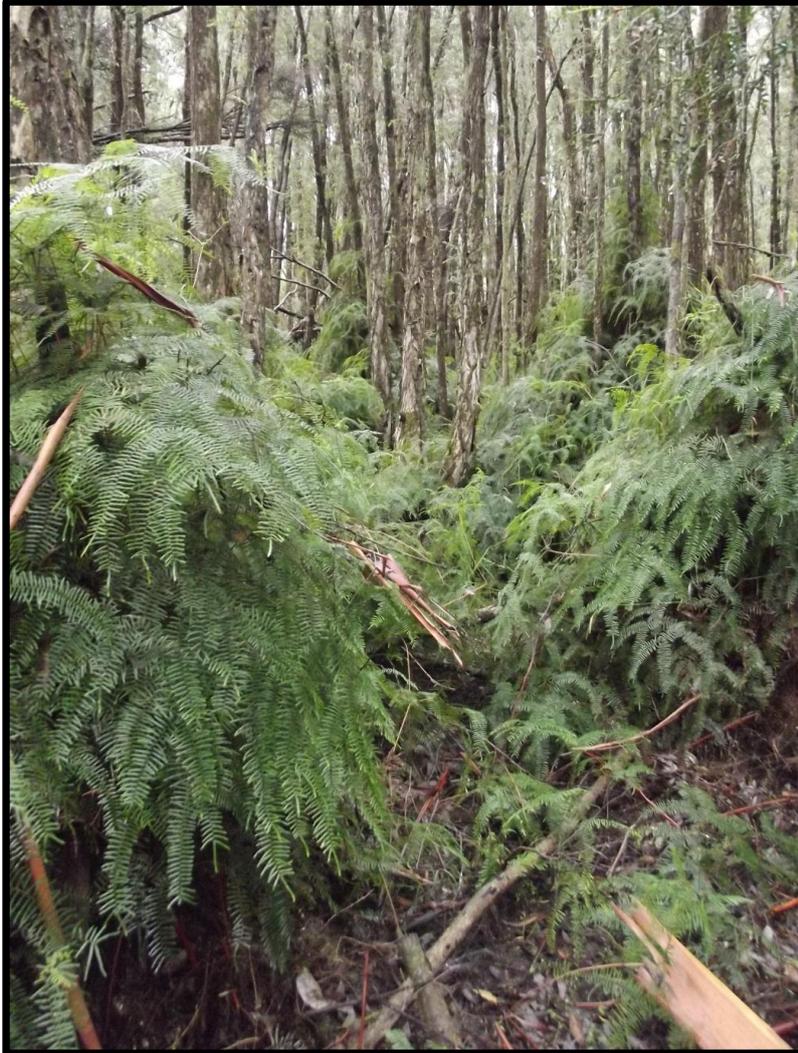
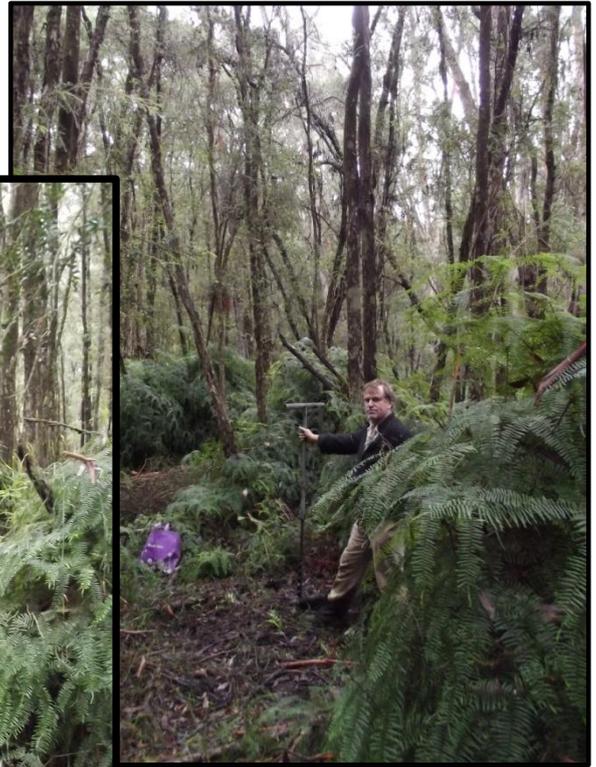
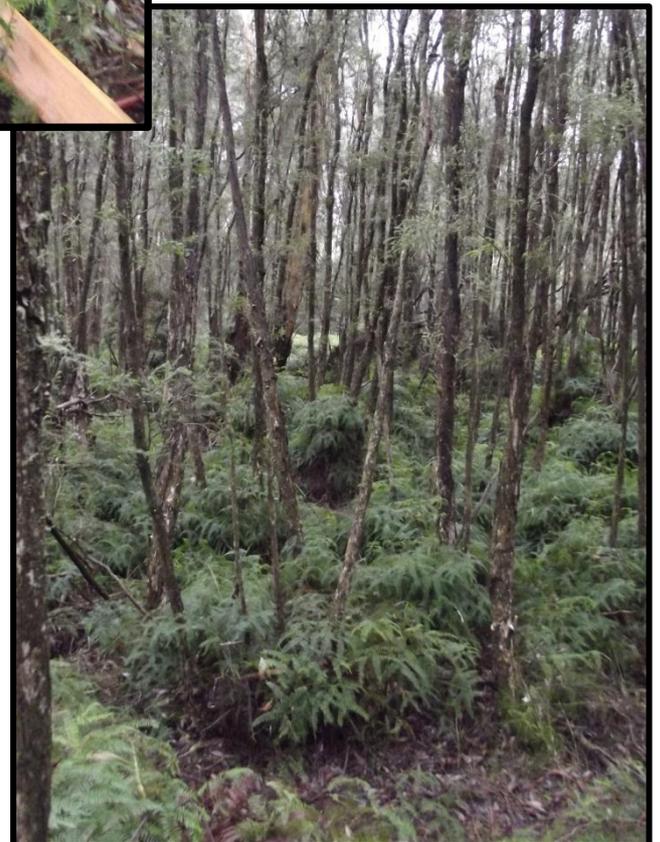
SITE 8 and SITE 9.

Samples were taken from the same profile.

Site 8 was approximately
400 mm below the surface.
Site 9 sample taken was
approximately 800 mm
below the surface.

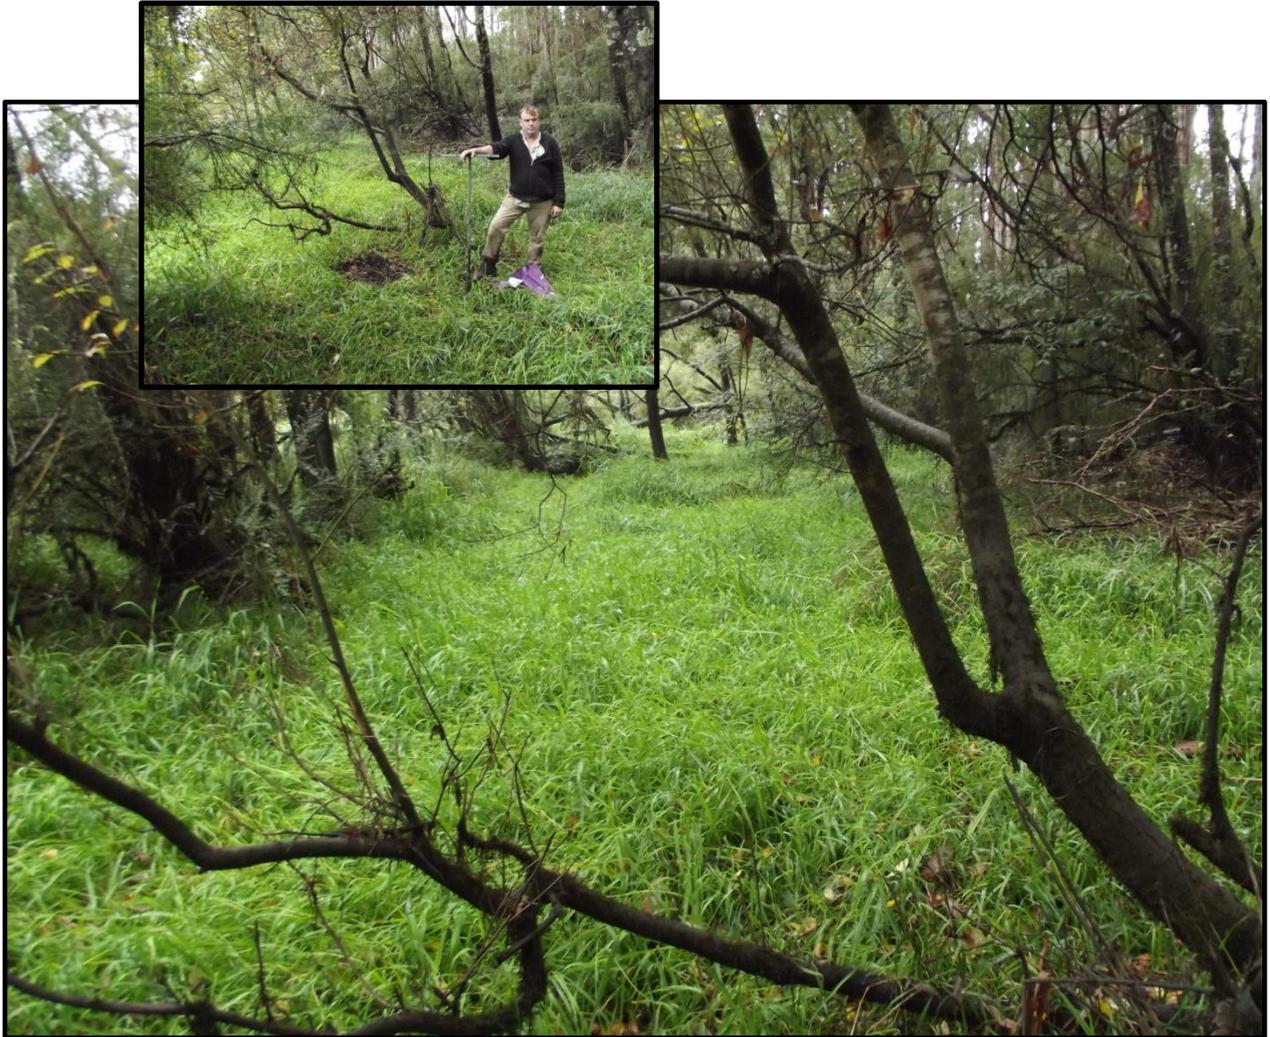
SITE 10.

This site is down on the flats in what appears to be a billabong area adjacent to the Gellibrand River. This site is on the west side of the river and the soil sample was taken at a depth of approximately 600 mm. The vegetation at this site was notably different to the other sites. Coprosma, Blackwood, Hazel Pomedaris and Ghania were present.

There is absolutely no doubt that a thorough assessment of ASS sites, within the drawdown influence from a test groundwater extraction at the Number 2 Wannon Water Pumping Station at the South Gellibrand River Offtake, should be undertaken. This assessment by an appropriate and accredited ASS expert needs to be done before the test pump is to proceed. Base-line data must be collected.

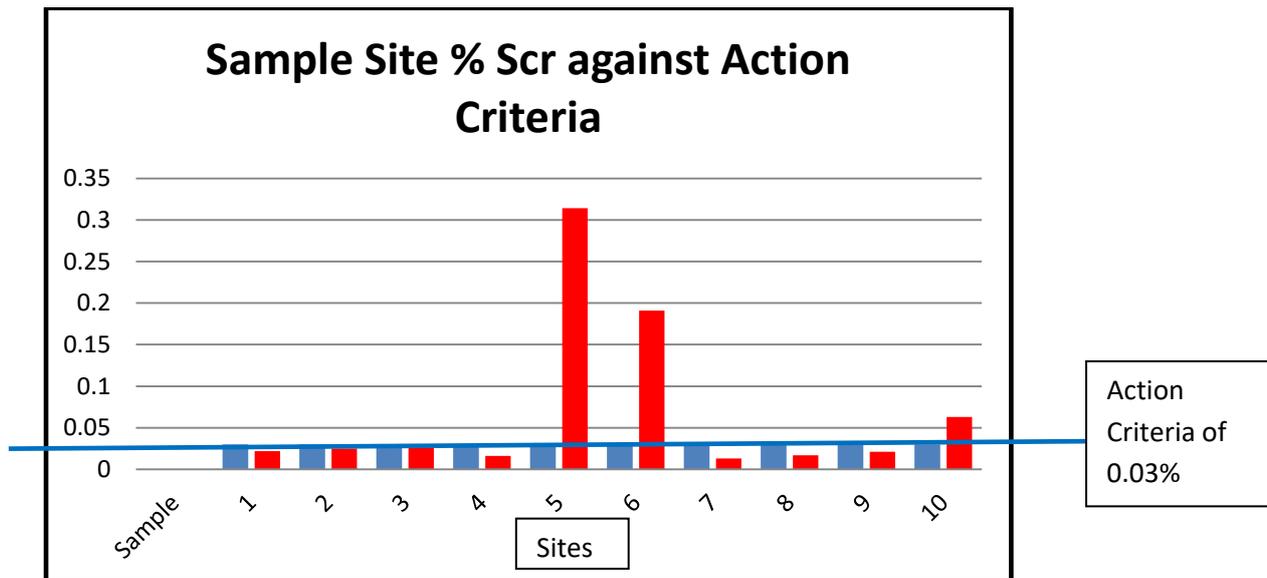
Chapplevale %SCR Levels.

The three readings in red are of most concern and can be regarded as Actual Acid Sulfate Soils. All of the remaining readings indicate they are Potential Acid Sulfate Soil sites to be managed with some caution.

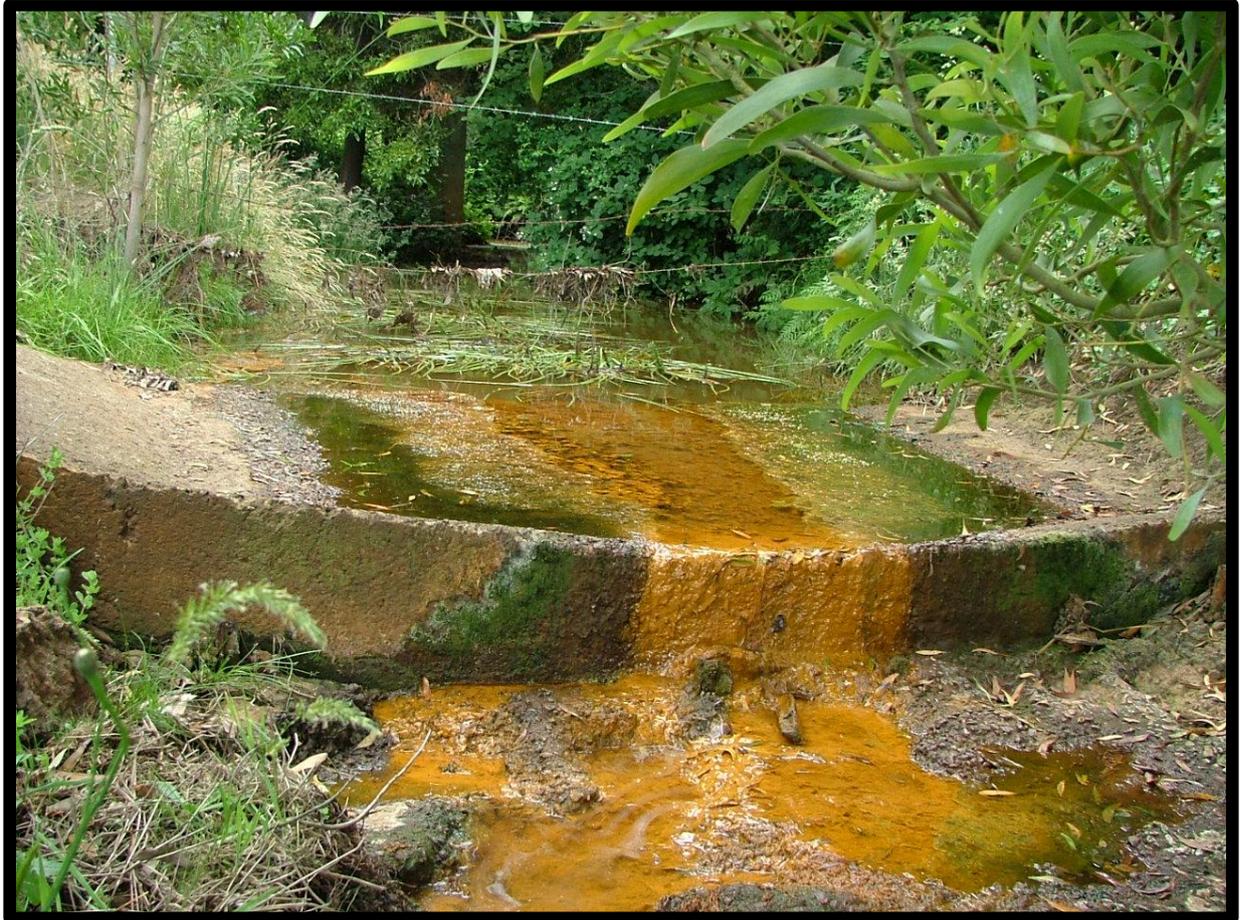
Contamination coming out of the Big Swamp.
