OTWAY WATER

Book 44B.

SEVEN DEAD CALVES along BOUNDARY CREEK – You be the judge.

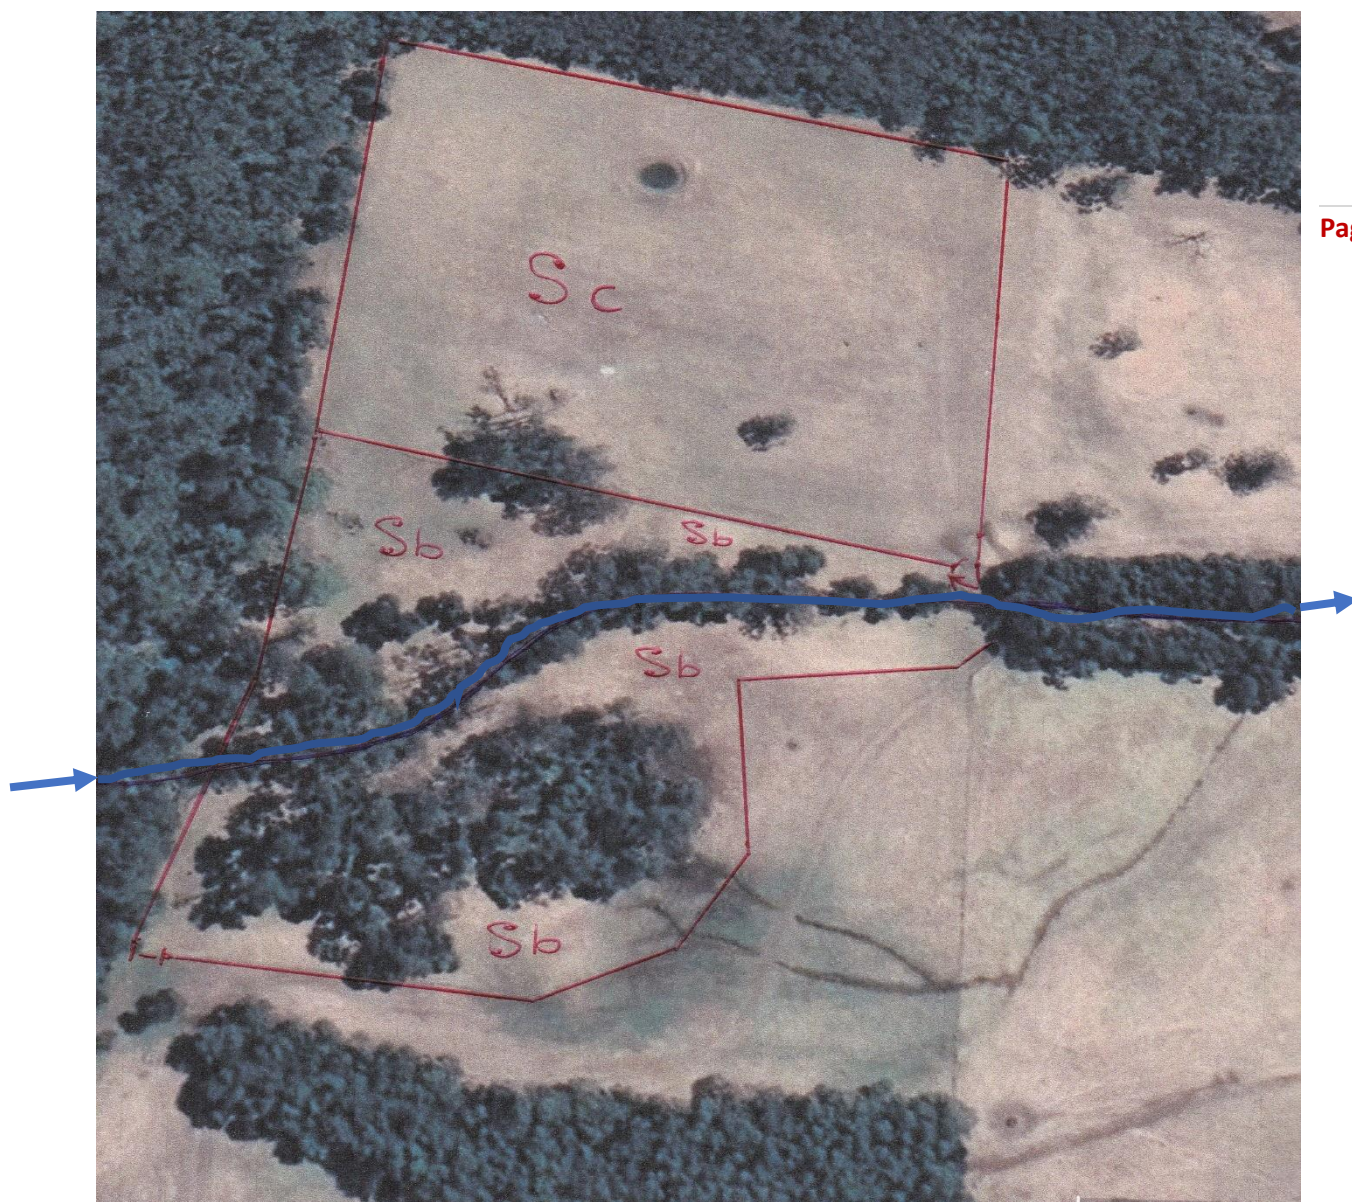
The property runs either side of Boundary Creek. The creek is fenced off from stock access for its entire length. However, there is a paddock around the upper section that stock are occasionally allowed to enter. This paddock is called **Sb** in this document (see the pages 6, 7 and 8).

The herd going into the **Sb** and **Sc** paddocks were herded into paddock **Sb** and left to find their way into paddock **Sc**.

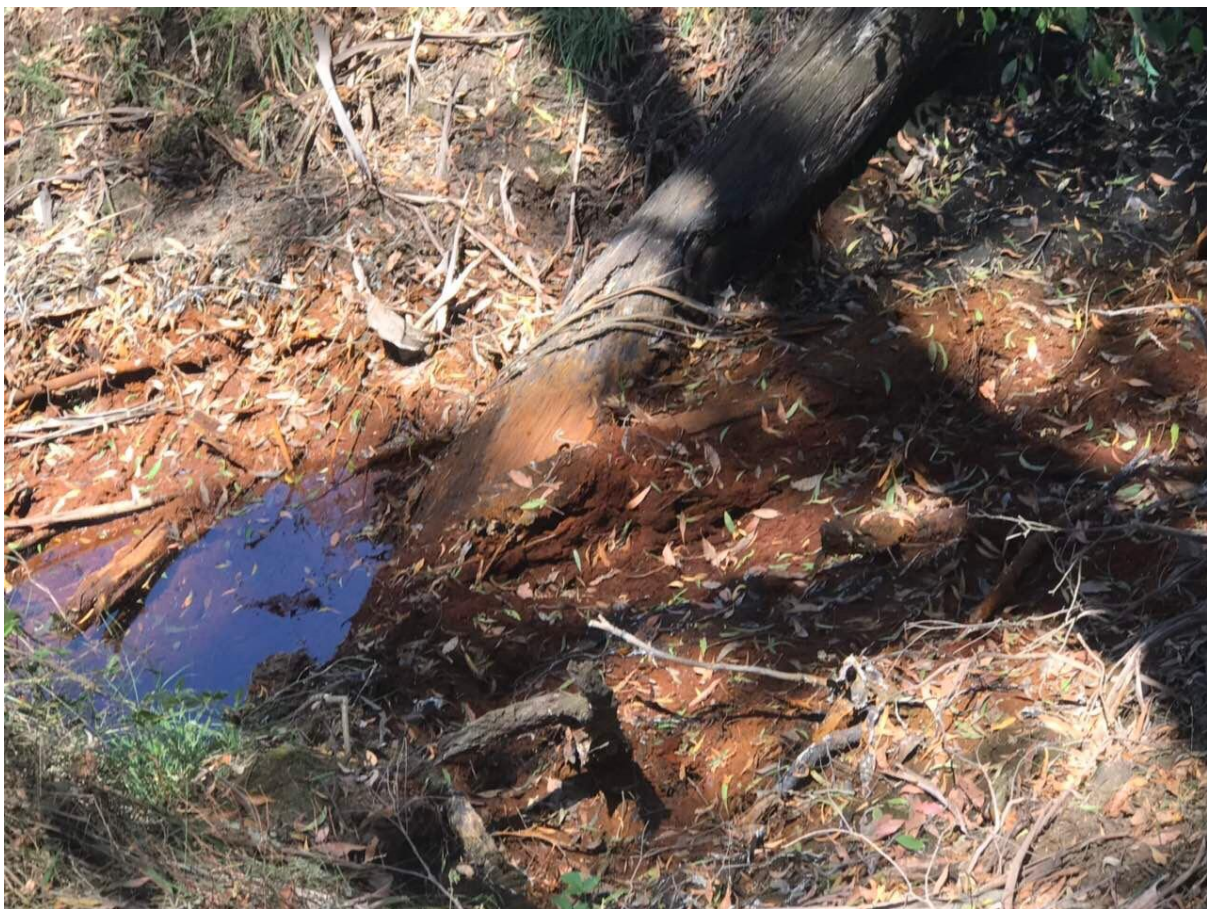
- It has not been assessed but any bacteria in the water would more than likely struggle to survive in water at pH levels of 2.93 and 2.97pH.

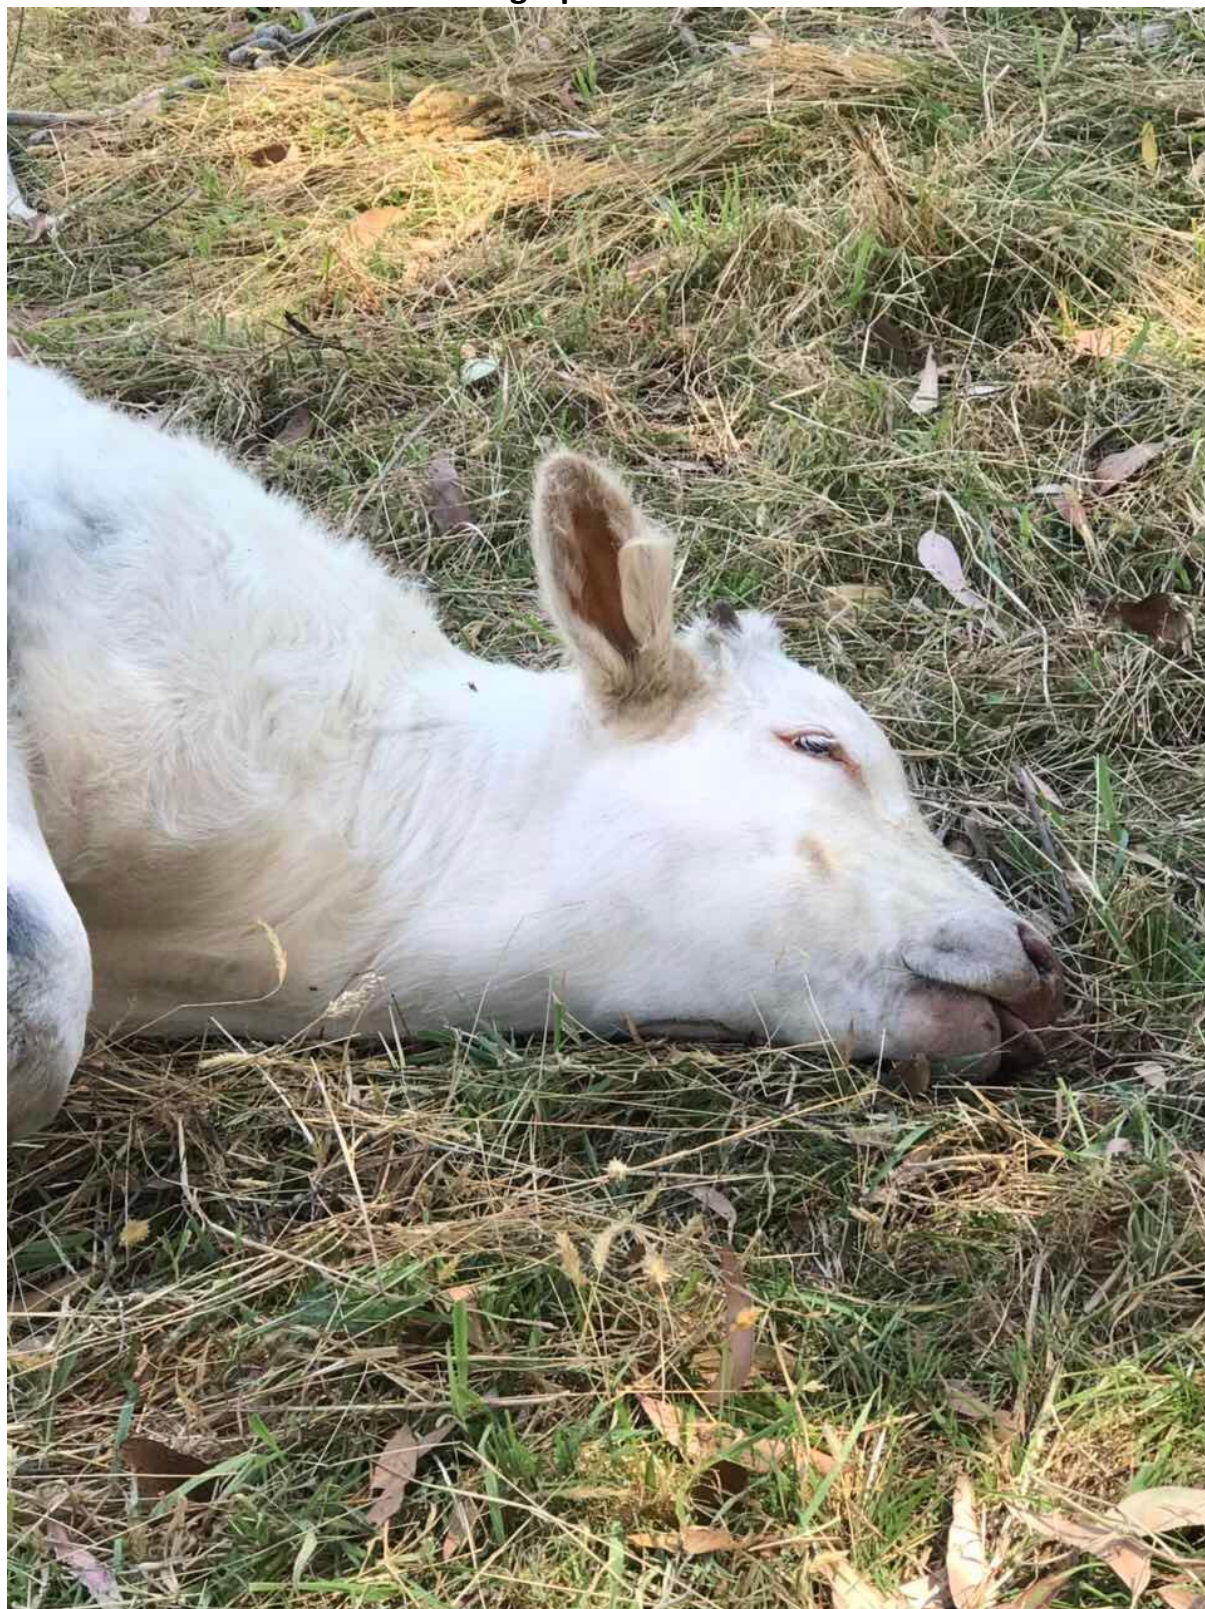
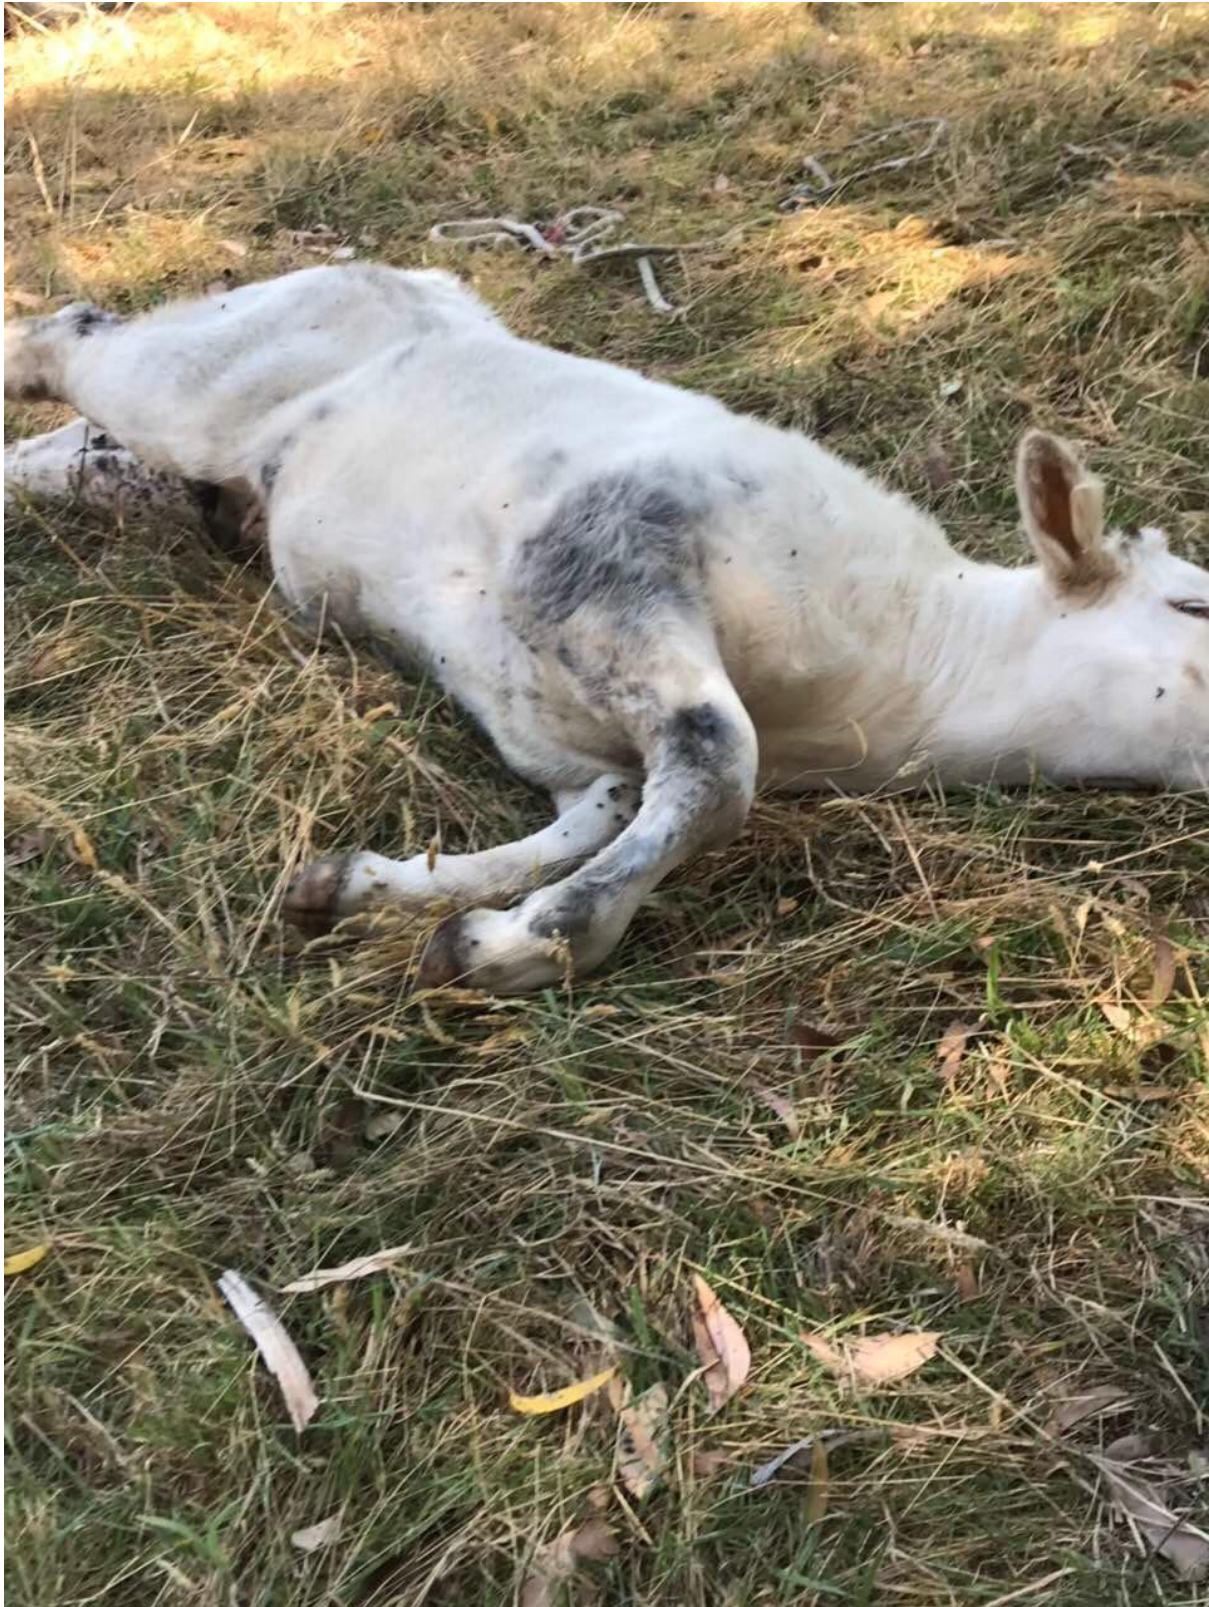
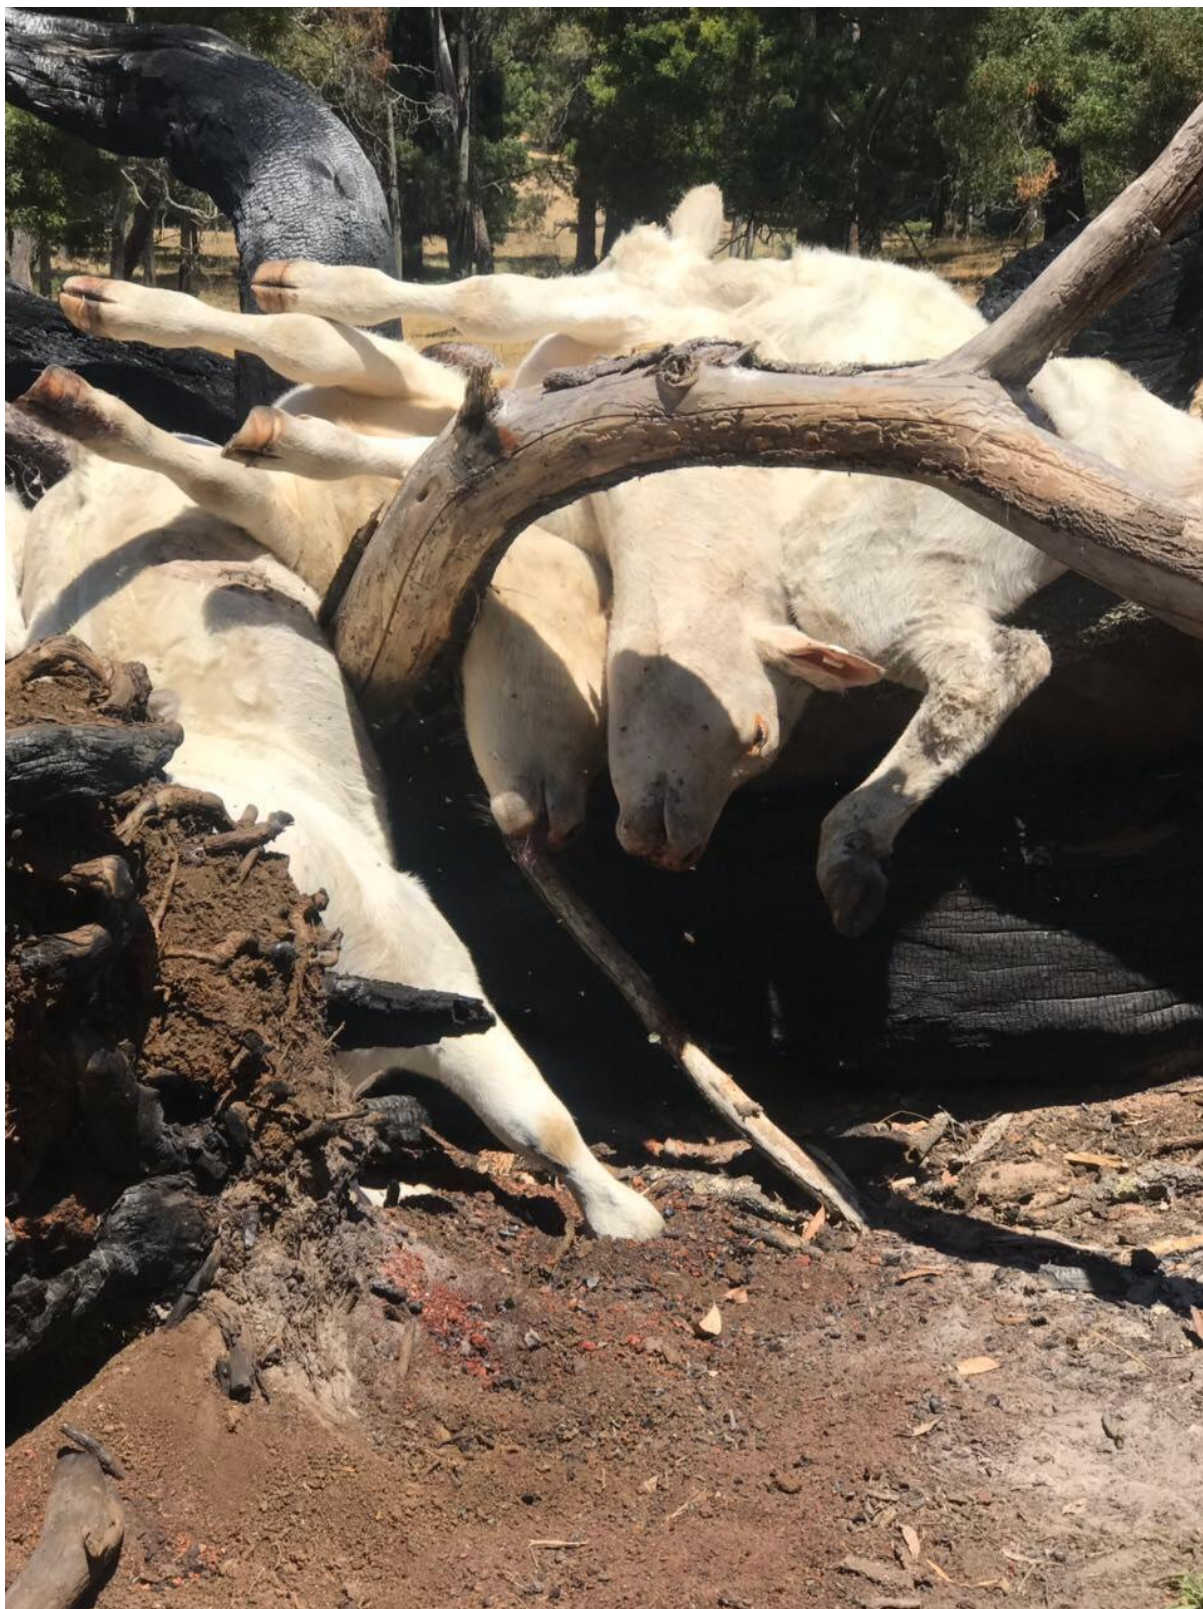
APPENDIX ONE. Dead Calf Photographs

The very next day, 2nd of February seven steer calves from the herd placed in paddocks **Sb** and **Sc** were found dead. One calf was found in paddock **Sb** and the other calves were found dispersed around paddock **Sc**.

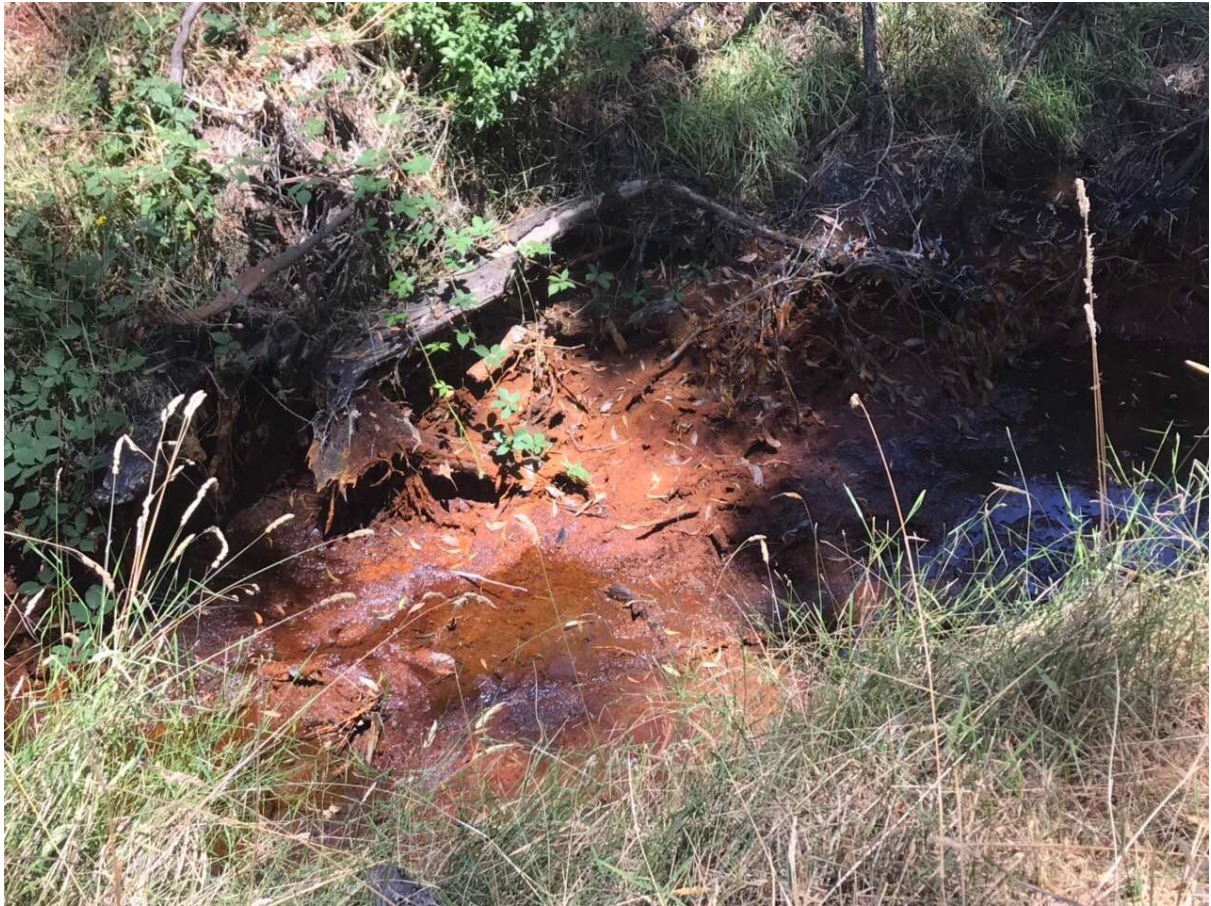
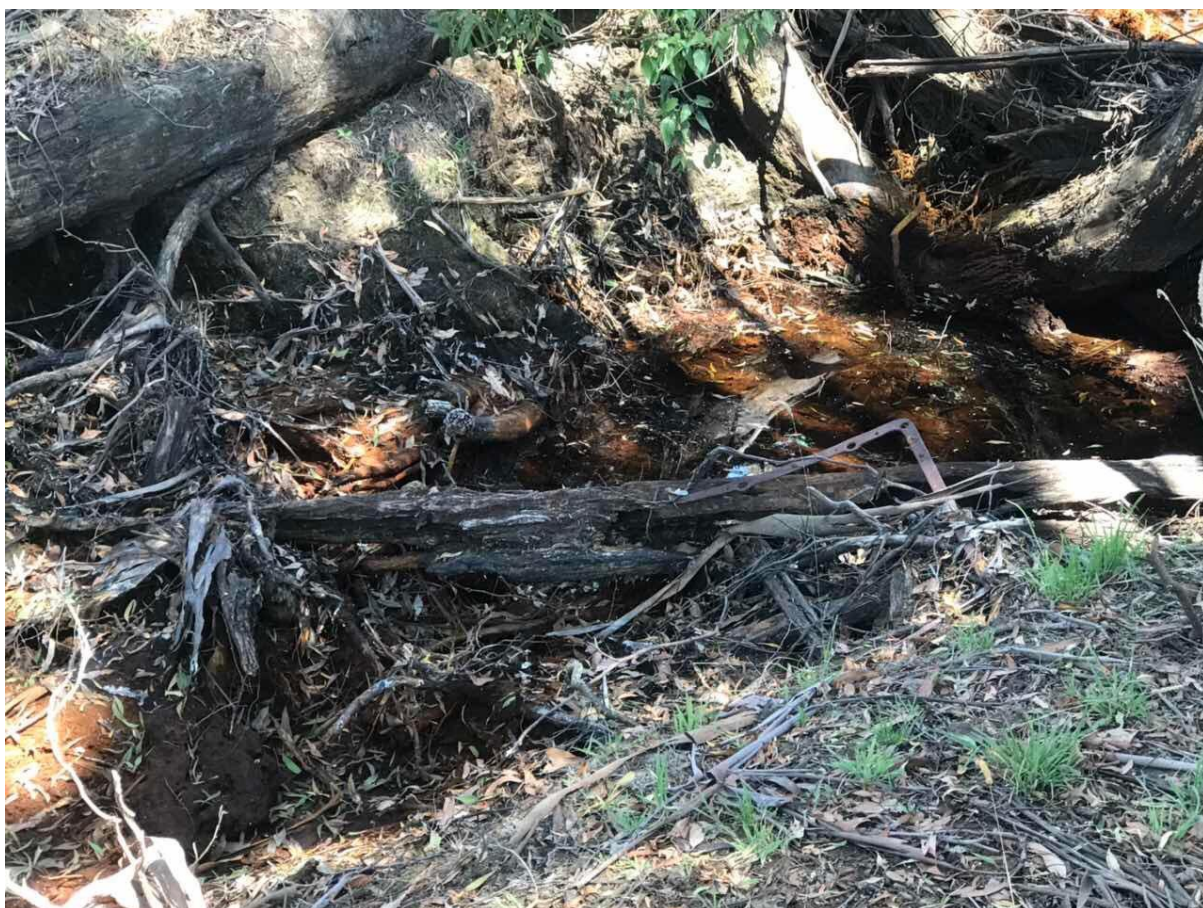
The larger herd had access to two paddocks marked **Sb** and **Sc**. Dam water serviced **Sc**. Paddock **Sb** allowed access to Boundary Creek which was not flowing at the time. However, there were shallow pools of water in various depressions in the creek bed.

The two samples sent to EAL for analysis were taken from pools of water in the bed of Boundary Creek.

Pooled water in Boundary Creek in paddock Sb.

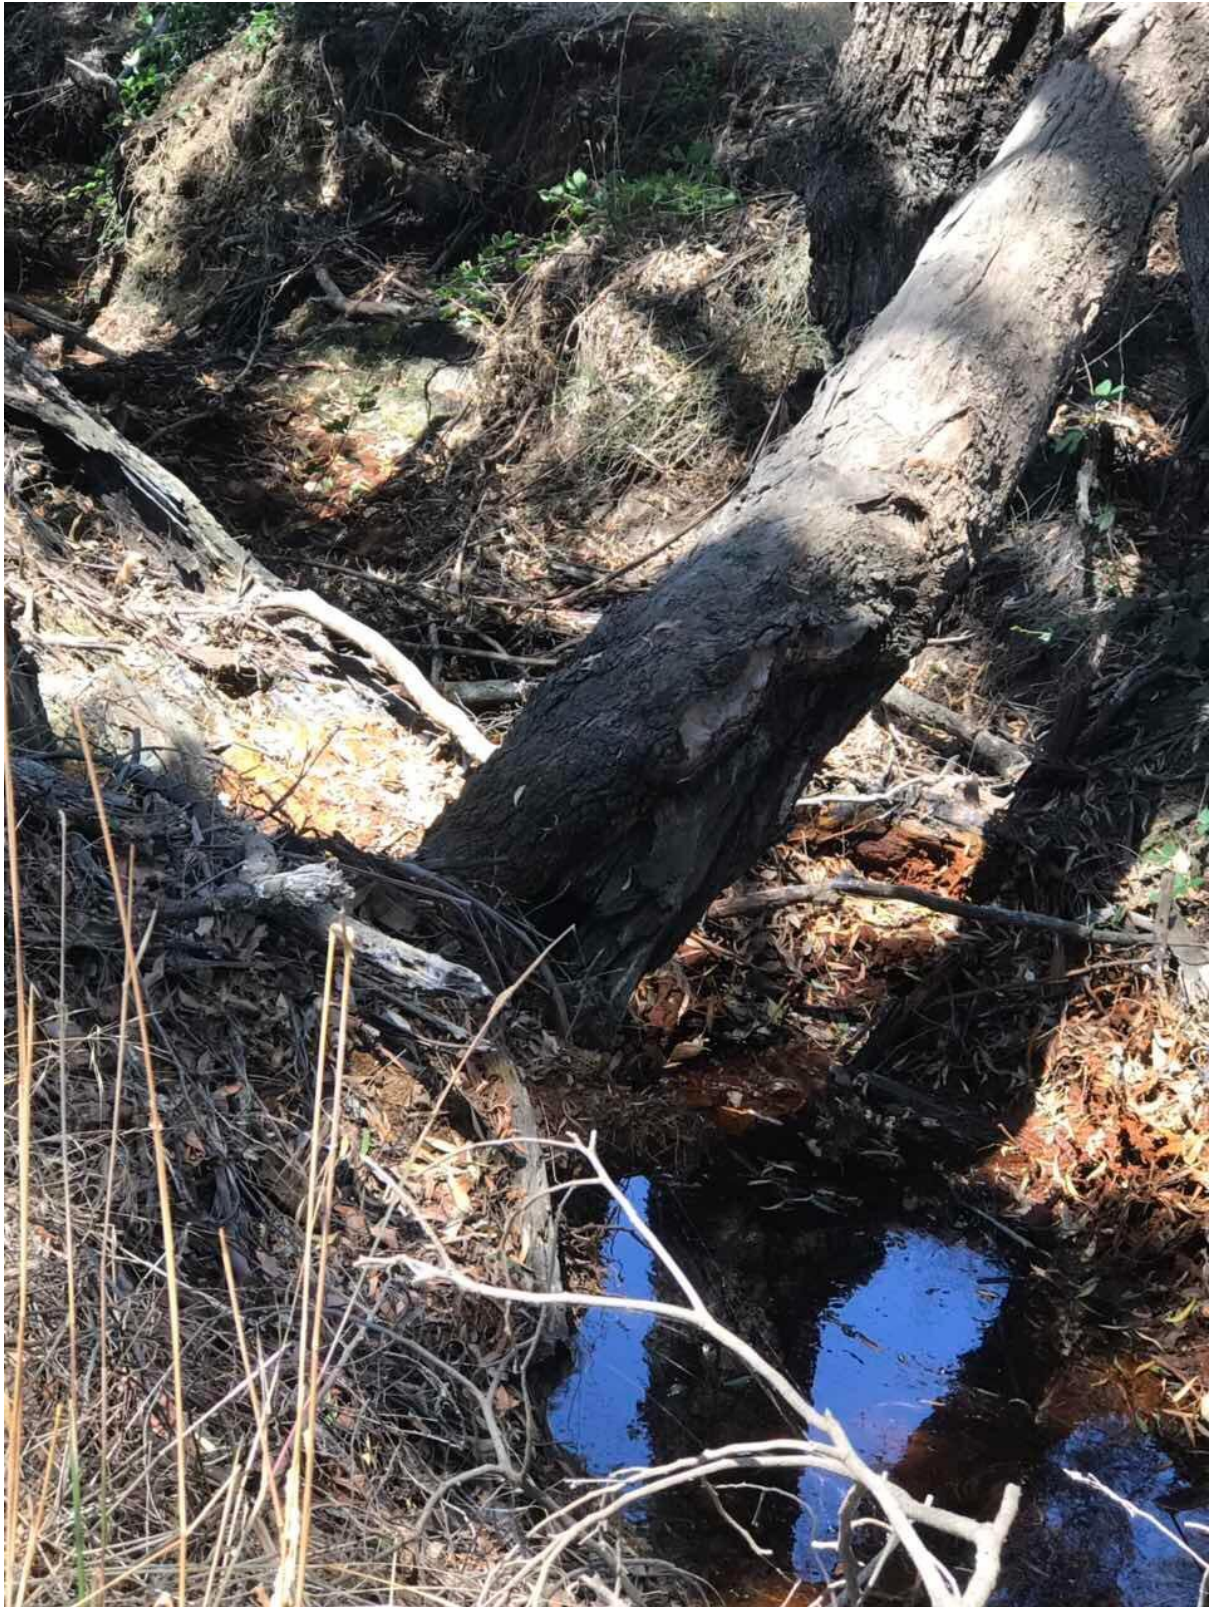
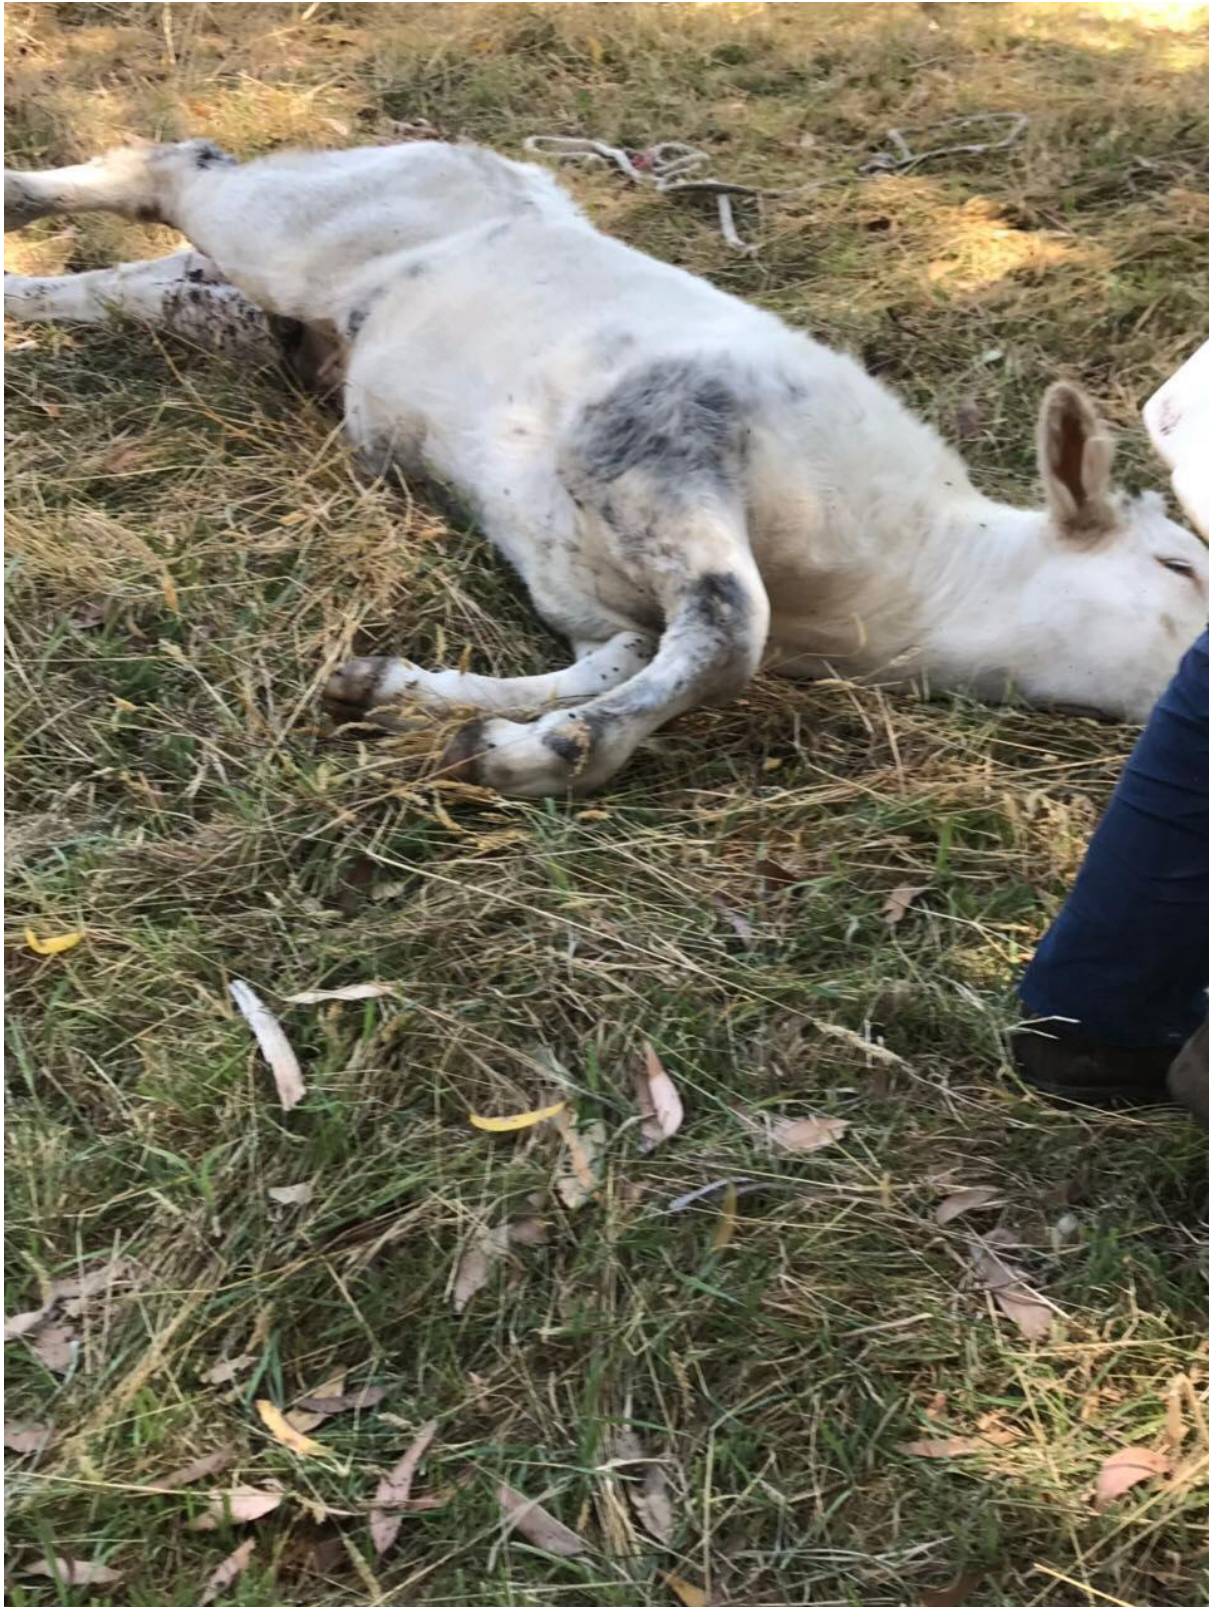
Dry bed of Boundary Creek in paddock Sb.
