# SAVE the BARWON RIVER LAWROC & Otway Water

## Fish Kill, Upper Reach of the Barwon River June 2016.

Save the Barwon River, LAWROC Landcare Group & Otway Water Book 32.

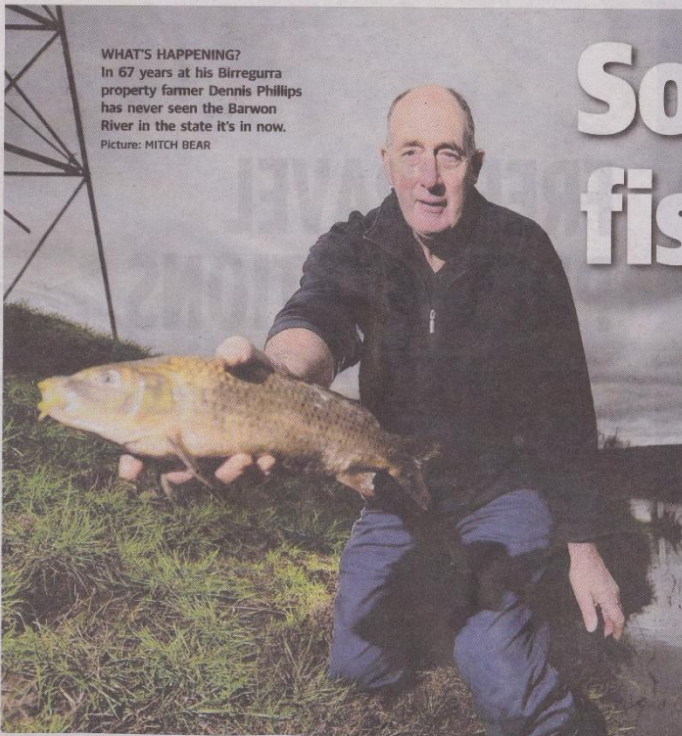
**WHAT'S HAPPENING?**  
In 67 years at his Birregurra property farmer Dennis Phillips has never seen the Barwon River in the state it's in now.  
Picture: MITCH BEAR

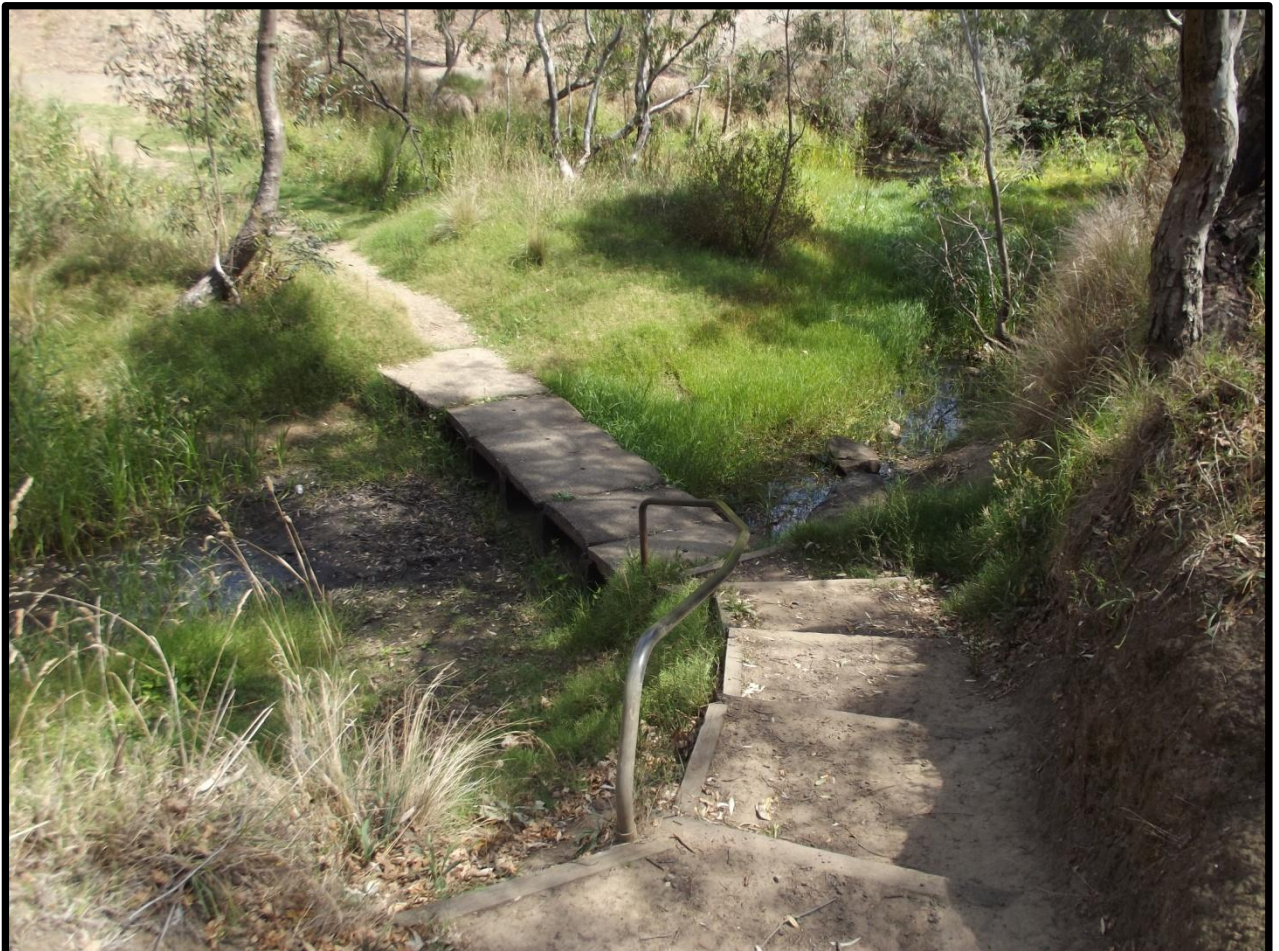
The dry Barwon River at Winchelsea June 2016.

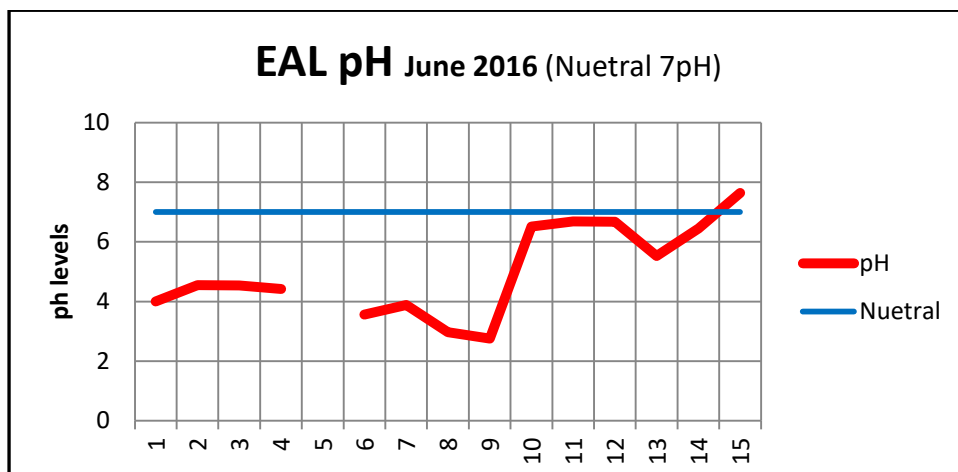
There was no surprise with the pH levels of the water samples.

All sites downstream of the Big Swamp had toxic levels of acidity. Sites outside the influence of the contamination proved to be very close to neutral. There is no doubt that the water coming out of Boundary Creek is extremely acidic and would cause biota not used to these levels considerable stress. Levels of pH above 4 is regarded as the critical level for biotic life to be sustained in the streams of the Otway Ranges.

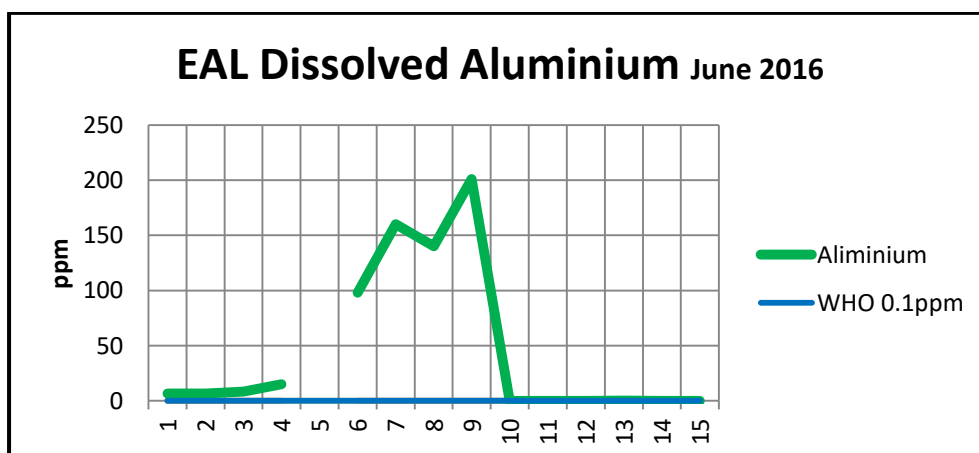
It is possible the real killer was the aluminium levels in the water. At the least having such massive amounts of dissolved aluminium could be a contributing factor if not the primary cause. Levels such as these could quite easily have clogged up gills suffocating the fish. What is known, is the World Health Organisation level for drinking water is 0.1ppm and aluminium levels at 200 ppm or up to 2000 times this, would clog up any human dialysis machine.

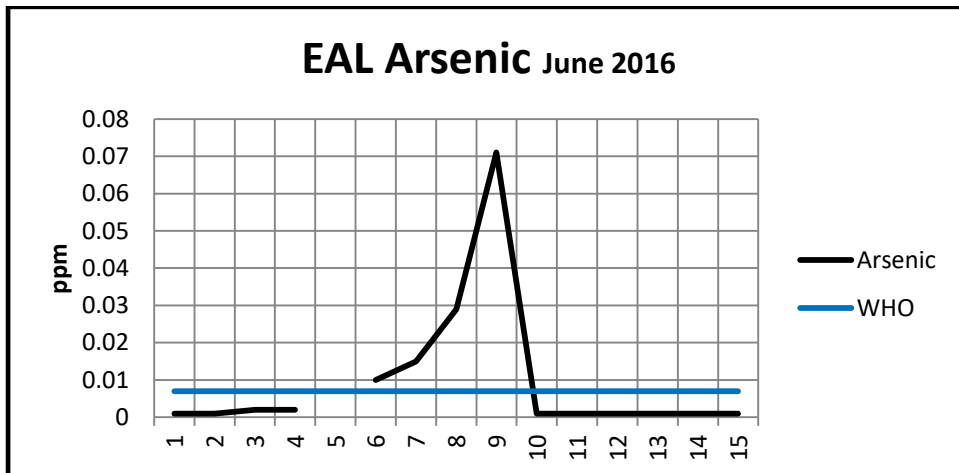
It is also possible that arsenic played a role in the deaths.

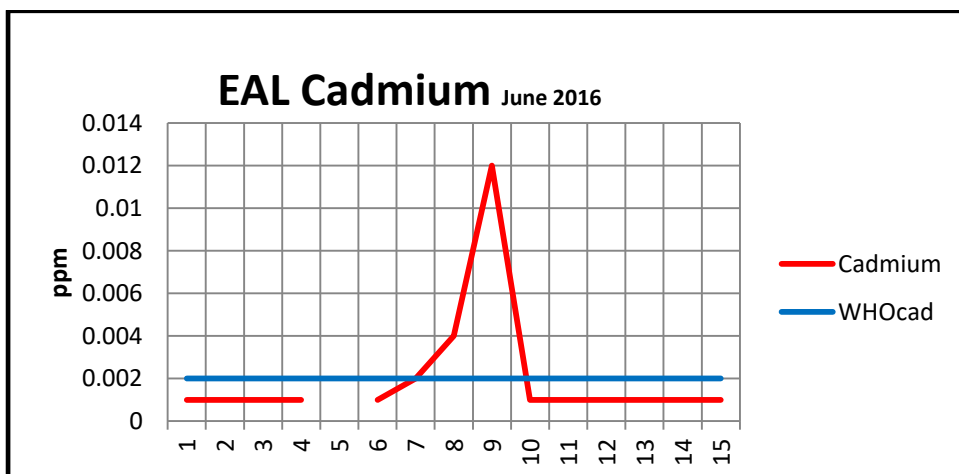
Or perhaps it was cadmium.

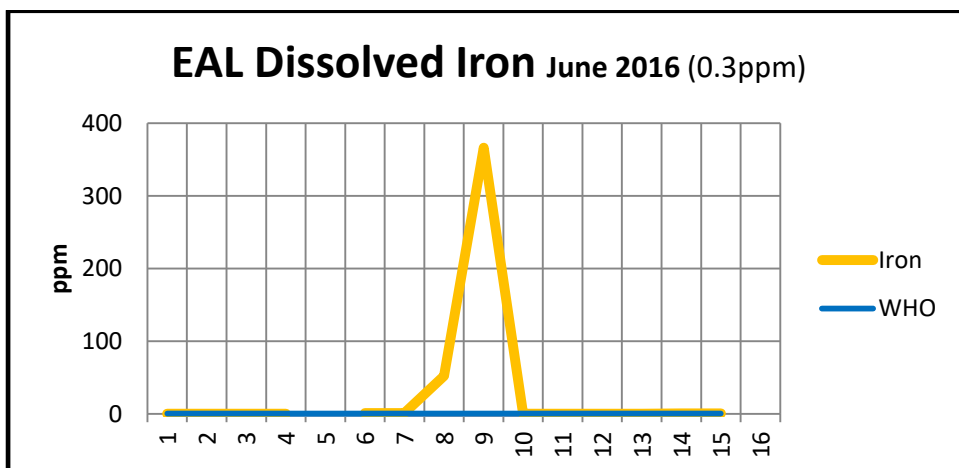
Or maybe it was dissolved iron.

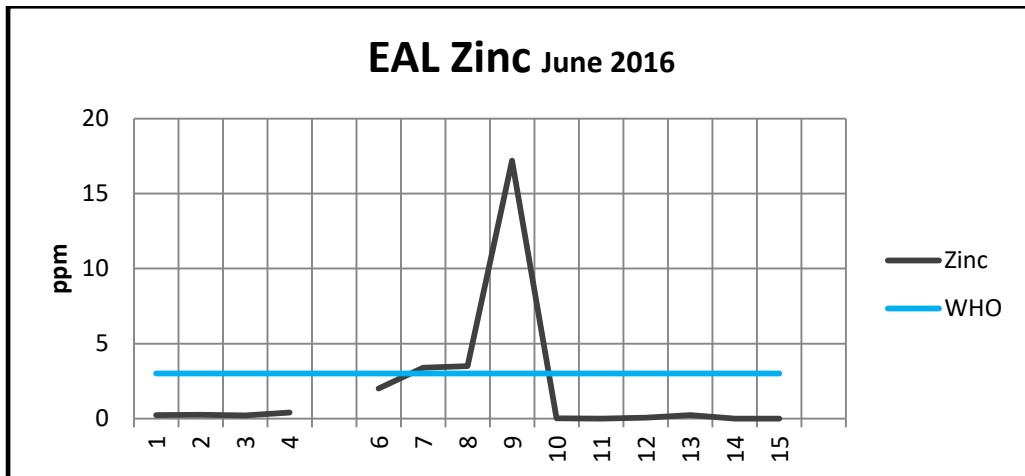
Zinc may have contributed as well.

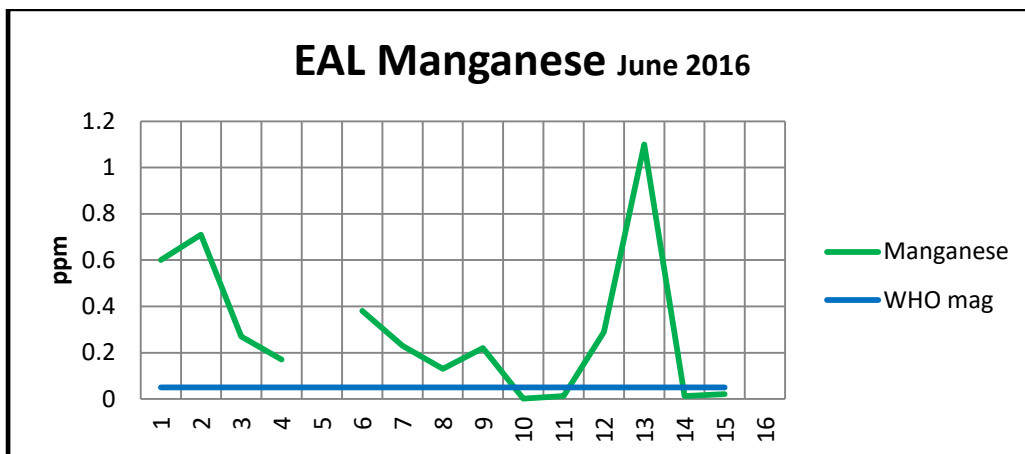
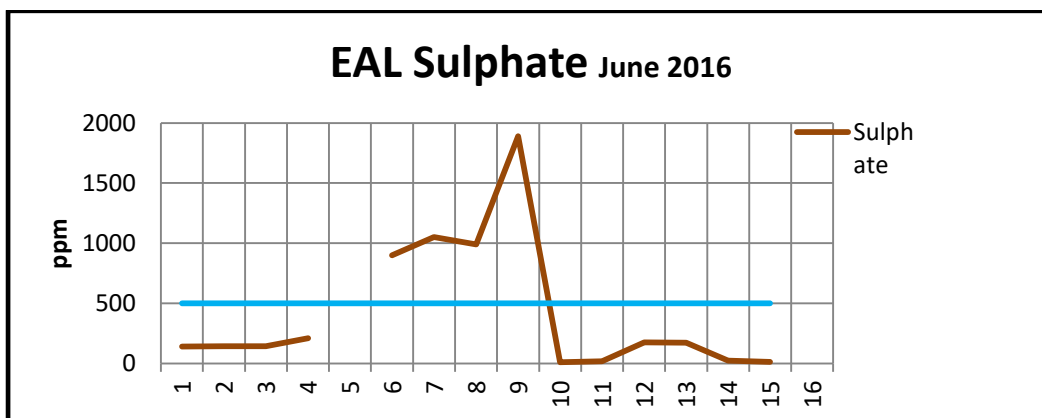
Manganese seems to also be at unnatural levels at several sites. Site 12 being in front of and downstream of the fish kill and site 13 being upstream of the kill, poses an interesting question of why this is so.

5. Collect water samples at varying depths.
  5. Take and analyse "fresh" dead fish for cause of death.
- E.** Other considerations.
1. Investigate the source of manganese at water sampling sites 12 & 13.

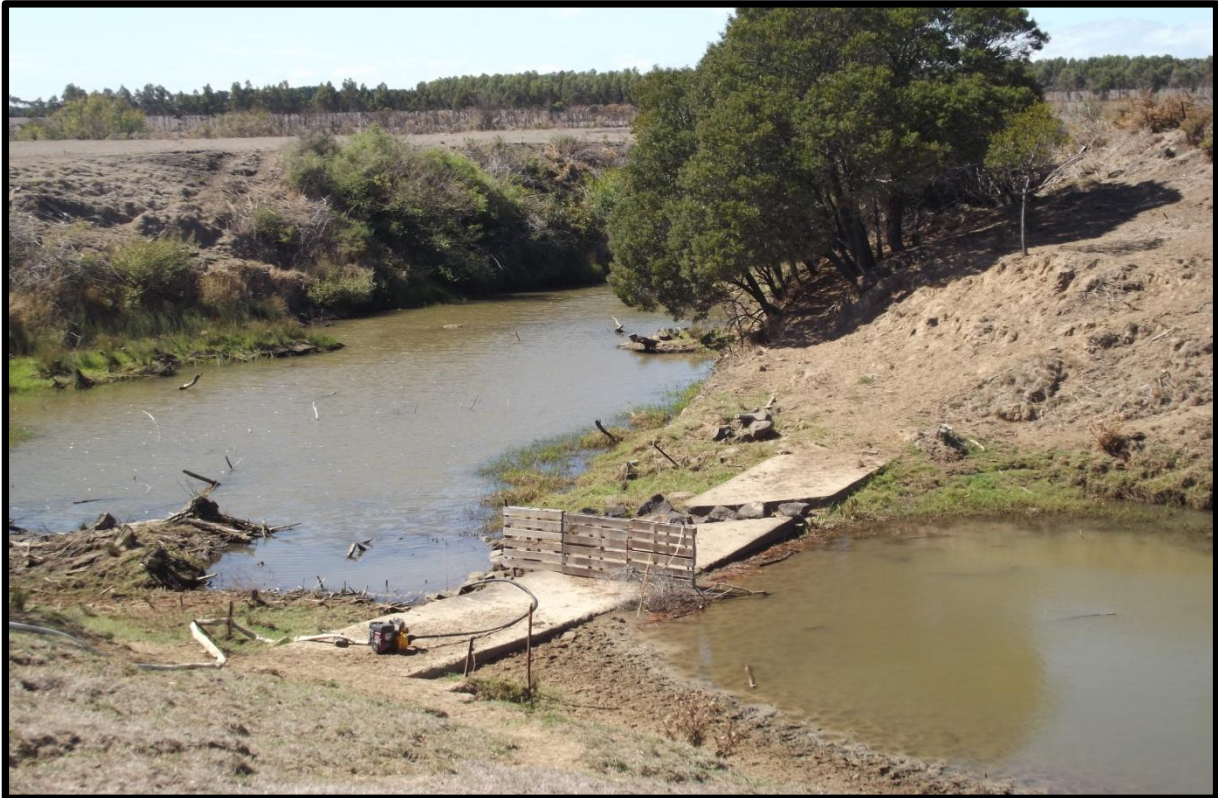
This is a photograph taken at the Stream Flow Gauging Station No. 233224 on the Barwon River at Conn Lane, March 2016 (see page 12 & 18).

In March it was quite obvious that things were not progressing well in regard to flows down the Barwon River. Then when the fish kill took place memories of this photograph prompted a look at the Vic. Water Warehouse data site for stream flows, and in particular the flows at Conns Lane. Amazingly the flow at Conns Lane went from 80 ML/day to 700ML/day overnight on 3 July. By the middle of July a newspaper announcement declared that the river's water was no longer a problem (see page 16).

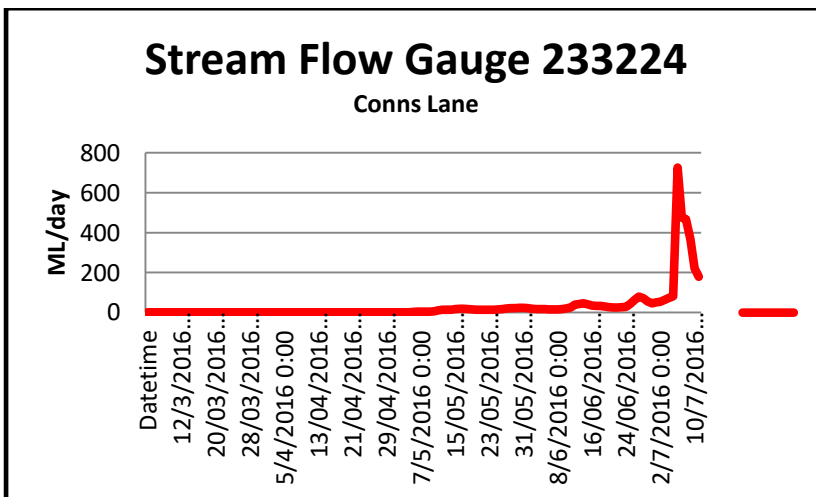
5-7-16. 80 ML flow
6-7-16. 728 ML
7-7-16. 482 ML
8-7-16. 474 ML
9-7-16. 374 ML
10-7-16. 230 ML
11-7-16. 187 ML
12-7-16 146 ML

This 700 ML daily flow was not a one off data collecting error because other high flows followed over the next few days. Being no substantial rainfall to account for this massive increase in flows prompted a line of investigation attempting to discover where the flows originated. Data was then collected from several Stream Flow Gauging Stations; groundwater extractions and rainfall station locations.

2. Determine where the 700 ML/day flush of water at the Conns Lane Stream Flow Gauging Station came from.
  3. Investigate the cause of the other huge increases in daily flows at the Conns Lane Stream low Gauging Station.

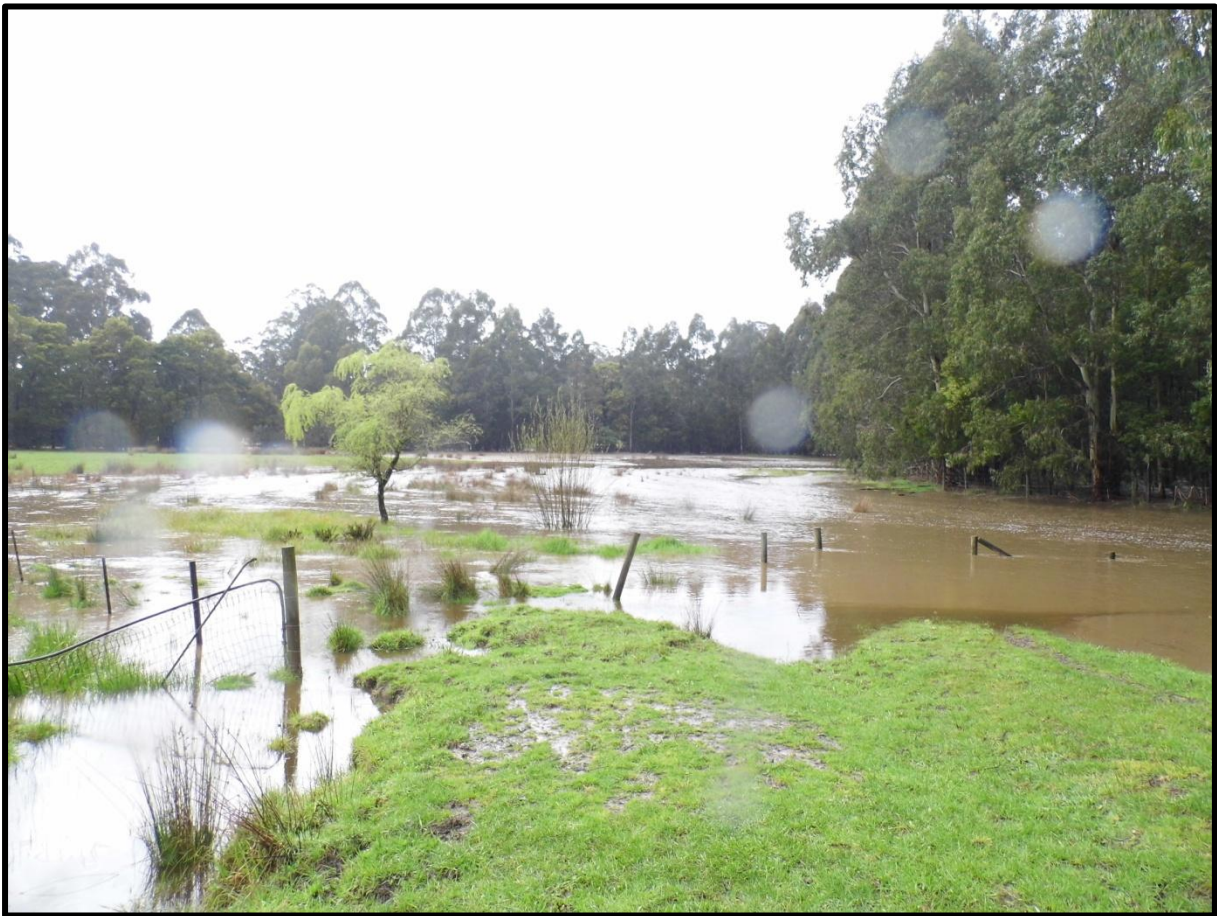
Loves Creek – KAWARREN September 2016..

Persistent rain started to fall from late in April. It was not until late in September that there was enough rain to cause creeks and river to flood.

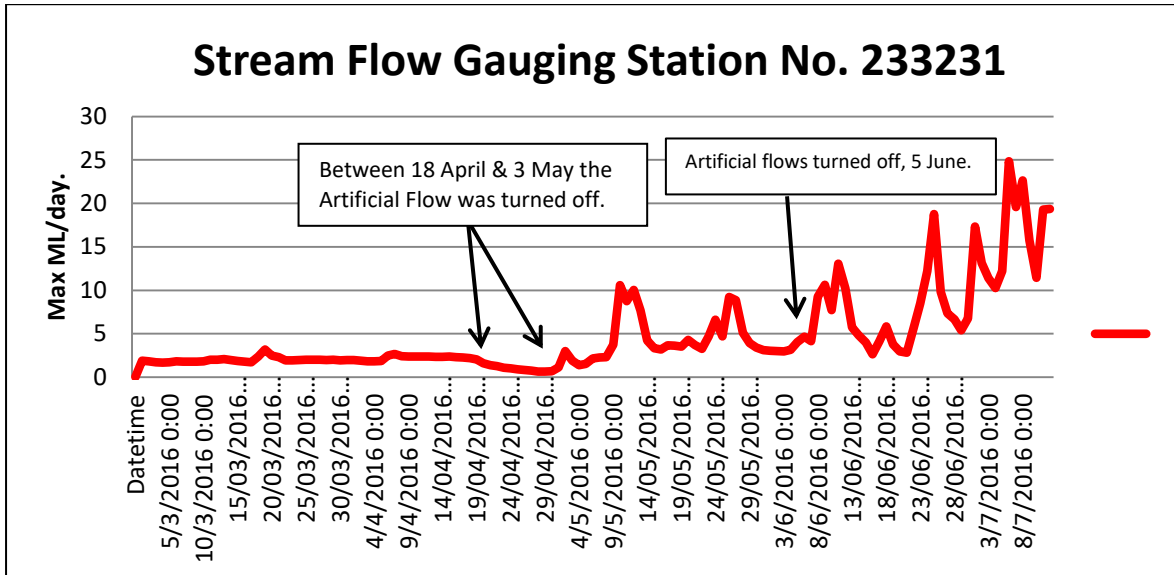
When the Stream Flow Gauging Station (SFGS) on Boundary Creek at the Colac Forrest Road Bridge, SFGS Number 233228, has flows less than 1 ML/day Artificial Supplementary Flows are released from the Otway to Colac Pipeline on Bushbys Road into a small tributary of Boundary Creek (see Map, page 12). This water then flows down into Boundary Creek and past SFGStation Number 233231 and is reflected in the following graph. Not massive flows.

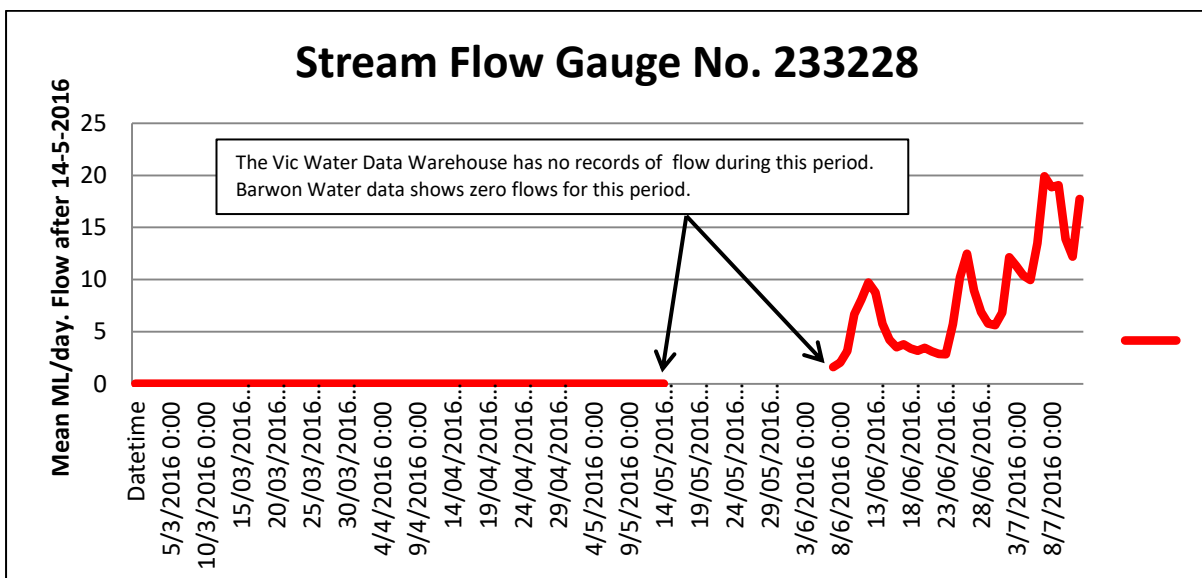
Once the flows at the Stream Flow gauging Station Number 233228 reach 1 ML/day the Artificial Supplementary Flows can be turned off.

Flows at the SFGStation Number 233228 were first recorded from 6 June 2016 at the same time that pH levels were first recorded (see page 16).

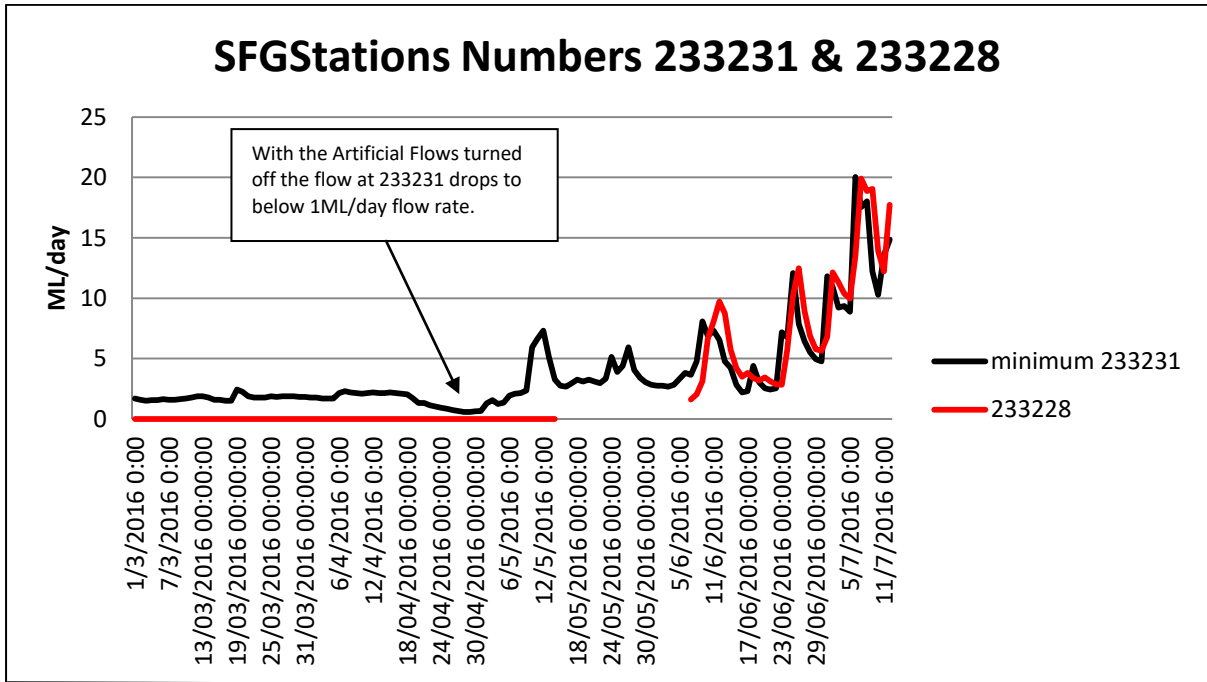
Once consistent rain began to fall the two graphs of SFGS 233231 and SFGS 233228 on Boundary Creek show a similar pattern.

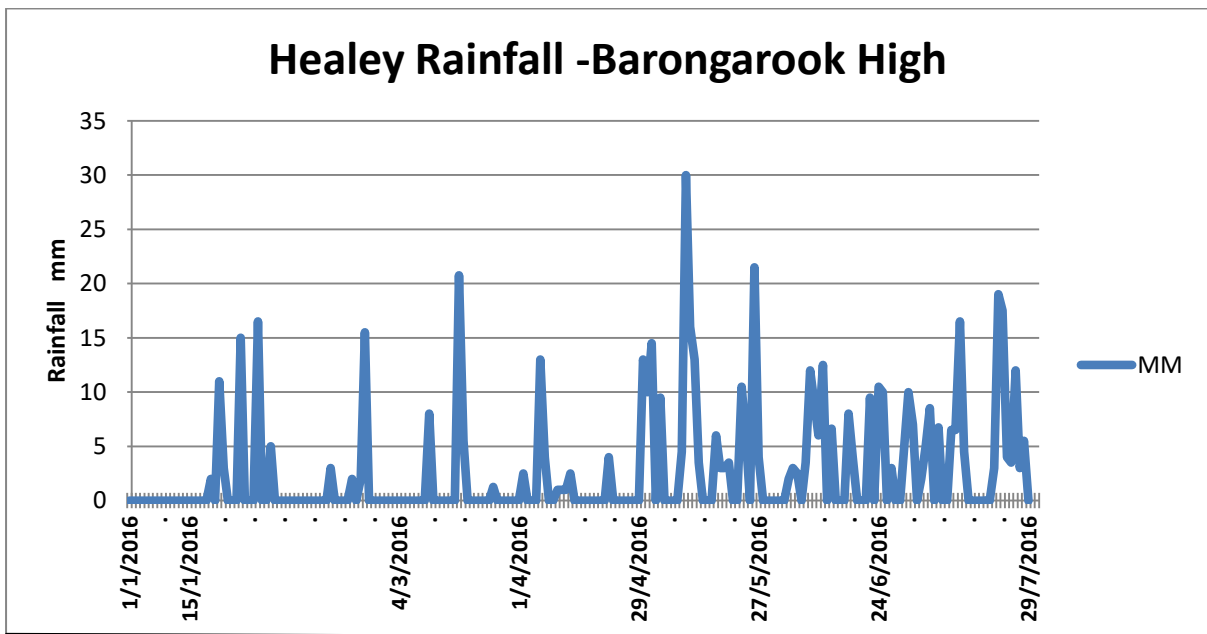
The Healey Rainfall Station (see page 12) graph shows persistent rainfall.

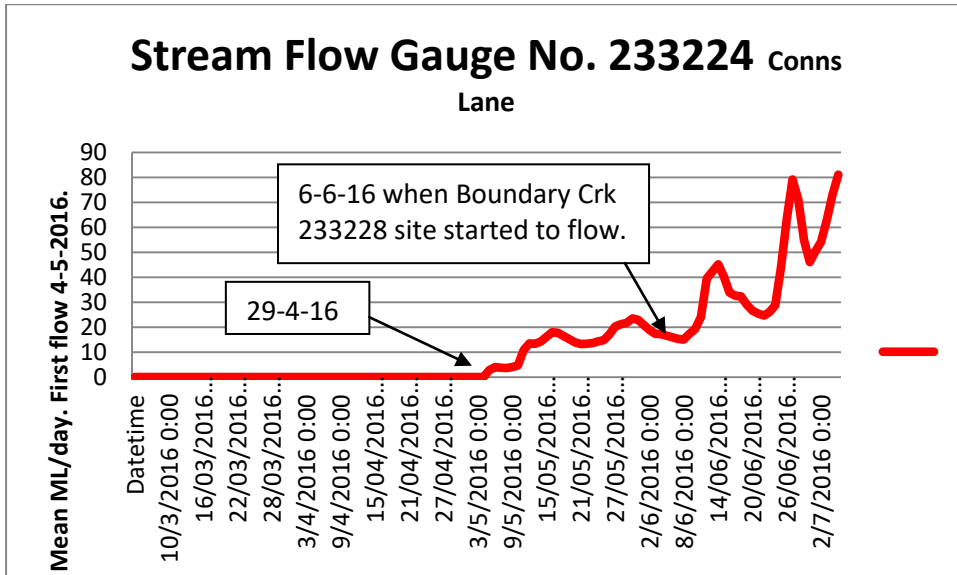
Flows at Cons Lane up to 2-07-2016.

This graph shows a pattern of river flow increase and when viewed with the rainfall charts, is a reasonable depiction of flows at Conn Lane up to the 5<sup>th</sup> of July. The numerous feeder tributaries that enter the Barwon River before Conns Lane contribute to this steady increase. The graph above stops at 84 ML/day flow on 5 July 2016. The next graph below tells a different story. The very next day the flow at Conns Lane jumps to over 700 ML.

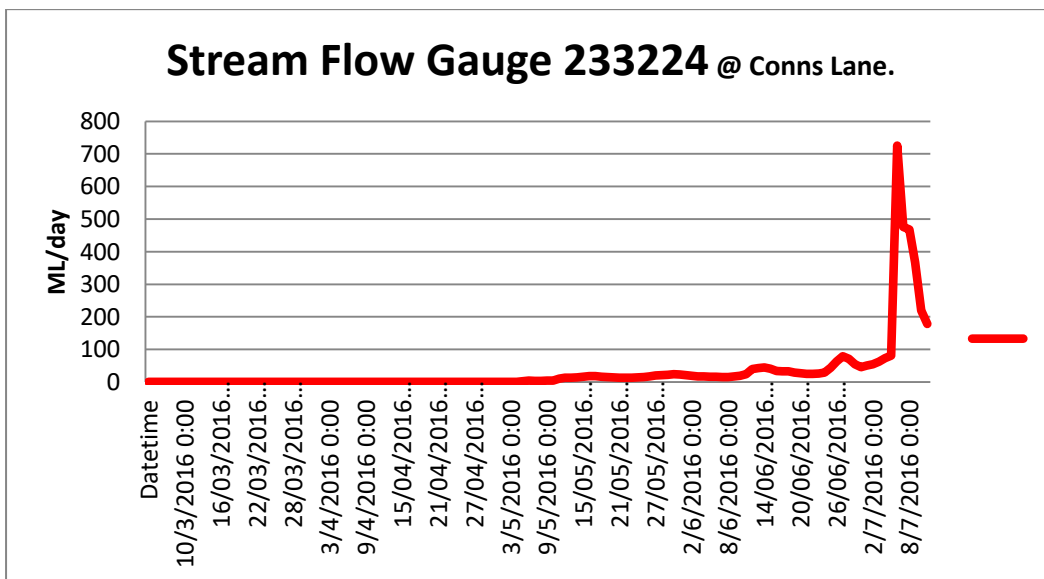
Considering the rainfall patterns for the same period this is difficult to explain. Could it be that a cleansing flush was being released from the West Barwon Dam?

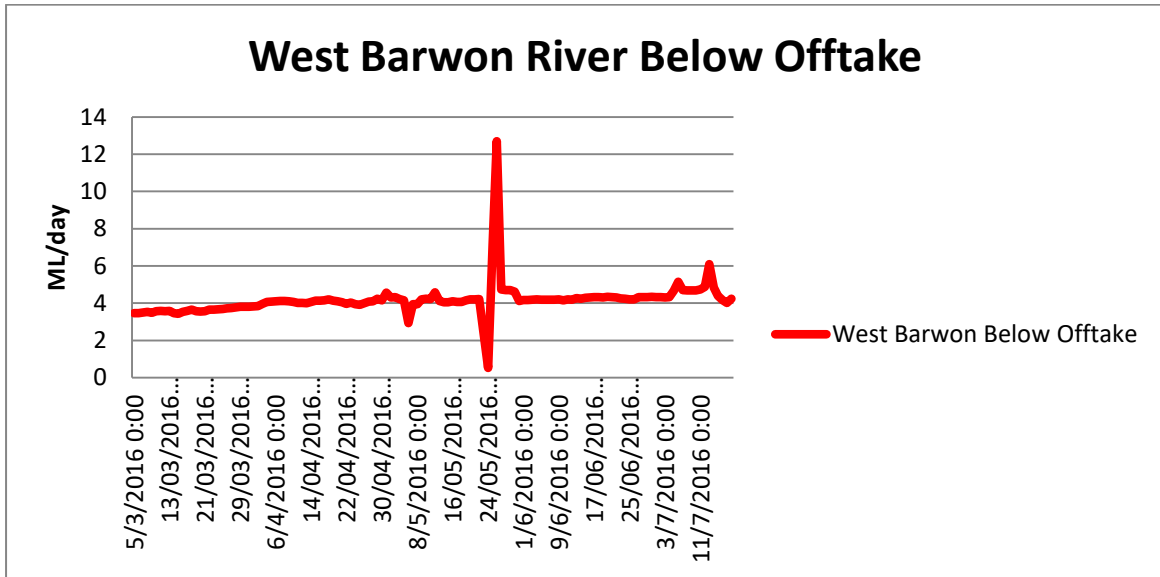
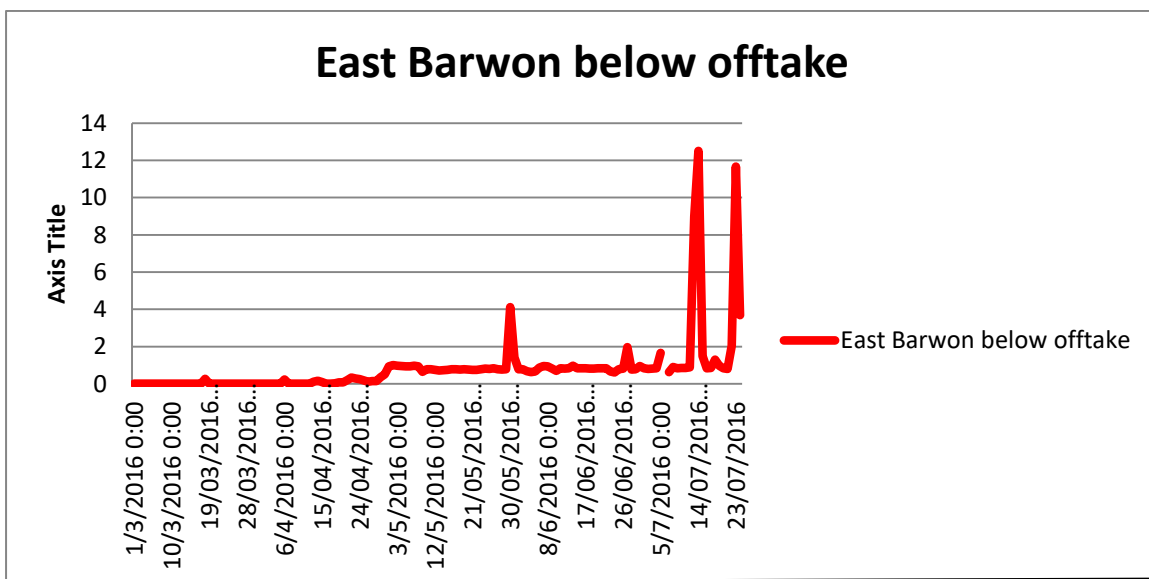
Neither of the releases from the West Barwon Reservoir into these branches of the Barwon River, could account for a 620 ML increases in flows at Conns Lane. During the same period the West Barwon Reservoir was still well below capacity.

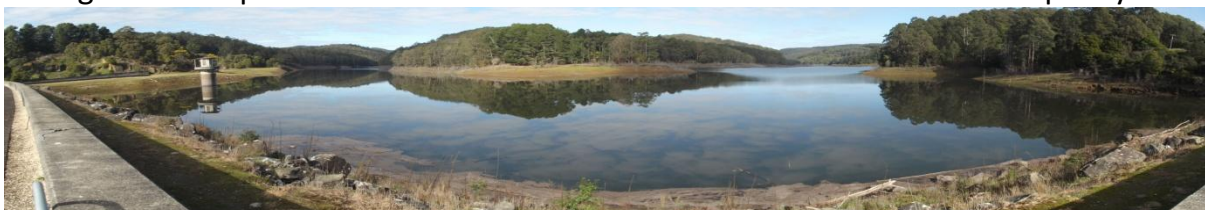
Daily Water Releases from West Barwon Reservoir - 1 Jan 2016 to 1 October 2016  
 (Result of FOI to BW Ref: F08726) - A11473210

Real-time Operational Data (as recorded at the time)	
29/05/2016 0:00	25.3
30/05/2016 0:00	56.6
31/05/2016 0:00	90.1
1/06/2016 0:00	69.2
2/06/2016 0:00	89.5
3/06/2016 0:00	89.3
4/06/2016 0:00	89.0
5/06/2016 0:00	87.5
6/06/2016 0:00	88.9
7/06/2016 0:00	90.1
8/06/2016 0:00	89.9
9/06/2016 0:00	89.9
10/06/2016 0:00	82.3
11/06/2016 0:00	69.0
12/06/2016 0:00	69.1
13/06/2016 0:00	69.1
14/06/2016 0:00	79.9
15/06/2016 0:00	90.4
16/06/2016 0:00	90.3
17/06/2016 0:00	90.1
18/06/2016 0:00	89.8
19/06/2016 0:00	89.5
20/06/2016 0:00	89.3
21/06/2016 0:00	89.2
22/06/2016 0:00	89.0
23/06/2016 0:00	76.7
24/06/2016 0:00	55.1
25/06/2016 0:00	45.2
26/06/2016 0:00	45.2
27/06/2016 0:00	65.1
28/06/2016 0:00	90.0
29/06/2016 0:00	89.9
30/06/2016 0:00	81.7
1/07/2016 0:00	81.7
2/07/2016 0:00	70.1
3/07/2016 0:00	60.4
4/07/2016 0:00	60.1
5/07/2016 0:00	64.4
6/07/2016 0:00	35.1
7/07/2016 0:00	4.83
8/07/2016 0:00	4.81
9/07/2016 0:00	4.80
10/07/2016 0:00	4.80
11/07/2016 0:00	4.85

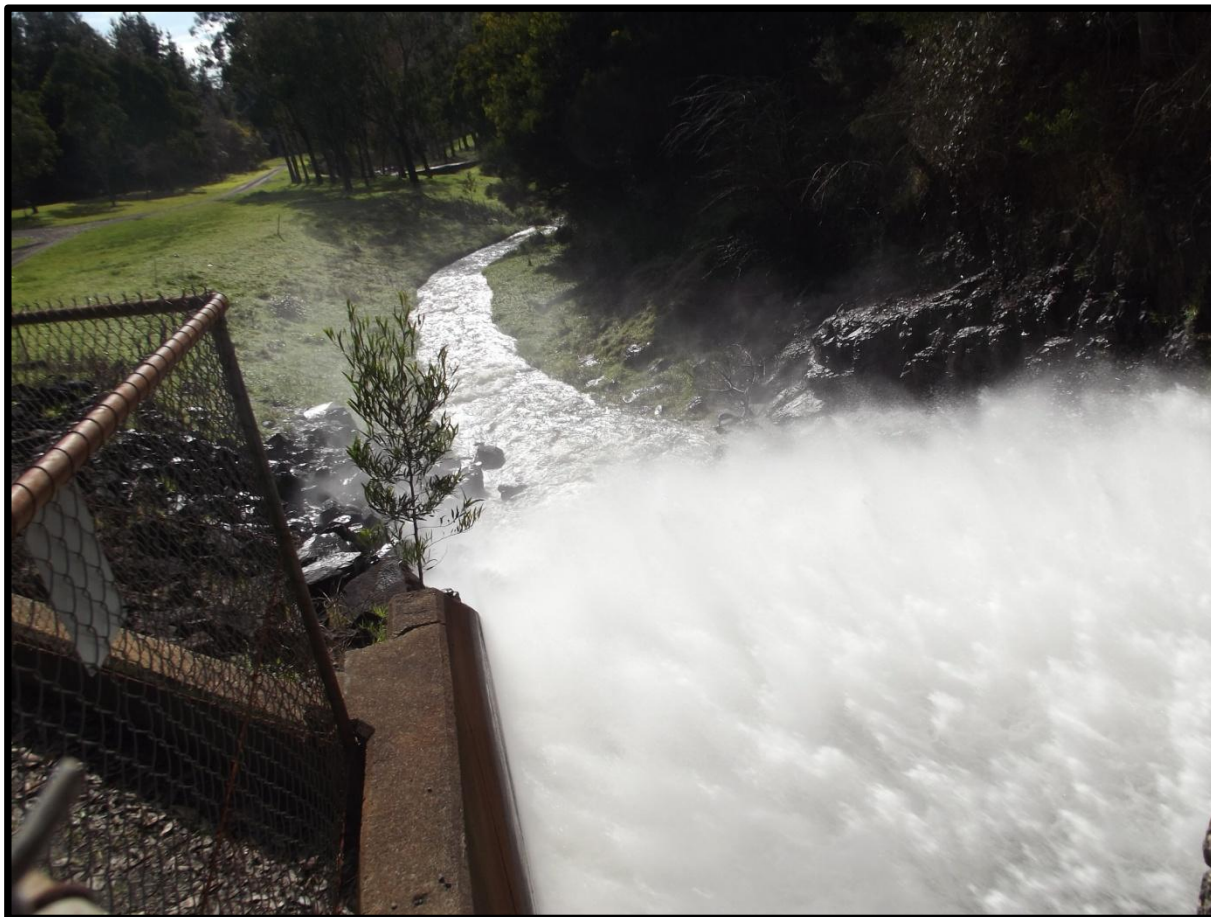
The Colac storages were overflowing in August.

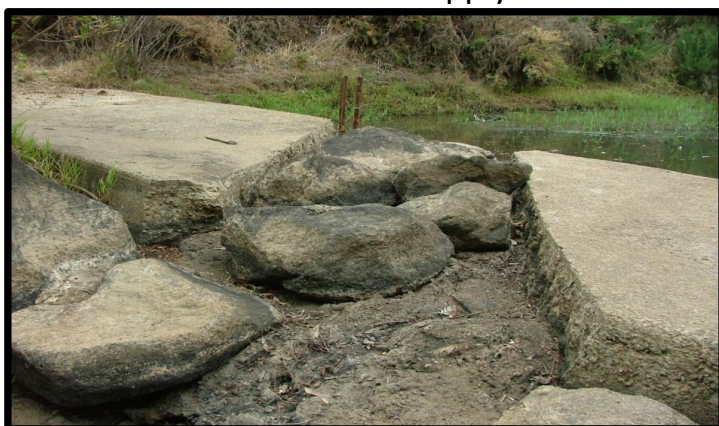
The Conns Lane Stream Flow Gauging Station weir on the Barwon River with no overflow. This situation has become a regular occurrence.

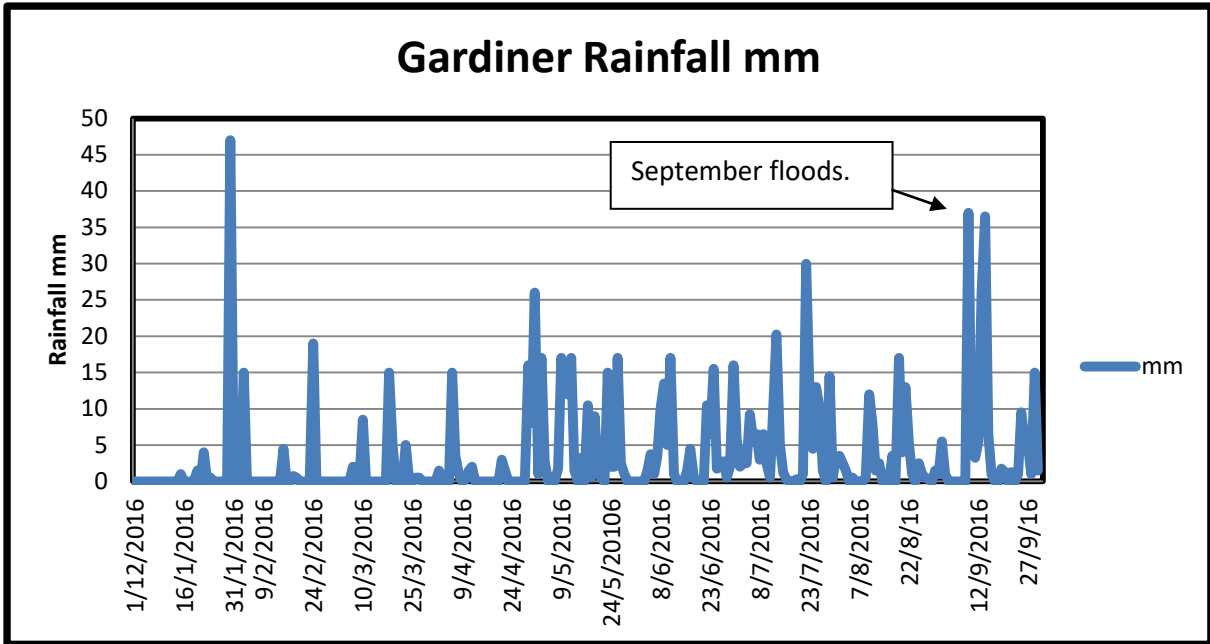
This Gardiner rainfall chart shows the falls to the end of September. Falls were persistent and consistent up to the flood of September. It took huge downpours of rain in a very short period to cause this flood and this is reflected in the huge flows at Conn Lane of over 6000 ML/day. However, the 6 July jump from 80 to over 600 ML in a day cannot be explained as easily nor can the other huge spikes of flow at Conns Lane.

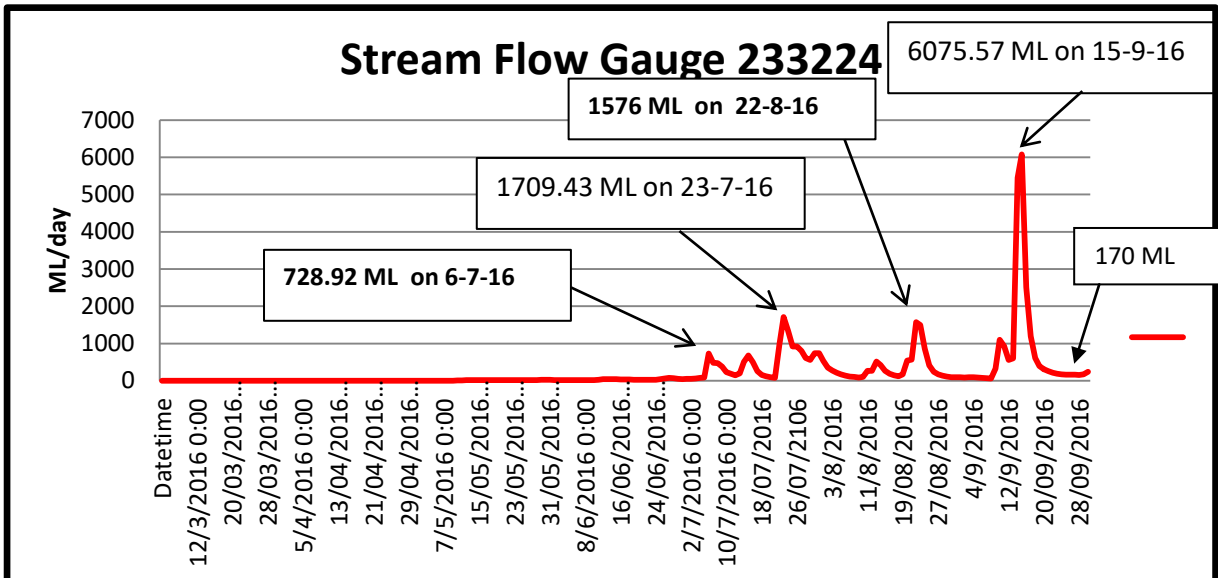
Then there are the low flows recorded between the first and the eighth of September when they ranged from just under 100 ML/day down to 60 ML/day. A closer investigation into the Conns Lane flows needs to be undertaken.
