Otway Water

- One Giant Environmental Footprint.

Boundary Creek

October 2008

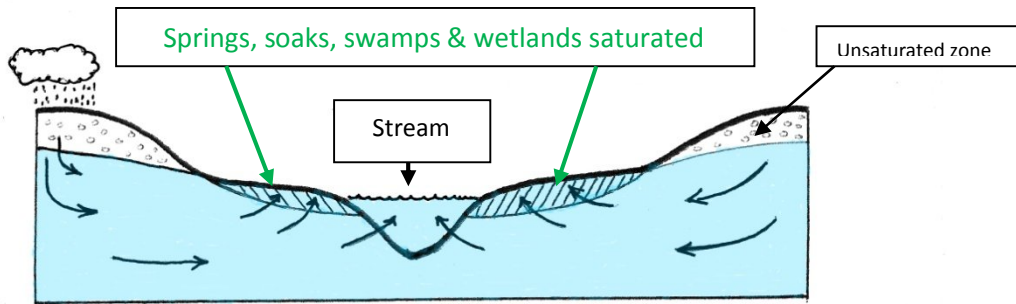
Diagram 5. Wetlands and stream interaction with groundwater & in this situation they are covered or saturated with water – aquifer overflows.

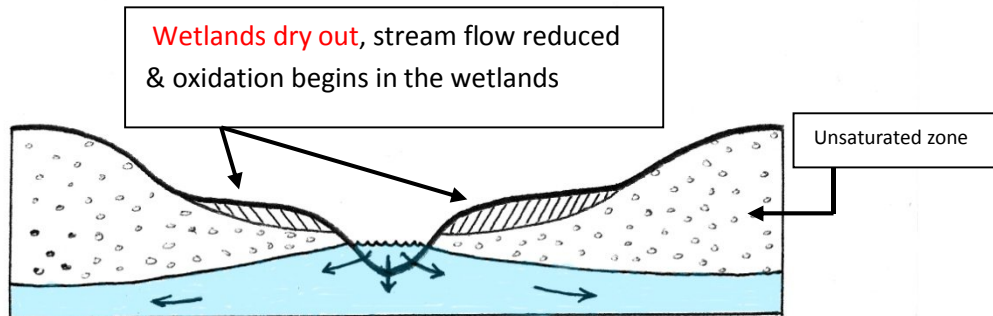
Diagram 6. Lower the water table by extracting groundwater and the wetlands and stream are affected when the watertable is dropped as a result of groundwater extraction. The stream becomes a losing stream and recharges the aquifer.

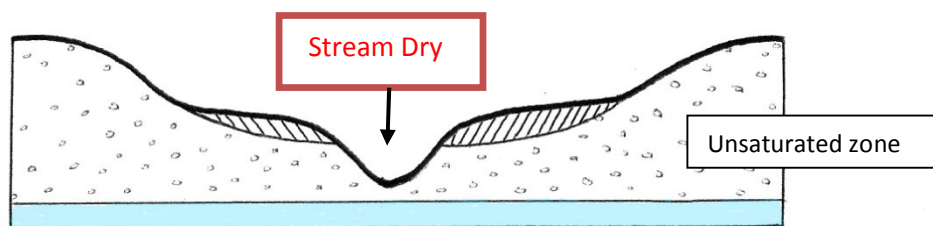
Diagram 7. Lower the water table to this degree and the stream will cease to flow in periods of no rain – the baseflow from the aquifer is totally eliminated and the stream bed. ASS also, if present, begin to oxidise. With a return of flows and or saturation the Potential Acid Sulfate Soils becomes Actual Acid Sulfate Soils and the results can be catastrophic.

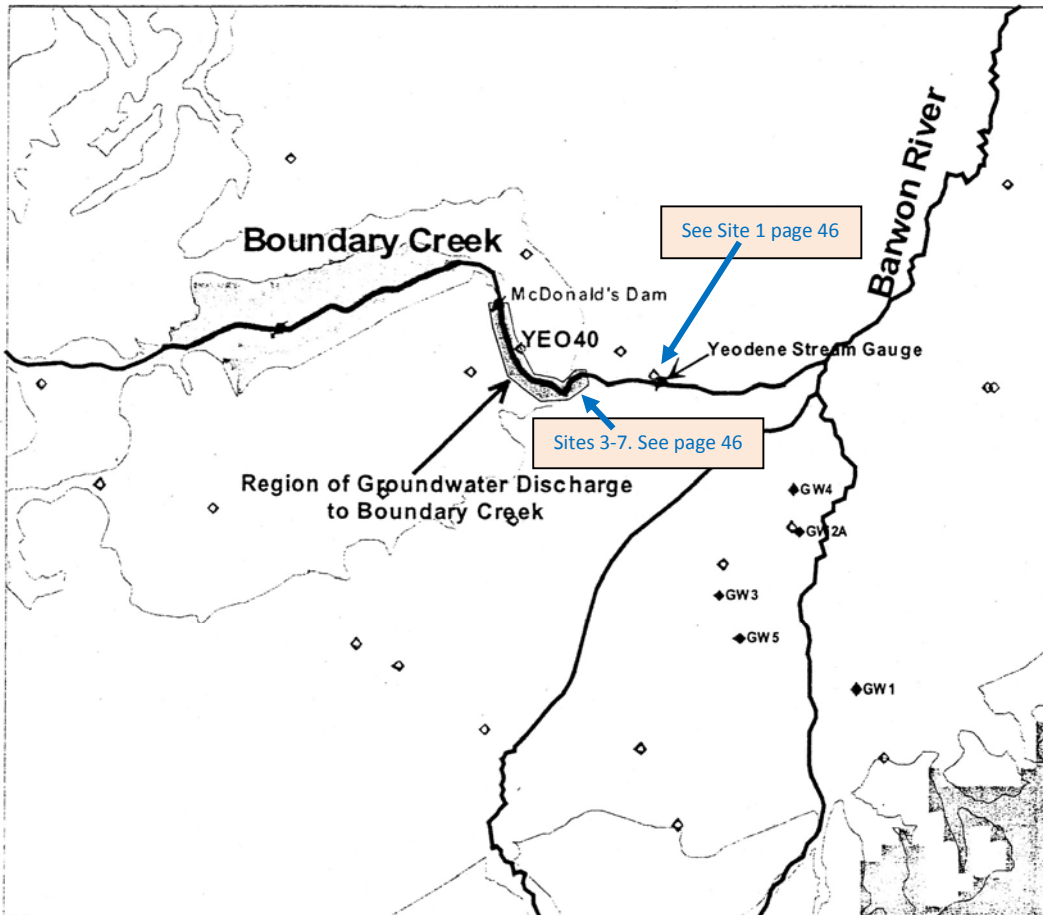
■ **Figure 3-1 Region of groundwater discharge to Boundary Creek**

The area in the map above marked as “Regional Groundwater Discharge to Boundary Creek,” encompasses the Big Swamp area. This groundwater discharge area was always saturated until one year after the 1982-83 pumping began. The Boundary Creek stream and wetlands below this point were also always saturated as the aquifer discharged from this area.

SKM determined that this area would dry out if the watertable dropped below 158 Australian Height Datum (AHD). A trigger level in the Yeo 40 bore (see above) was set at 158.5 AHD. The AHD in this observation bore has been consistently below this for years. Consequently the peat in the wetlands has been dried out to a considerable depth and Boundary Creek has run dry on numerous occasions⁽¹⁴⁾⁽¹⁷⁾.

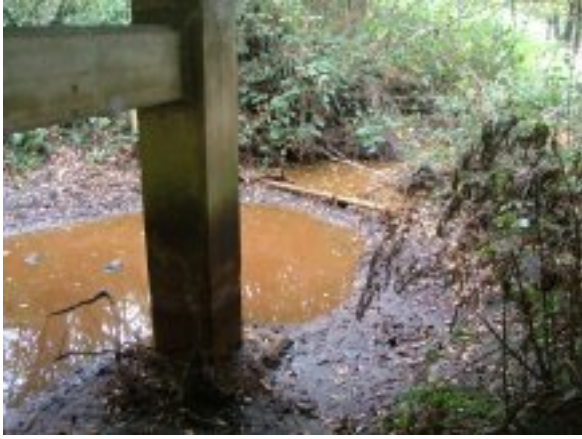
Upstream of the location of these photographs is the Big Swamp, extensive peat wetlands that have been dried out as a result of groundwater extraction.

The oxidising acid sulfate soils can cause rust coloured stains and slimes as an orange-red iron oxide scum. This scum can smother stream beds destroying aquatic habitat.

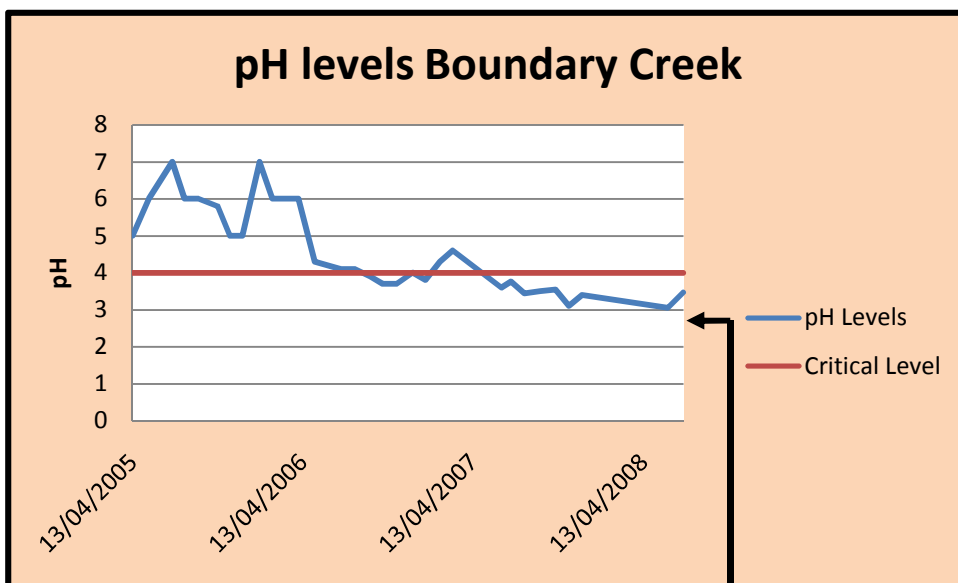
The graph below shows Boundary Creek has been under a pH reading of 4 on numerous occasions since September 2006.⁽²¹⁾

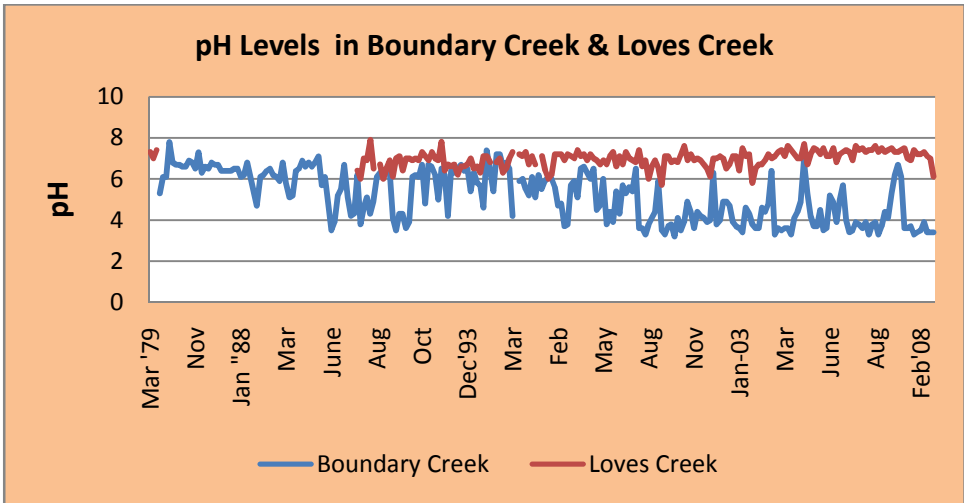
This graph depicts acid problems since the late 1980s. The latest water tests suggest the pH has not stopped falling. Loves Creek has remained relatively stable and healthy throughout the same period.

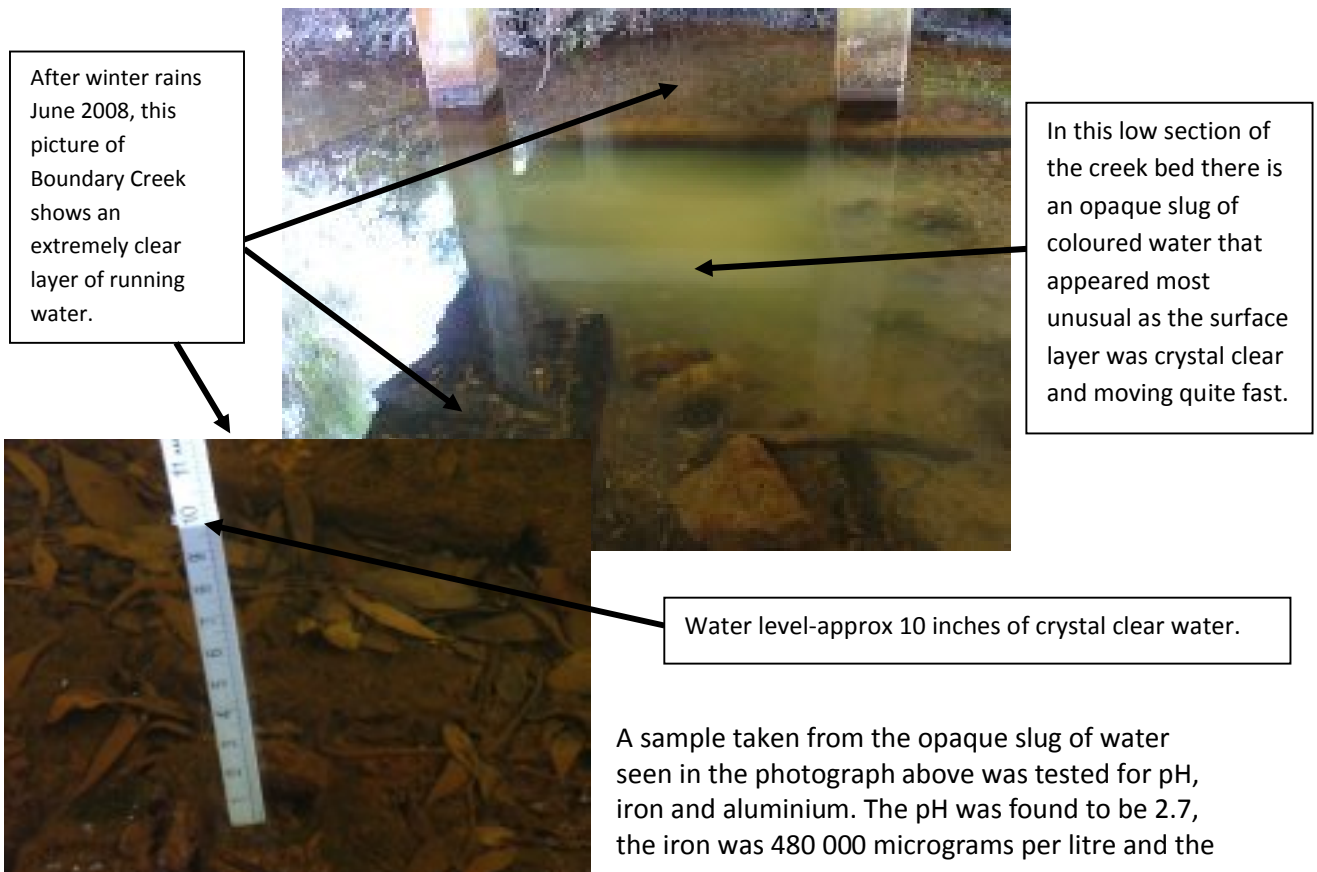
aluminium content was 980 micrograms per litre. It is interesting to note that the 1992 ANZECC⁽²⁾ freshwater and marine guidelines, quoted in a CSIRO report⁽²²⁾ suggests that an acceptable aluminium level is 5 micrograms per litre. This Boundary Creek sample is 196 times this ANZECC⁽²⁾ level. For iron the acceptable level in this report was set at 500 micrograms per litre. Another CSIRO report⁽⁸⁾ states that a main effect of high acidity on plants can be via aluminium toxicity, one effect of which is to injure root tips and prevent root growth.

One sample such as this can only be regarded as indicative of the need for further investigation. Considering the numerous other indicators the high aluminium content should be regarded as serious.

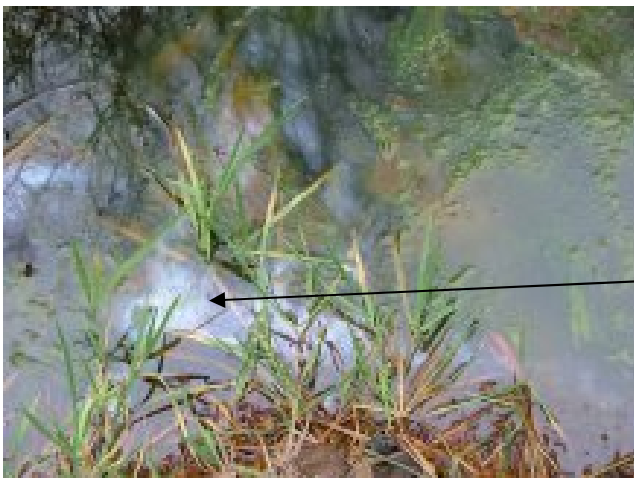
This is oily bacterial scum in Boundary Creek. The scum would not adhere to a stick being placed into it.

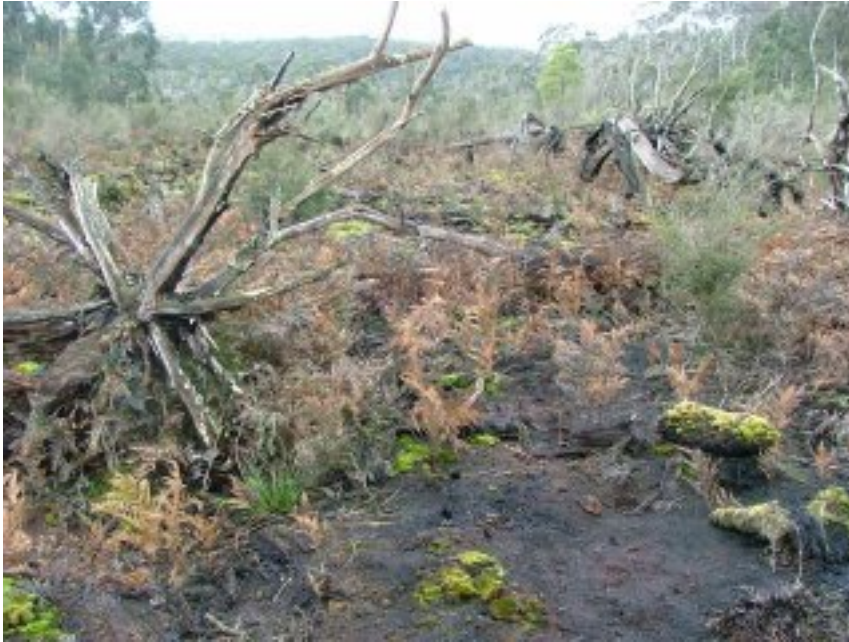
Site Four –The Big Swamp

The elevation of this area was recorded at 154 metres (GarminGPS). The critical trigger level for water releases into Boundary Creek is set at 158.5 AHD.

moisture was located at 75 cm and left for 45 minutes before the water sample was extracted from the hole. The sample tested was 2.5 pH (15 Sep. 2008).

This site within 50 metres of the creek shows absolutely no sign of animal life in the soil. Logs and peat alike can be turned over and searched minutely and no animal life form can be found. The surface peat is dry, bracken fern struggles to survive and to find any fungi is a most difficult task.

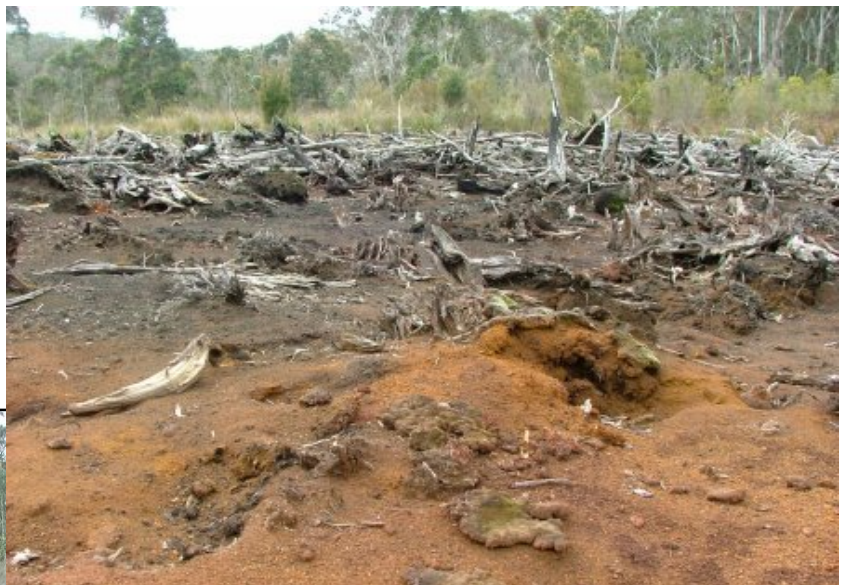
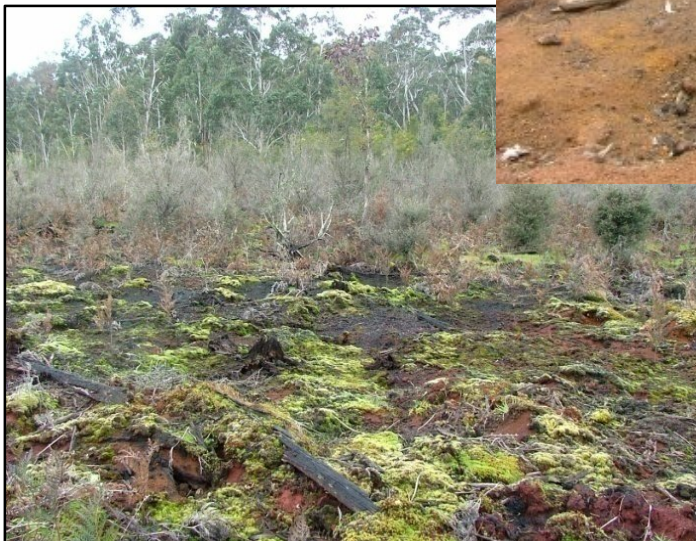
There is little evidence of mycorrhizal association. Mycorrhiza is a mutualistic symbiotic association that forms between the plants and fungi

active in the root zone. The roots of at least 95% of higher order plants form this mutualistic association. Any natural ecosystem normally contains a mixture of types of mycorrhizal associations. These associations are critical, complex and vary widely in form and function. Without these mycorrhizal root-fungal association, plant strategies for efficient

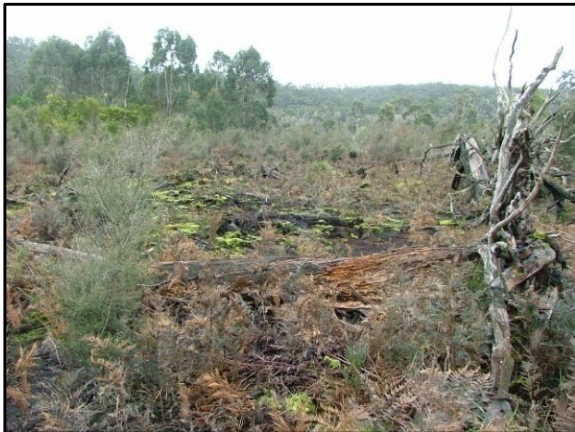
This area has had ten years to regenerate and these photographs depict how this has not happened.

Mosses, algae and stunted tea-tree appear to be the dominant growth in this peat area.

There are areas of the peat displaying hydrophobic reaction to water. This means that the peat and water repel one other. This is quite unusual considering this whole area was water logged pre groundwater pumping. The soil being hydrophobic also creates a problem for any seed germination.

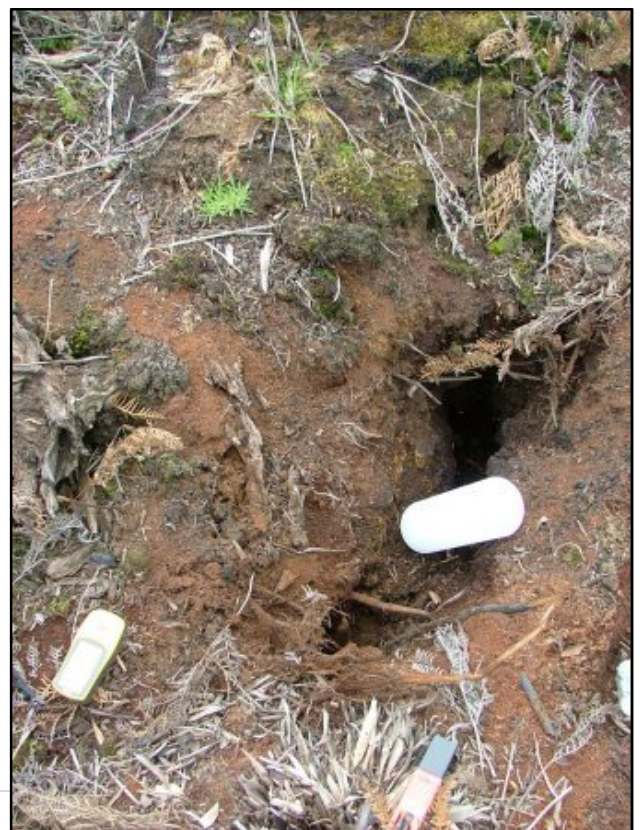
SITE FIVE – The Big Swamp

A similar hole to site 4 was dug under where a stump had been pulled out. The water tested at 2.7 pH (15 September 2008).

Any regeneration that has attempted to grow in this area has hugged the surface layer of peat and in most cases has succumbed to the acid levels as the

water table rises. Any living vegetation is struggling and would appear to have little chance of surviving.

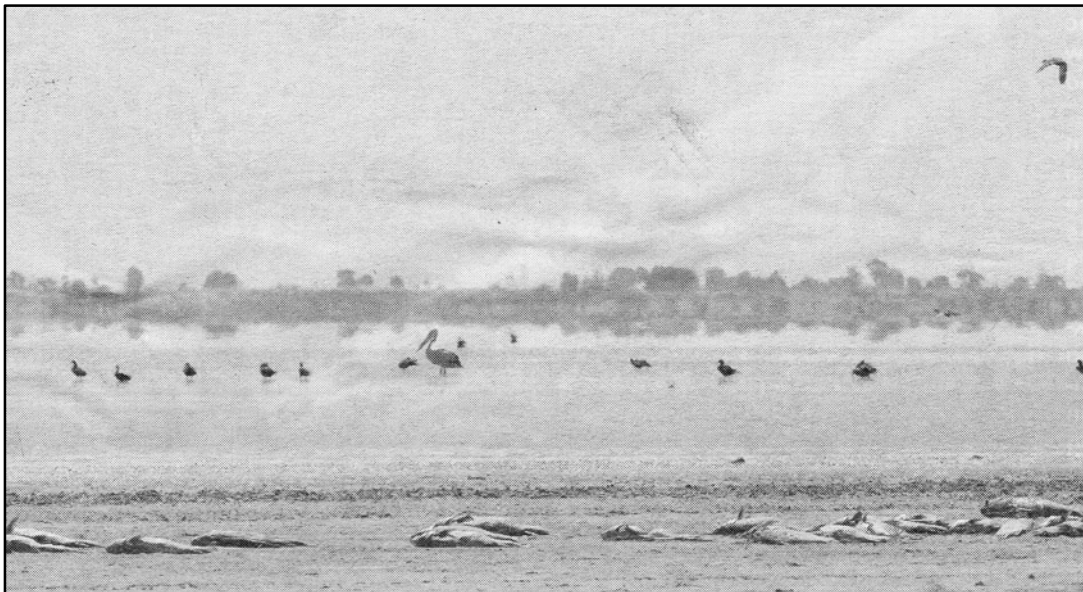
Photograph – Colac Herald 12 March 2008

Lake Colac is slowly drying up and groundwater extraction is a possible contributing factor.

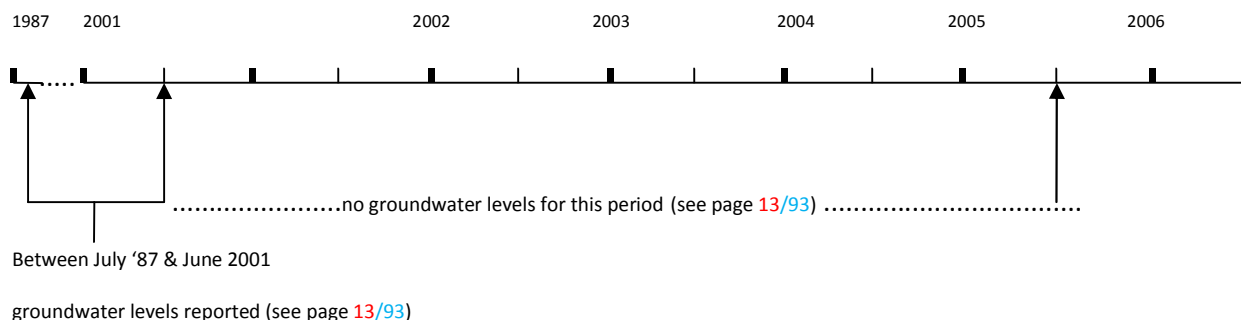
FIGURE. A . Year 2004/05 Report.

Figure A shows that the groundwater levels in Yeo 40 were taken from at least 1987 through to June 2001, (see page 13/93). For some reason there are no records shown from this date up to June 2005. Groundwater extraction at Barwon Downs took place during this period. Chris, can you explain to me why the extractions during this period are not shown?

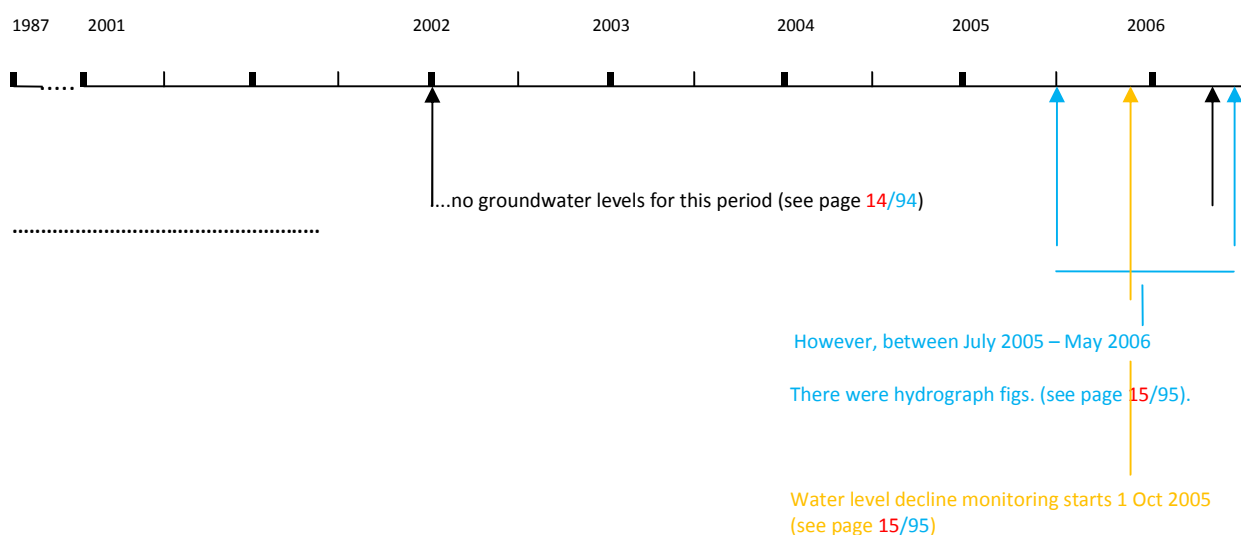
FIGURE. B. Year 2005/06 Report.

In Figure B during the 2005/06 reporting period one set of data states there are no water levels available, (see page 14/94) yet there are hydrograph (water level) figures, (see top of page 15/95) for some of the same period. In another section of the report (see bottom of page 15) there is a different set of data. Chris, why is there a different set of data?

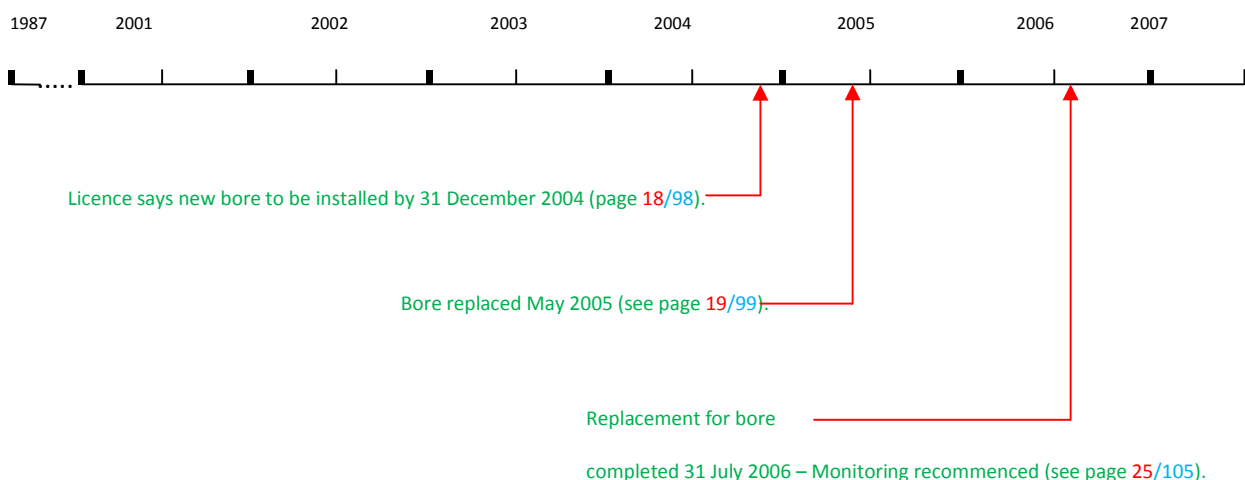
FIGURE. D. Data for the observation bore Yeo 40, taken from Barwon Water’s Groundwater Licence No. 893889 Gerangamete Area 2004/07 Reports that was sent to Southern Rural Water.

These reports clearly state Yeo 40 as being replaced in two different years.

A clear status of the operational condition of Yeo 40 is not apparent. Chris, can you tell me what the current functional status of Yeo 40?
